# CULVERT REPAIR AT BERKSHIRE DRIVE

Macedonia, OH

CUYAHOGA RIVER SOUTH · INDIAN CREEK

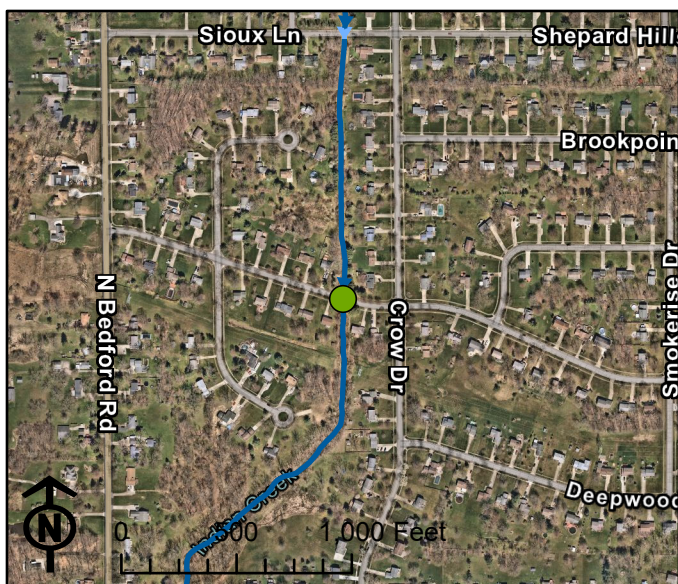
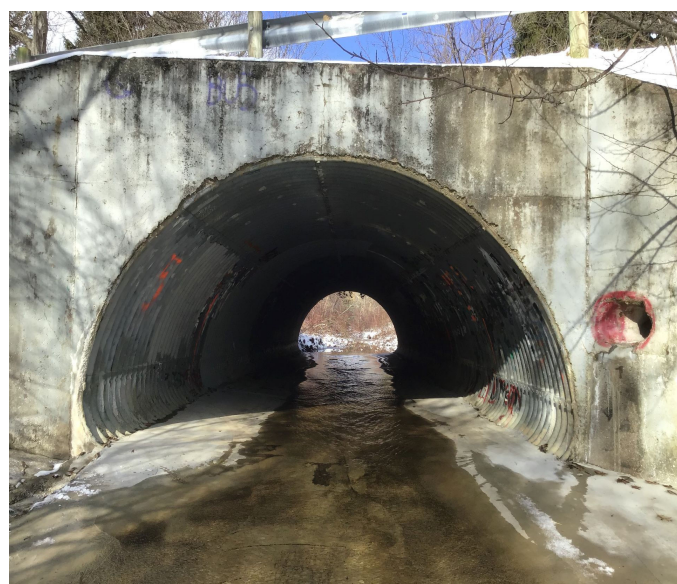
The invert of a corrugated metal pipe culvert beneath Berkshire Drive in Macedonia was corroded with erosion present at inlet, outlet, and nearby gabions. Culvert was sandblasted to remove rust, re-coated for corrosion resistance, and re-lined with concrete to preserve the integrity of the structure, extending the life of the culvert by another 10-20 years.
