DOAN BROOK STRUCTURAL REPAIR AT EATON ROAD

Shaker Heights, OH

LAKE ERIE DIRECT TRIBUTARIES · DOAN BROOK

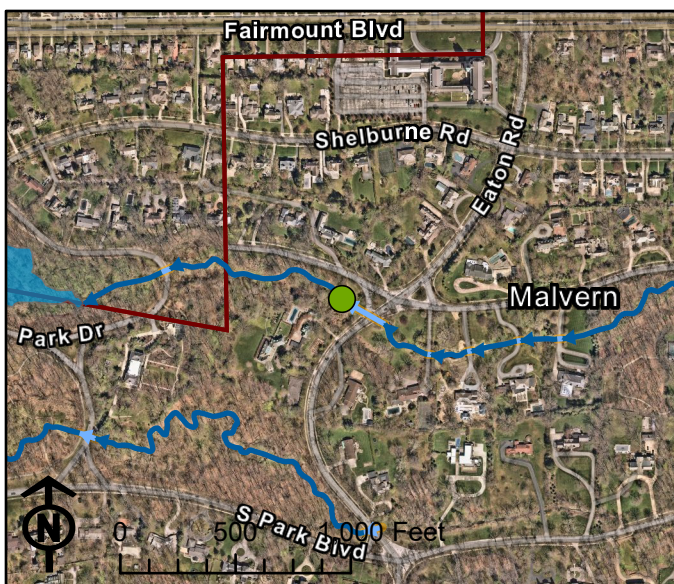
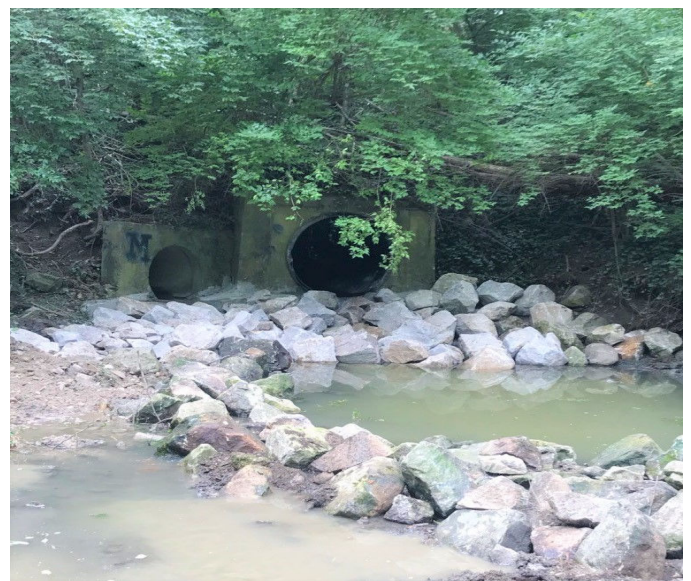
This project addressed the deep scour pool and undermined headwalls of the Eaton Rd. crossing outlet along Doan Brook in Shaker Heights. Riprap protection was installed at the culvert outlet to arrest further scour and minor repairs were made to the outlet footers to extend the useful life of the culvert.
