DOAN BROOK STRUCTURAL REPAIR AT EATON ROAD

Shaker Heights, OH

Summary

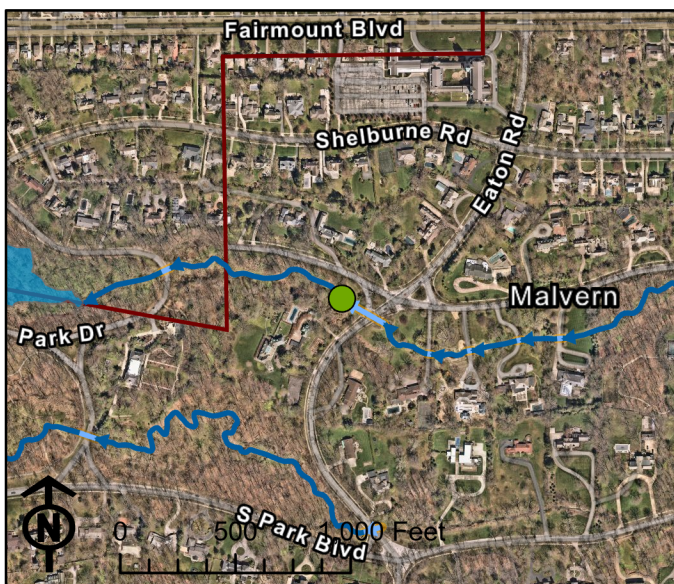
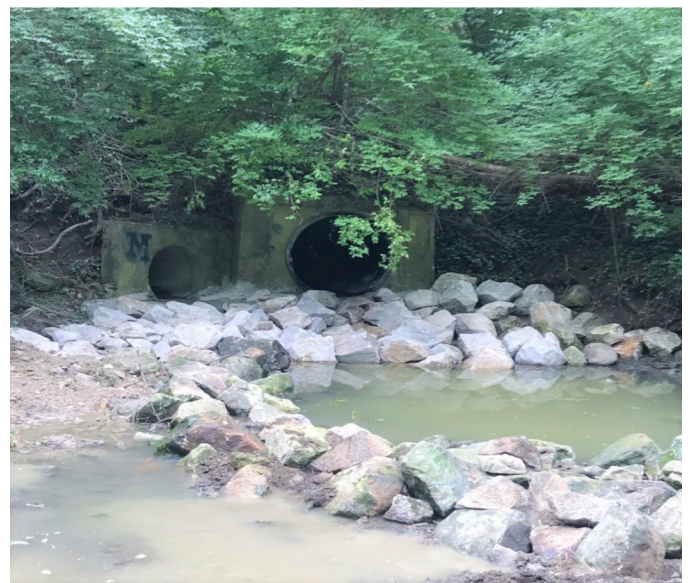
This project addressed the deep scour pool and undermined headwalls of the Eaton Rd. crossing outlet along Doan Brook in Shaker Heights. Riprap protection was installed at the culvert outlet to arrest further scour and minor repairs were made to the outlet footers to extend the useful life of the culvert.
