## Permeable Pavement Inspection and Maintenance Checklist

<b>Facility:</b> Western Reserve Historical Society			
<b>Location/Address:</b> 10824 East Blvd Cleveland, OH 44106			
<b>Date:</b> 7/2/2019	<b>Time:</b> 12:55pm	<b>Weather Conditions:</b> Sunny	<b>Date of Last Inspection:</b> N/A
<b>Inspector:</b> Crystal Davis, Spencer Nash, Christopher Hartman		<b>Title:</b> Inspection Report	
<b>Site Plan or As-Built Plan Available:</b> <input type="checkbox"/> Yes <input checked="" type="checkbox"/> No

## Bioretention Area Inspection and Maintenance Checklist

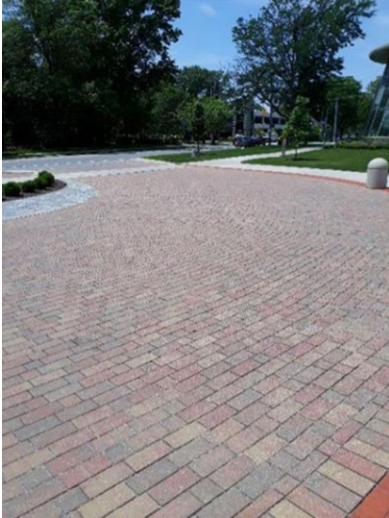
<p>Sediment has accumulated on pavement surface.  <input checked="" type="checkbox"/> Yes <input type="checkbox"/> No <input type="checkbox"/> NA</p> <p>Trash and debris have accumulated on pavement surface or around curbing.  <input checked="" type="checkbox"/> Yes <input type="checkbox"/> No <input type="checkbox"/> NA</p>

<p>Pavement has deteriorated, cracked, settled, or raveled.  <input type="checkbox"/> Yes <input checked="" type="checkbox"/> No <input type="checkbox"/> NA</p>	
<p>Sediment has accumulated in the joints of PICP.  <input checked="" type="checkbox"/> Yes <input type="checkbox"/> No <input type="checkbox"/> NA</p>	
<p>Vegetation is growing in the joints of PICP.  <input checked="" type="checkbox"/> Yes <input type="checkbox"/> No <input type="checkbox"/> NA</p>	
<p>Gravel is insufficient in the joints of PICP.  <input type="checkbox"/> Yes <input checked="" type="checkbox"/> No <input type="checkbox"/> NA</p>	
<p>Action needed.  <input checked="" type="checkbox"/> Yes <input type="checkbox"/> No <input type="checkbox"/> NA</p> <p>Comments: Sedimentation has occurred towards the middle area of the permeable pavers.</p>

<b>Wet weather inspection to be conducted by NEORS</b>	
<input type="checkbox"/> Yes <input checked="" type="checkbox"/> No <input type="checkbox"/> NA	
<b>SUMMARY</b> <b>Please address the following items:</b>  1. Permeable pavers in the back of Historical Society in the paid parking are to be cleaned (Refer to photo 1). The pavers in the roundabout area are in good condition.

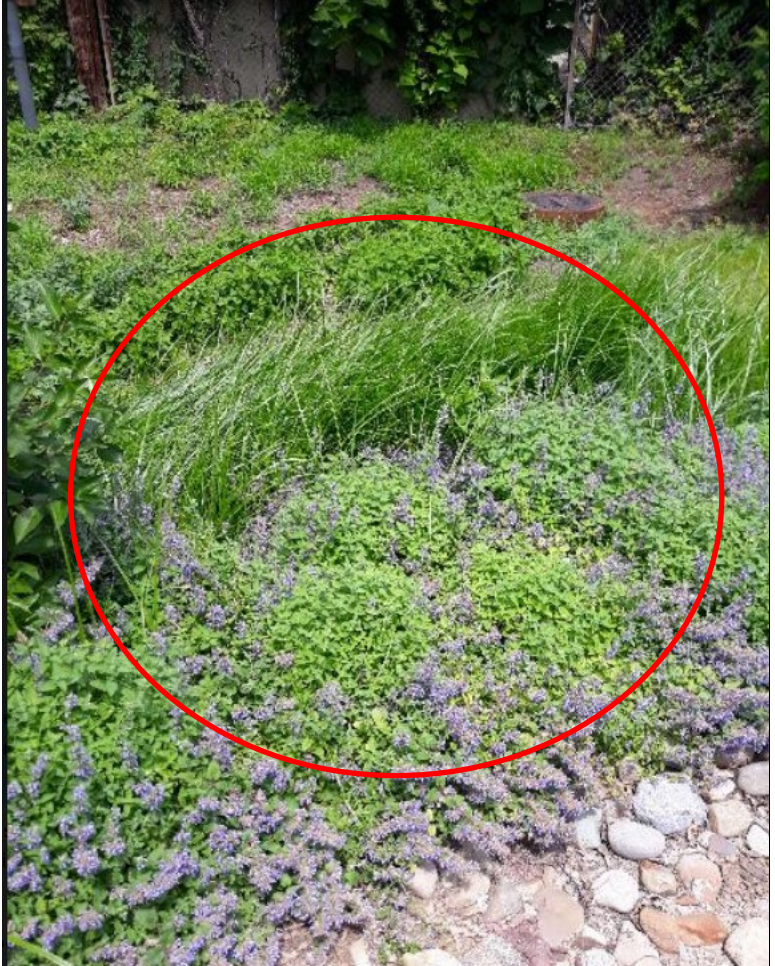
**Photo 1.**

<p>Comments: No additional comments.</p>	
<b>VEGETATION</b>	
<p>Vegetation is wilting, discolored, or dying due to disease or stress.  <input type="checkbox"/> Yes <input checked="" type="checkbox"/> No <input type="checkbox"/> NA</p>	
<p>Vegetation needs to be controlled through mowing or manual removal.  <input checked="" type="checkbox"/> Yes <input type="checkbox"/> No <input type="checkbox"/> NA</p>	
<p>Action needed.  <input checked="" type="checkbox"/> Yes <input type="checkbox"/> No <input type="checkbox"/> NA</p>	
<p>Comments: Applicant needs to weed the entirety of the cell.</p>	
<b>BIORETENTION MAIN INFILTRATION AREA</b>

Height from surface of practice to top of overflow structure is insufficient to allow for ponding during rain events. <input type="checkbox"/> Yes <input checked="" type="checkbox"/> No <input type="checkbox"/> NA	
Action needed. <input type="checkbox"/> Yes <input checked="" type="checkbox"/> No <input type="checkbox"/> NA	
Action needed. Note: No additional comments.	
<b>SUMMARY</b>  <b>Please address the following items:</b>  1. Regarding the bioretention cell, weeding efforts for the entirety of the practice should occur.
