Small Scale Stormwater Demonstration Projects (S3DP)  
Maintenance Inspection Checklist

<b>Project Site: Collinwood Art District Azure Green Parking Lot</b>	
<b>Address: 15602 Waterloo, 44110</b>	
<b>Inspector's Name:</b> Christopher Hartman, CPESC, CPSWQ, CESSWI	<b>Date and Time:</b> 6/19/18, 10:44am
<b>Overall Notes:</b>  1. Minor cracking of the porous concrete was observed, which should be monitored. 2. Applicant should conduct some minor weeding of all the areas of the practice. 3. Recommend adding mulch to the bioretention cell.

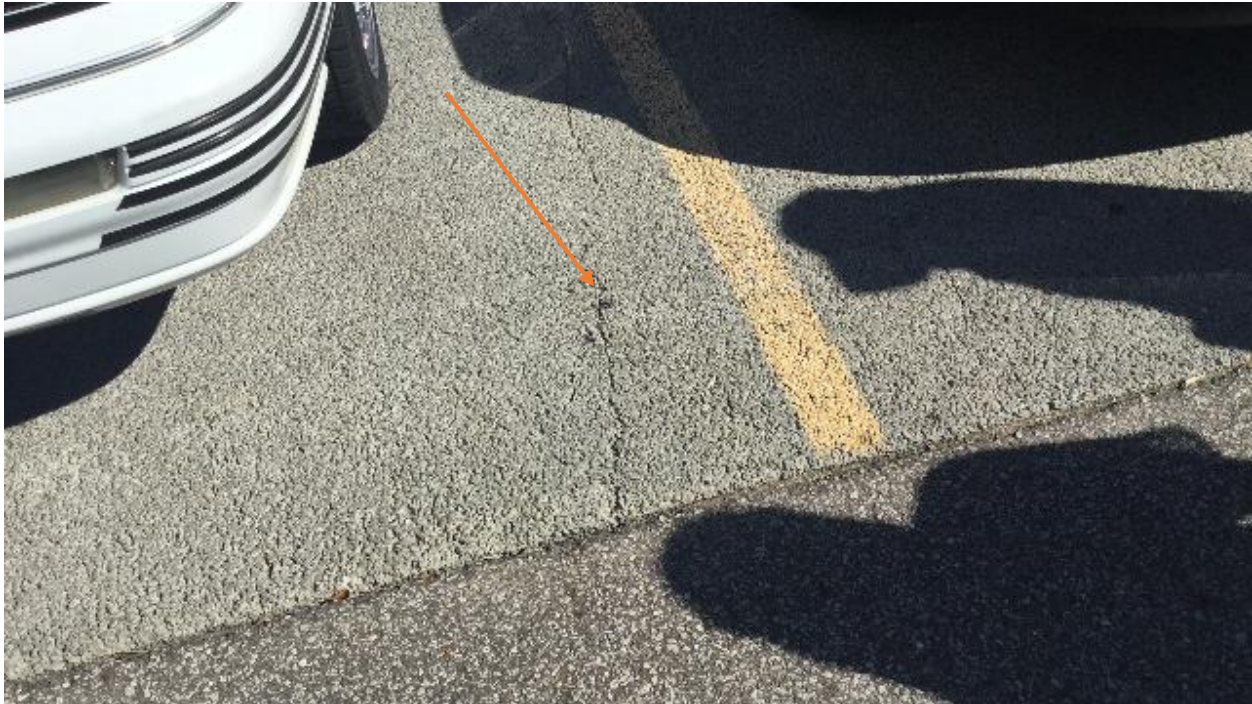
Pavement has deteriorated, cracked, settled, or raveled? <b>Yes</b>	Permeable pavement cracked notes:  <b>One crack in western area.</b>
Vegetation is growing in the joints? <b>Yes</b>	Vegetation notes:  <b>One small area on western section.</b>
Gravel is insufficient in the joints of the practice? <b>No</b>	Gravel notes:  <b>N/A</b>

**Explanation: Minor cracking observed within the porous concrete.**

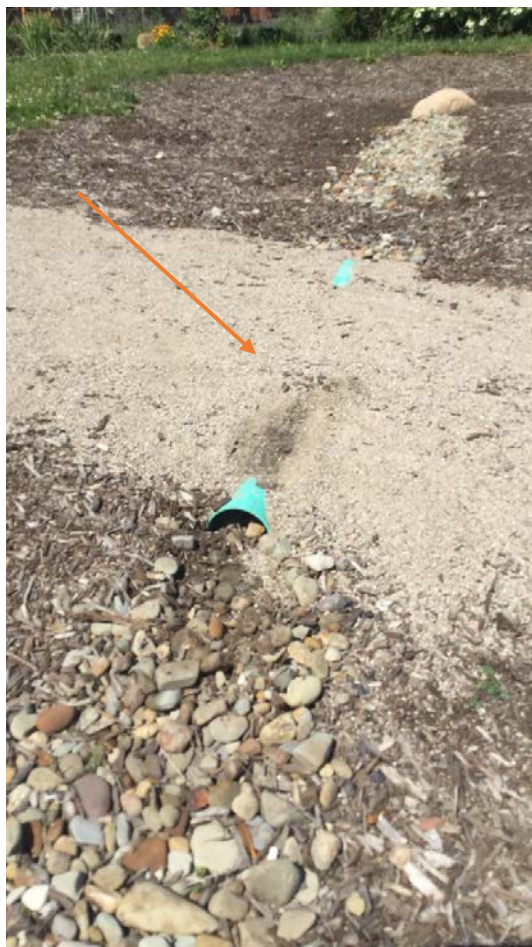
BIORETENTION (Select yes or no to the following maintenance questions)	
Is there debris present? <b>Yes</b>	Debris notes:  <b>Debris has accumulated in the PVC pipe.</b>
Is there a layer of sediment? <b>No</b>	Sediment notes:  <b>N/A</b>
Do the inlets provide stable conveyance into facility? <b>Yes</b>	Inlet notes:  <b>N/A</b>
Presence of invasive species/weeds? <b>No</b>	Invasive notes:  <b>N/A</b>
Dead vegetation/exposed soil? <b>No</b>	Soil notes:  <b>N/A</b>
Evidence of clogging? <b>Yes</b>	Clogging notes:  <b>Pvc pipe conveying runoff from downspout inlet is clogged.</b>

**Explanation: This pipe will need to be cleaned out in order to convey stormwater correctly.**

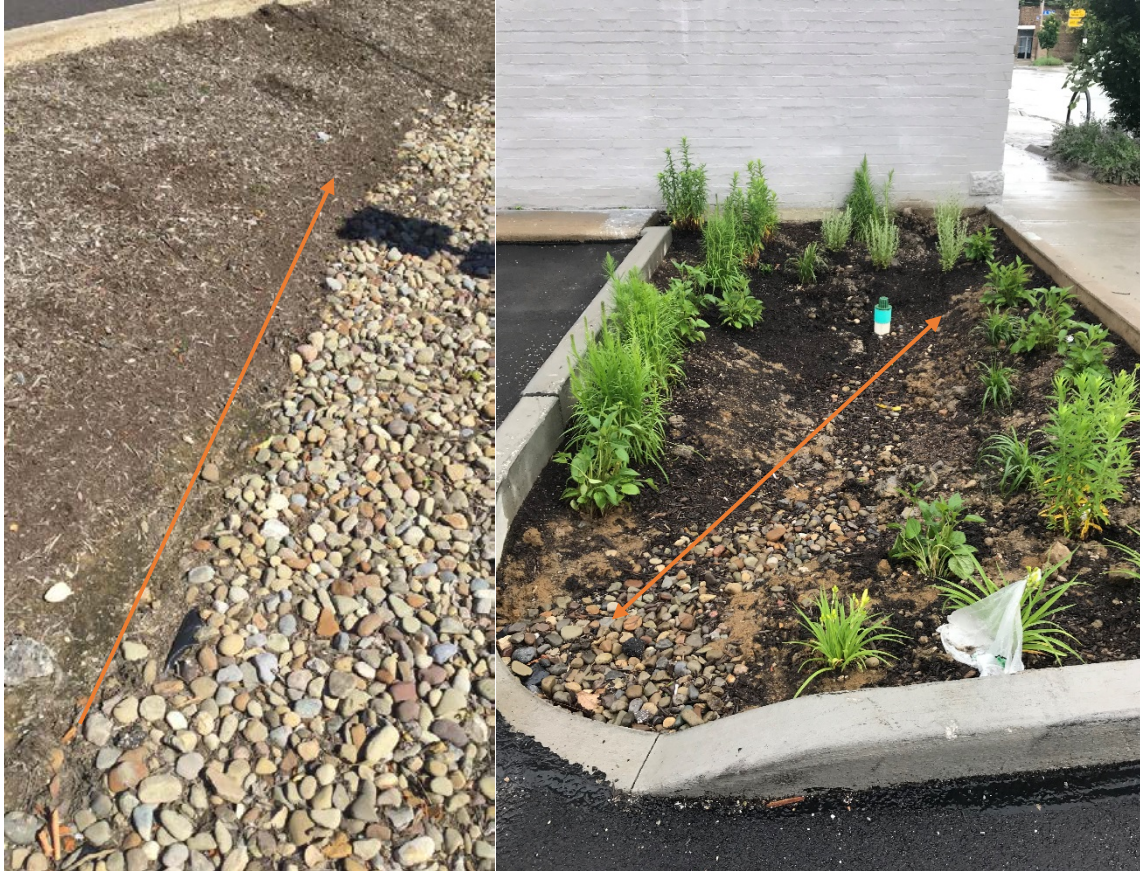
**Explanation:** Low flow rock channels need to be formed in a concave manner. The applicant will also need to remove debris from the practice that is at the entrance of the property. Ensure runoff is not first entering parking lot drain (just off right-hand photo) prior to entering the cell (i.e., add solid lid, re-grade as necessary, etc.).
