Green Infrastructure Grant Program (GIGP)

Maintenance Inspection Checklist

Site Name: Towpath Trail Stage 3		
Address: Clark Ave and Mary Court		
Inspector's Name:	Date and Time:	
Christopher Hartman, CPESC, CPSWQ, CESSWI	July 16 th 1:57pm	
Overall Notes:		
Ensure sediment-laden runoff from adjacent construction operations is properly managed prior to discharging into the practices. To date a significant amount of sediment has already accumulated within the practices. Practices will need to be restored to original design dimensions once contributing drainage areas are permanently stabilized.		
Ensure there is a watertight seal between the concrete riser sections and the outlet control structures.		
CISTERN (Select yes or no to the following maintenance questions)		
	Debrie notes: Debrie and runoff has deposited in the detention

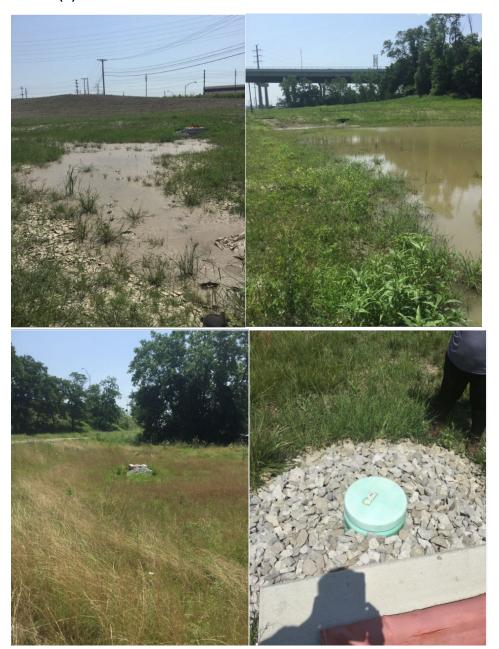
PHOTO(S) INFORMATION

CISTERN (Select yes or no to the following maintenance questions)	
Is there debris present?	Debris notes: Debris and runoff has deposited in the detention basins that are near the active construction sites.
Is there a layer of sediment?	Sediment notes: Ponding water at the beginning of the construction site.
Do the inlets provide stable conveyance into facility?	Inlet notes: N/A
Presence of invasive species/weeds?	Invasive notes :N/A
Dead vegetation/exposed soil?	Soil notes: N/A
Evidence of clogging?	Clogging notes: N/A
Evidence of erosion?	Erosion notes'/A
Evidence of standing water?	Standing water notes: N/A

Site Visit 10/18/18- The sediment that has deposited in the Stormwater Wetlands has accumulated at the bottom. Construction is still not finished.

After the site visit, the applicant said they would clean up the practices after construction. Plan to follow up on October 15th, 2018. They will not be conducting any plantings.
