## Bioretention Area Inspection and Maintenance Checklist

<b>Green Infrastructure Site Location and Address:</b> 3952 Brow Ave Newburgh Heights, OH 44105		
<b>Date and Time:</b> 07/2/2019 9:59am	<b>Weather Conditions:</b> ☀ Sunny	<b>Date of Last Inspection:</b>
<b>Inspector and Title:</b> Chris Hartman, CPESC, CESSWI, CPSWQ, Stormwater Technical Specialist, Crystal Davis, Watershed Programs Specialist, Spencer Nash, Watershed Programs Intern		
<b>Rain in Last 48 Hours</b> No <b>If yes, list amount and timing:</b> N/A		
<b>Pretreatment:</b> Other, Specify		<b>Other, specify:</b> N/A
<b>Site Plan or As-Built Plan Available:</b> Yes		
<b>Action items are noted below in SUMMARY section.</b>

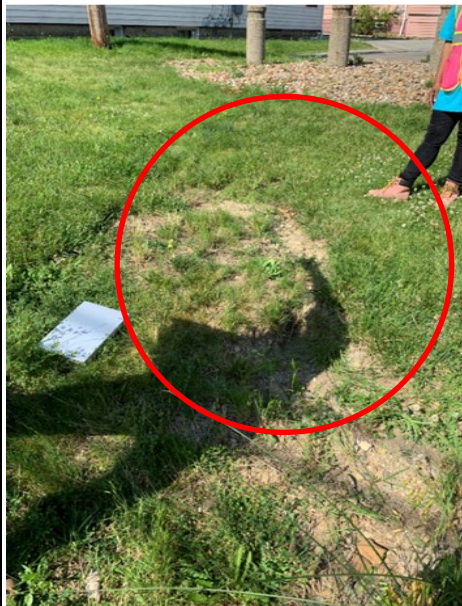
**Photo 2. Refer to action item 2.**

Topmost layer is caked or crusted over with sediment. <input type="checkbox"/> Yes <input checked="" type="checkbox"/> No <input type="checkbox"/> NA
Erosion is evident. <input checked="" type="checkbox"/> Yes <input type="checkbox"/> No <input type="checkbox"/> NA
Mulch is compacted. <input type="checkbox"/> Yes <input checked="" type="checkbox"/> No <input type="checkbox"/> NA
Sinkholes or animal borrows are present. <input type="checkbox"/> Yes <input checked="" type="checkbox"/> No <input type="checkbox"/> NA
Action needed. <input type="checkbox"/> Yes <input checked="" type="checkbox"/> No <input type="checkbox"/> NA
Comments: Erosion of topsoil is evident. Applicant needs to address the erosion in the middle of the cell east of the bollards.
<b>6. SIDE SLOPES AND EMBANKMENT</b>
Erosion is evident. <input type="checkbox"/> Yes <input checked="" type="checkbox"/> No <input type="checkbox"/> NA

1. Provide an answer on why the upturned elbow is currently capped (Photo 1).
2. Address the erosion that is taking place near the concrete bollards (Photo 2).
3. Remove the sediment and debris that has clogged the trench drain.
4. Conduct minor weeding efforts.
