Bioretention Area Inspection and Maintenance Checklist

Green Infrastructure Site Location and Address: St. Casimir Green Infrastructure Project, 8223 Sowinski Ave, 44103		
Date and Time: 07/23/2019 12:34 PM	Weather Conditions: ☀ Sunny	Date of Last Inspection:
Inspector and Title: Chris Hartman, CPESC, CESSWI, CPSWQ, Stormwater Technical Specialist, Crystal Davis, Watershed Programs Specialist, Spencer Nash, Watershed Programs Intern		
Site Plan or As-Built Plan Available: Yes

Permeable Pavement Inspection and Maintenance Checklist

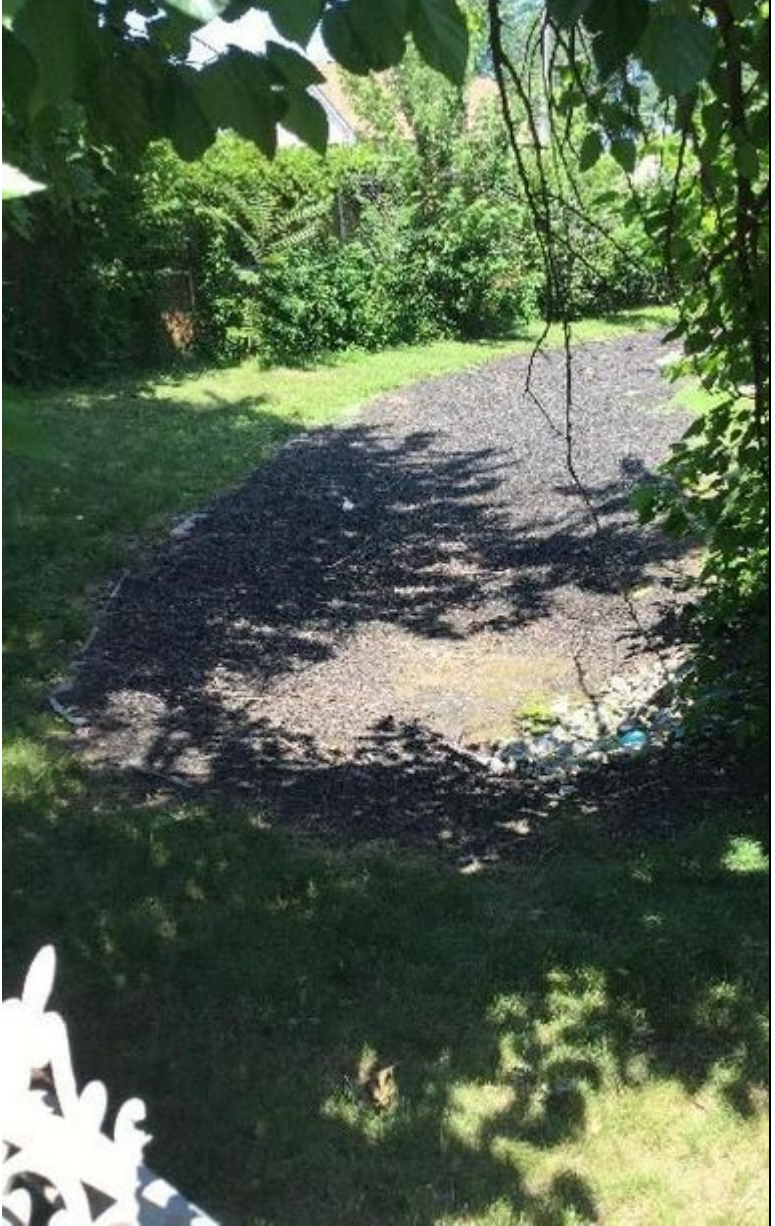
Photo 1

<p>No additional comments.</p>	
VEGETATION	
<p>Vegetation is wilting, discolored, or dying due to disease or stress.</p> <p><input type="checkbox"/> Yes <input checked="" type="checkbox"/> No</p>	
<p>Vegetation needs to be controlled through mowing or manual removal.</p> <p><input type="checkbox"/> Yes <input checked="" type="checkbox"/> No</p>	
<p>Action needed.</p> <p><input type="checkbox"/> Yes <input checked="" type="checkbox"/> No</p>	
<p>Additional comments.</p> <p>No planting plan for bioretention cells. No action needed.</p>	
BIORETENTION MAIN INFILTRATION AREA	
<p>Trash and debris have accumulated.</p> <p><input type="checkbox"/> Yes <input checked="" type="checkbox"/> No <input type="checkbox"/> NA</p>

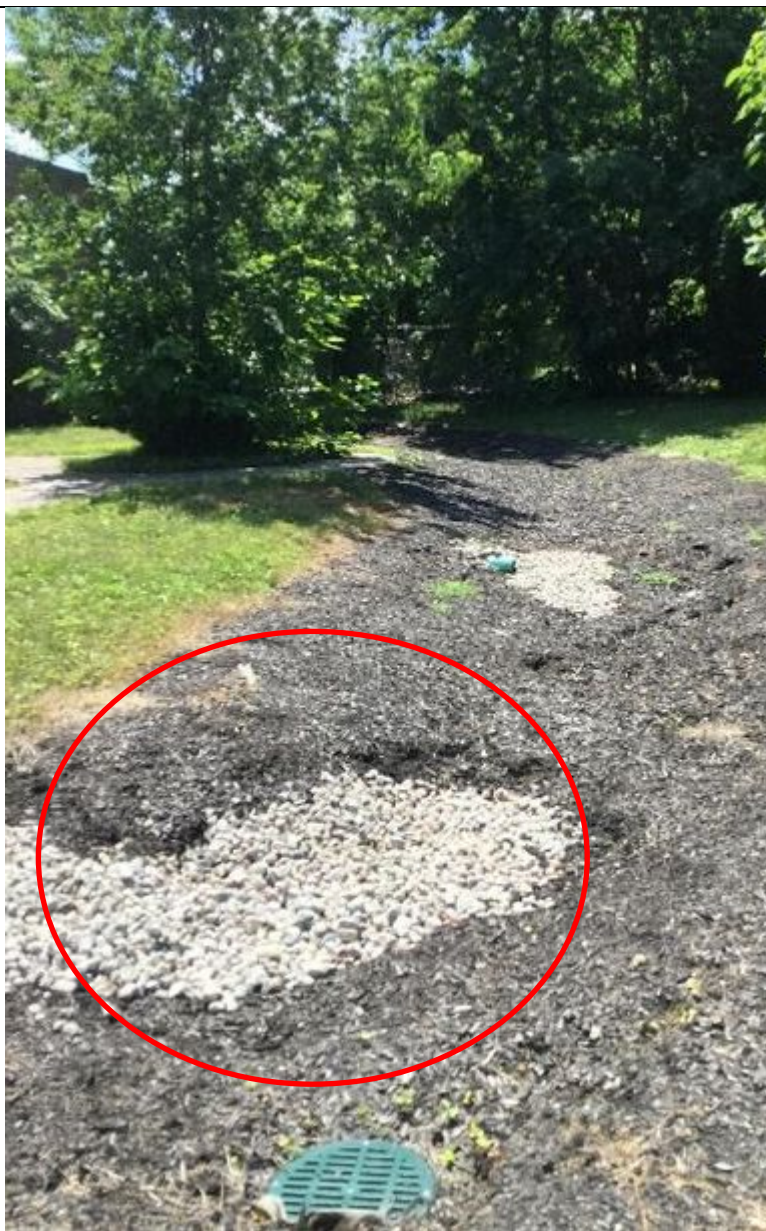
Photo 2.

Note: Sediment accumulation by outlet.
Check plans to see height of outlet structure
(Refer to photo 2).

1. Clear debris from the outlet structure (Refer to photo 2). Ensure the outlet structure on western basin is at the correct elevation to cause inflow to pond and infiltrate.
2. Trim away the vegetation that is covering the signage near the rear bioretention cell (Refer to photo 3 for location) (Vegetation that has grown on the fence).

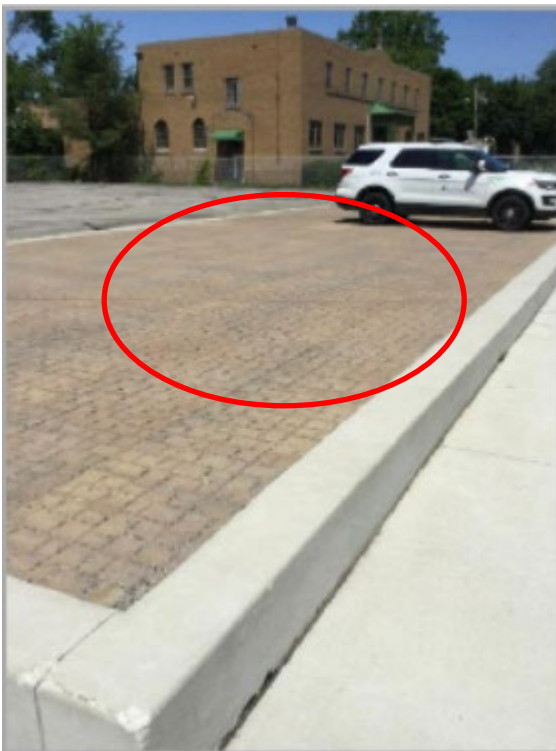
Action needed. <input type="checkbox"/> Yes <input checked="" type="checkbox"/> No <input type="checkbox"/> NA		
Comments: There is some slight heaving in the northeast portion of the permeable pavers.		
DEWATERING		
Standing water is present after 24 hours. If yes, describe sheen, color, or smell. Yes <input checked="" type="checkbox"/> No <input type="checkbox"/> NA		
Action needed. <input type="checkbox"/> Yes <input checked="" type="checkbox"/> No <input type="checkbox"/> NA		
Comments: No additional comments.		
PAVEMENT SURFACE AND JOINTS		
Sediment has accumulated on pavement surface. <input type="checkbox"/> Yes <input checked="" type="checkbox"/> No <input type="checkbox"/> NA	Photo 1 ----- -----

Trash and debris have accumulated on pavement surface or around curbing. <input type="checkbox"/> Yes <input checked="" type="checkbox"/> No <input type="checkbox"/> NA		
Pavement has deteriorated, cracked, settled, or raveled. <input type="checkbox"/> Yes <input checked="" type="checkbox"/> No <input type="checkbox"/> NA		
Sediment has accumulated in the joints of PICP. <input checked="" type="checkbox"/> Yes <input type="checkbox"/> No <input type="checkbox"/> NA		
Vegetation is growing in the joints of PICP. <input type="checkbox"/> Yes <input checked="" type="checkbox"/> No <input type="checkbox"/> NA		
Gravel is insufficient in the joints of PICP. <input type="checkbox"/> Yes <input checked="" type="checkbox"/> No <input type="checkbox"/> NA		
Action needed. <input checked="" type="checkbox"/> Yes <input type="checkbox"/> No <input type="checkbox"/> NA		
Comments: Applicant needs to conduct routine maintenance on the paver system. Remove the sediment that has accumulated and dispose of properly.

Wet weather inspection to be conducted by NEORS	
<input type="checkbox"/> Yes <input checked="" type="checkbox"/> No <input type="checkbox"/> NA	
SUMMARY Please address the following items: 1. Applicant needs to conduct routine maintenance on the paver system. Remove the sediment that has accumulated and dispose of properly (Refer to photo 1).
