Re: Annual Inspection with Concerns
Project Title: Colfax Green Links

Bioretention Area Inspection and Maintenance Checklist

| Green Infrastructure Site Location and Address: Colfax Ave & East 75th Street and & 541 Kinsman Road, Cleveland, OH, 44104 | | |

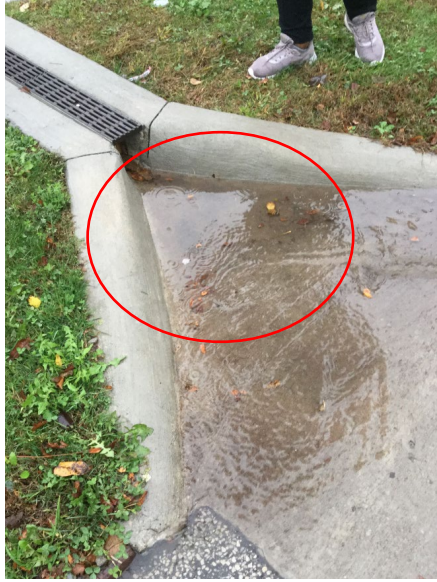
| Inspection Item | Images |
|---|---|
| Comments: Both trench drains located on the right side of East 75 th Street, facing North, are clogged with sediment and debris. Stormwater is bypassing the drains. Drains will need to be cleared (Refer to photo 1). | |

| Summary: <ol style="list-style-type: none"> Both trench drains need to be cleared of trash and debris (Refer to photo 1). Cell on the right side of East 75th street has collected trash. Remove trash and dispose of properly (Refer to photo 2). Stone placed at the end of the first trench drain located on the right side of East 75th is too high. This creates a small dam and does not allow water to enter the cell properly. Reduce stone height and spread out stone (Refer to photo 3). | |

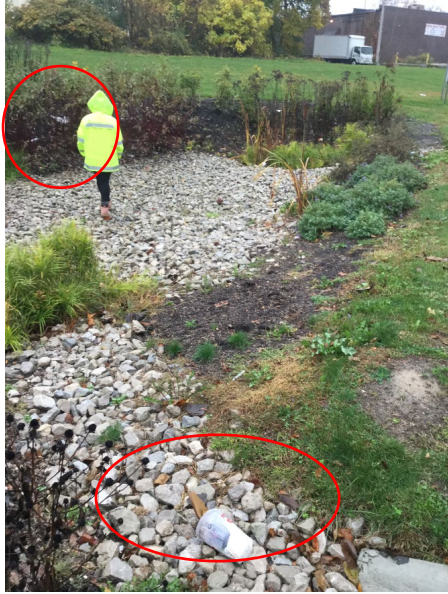
| Comments: Trash and debris has accumulated in the cell (Refer to photo 2). | |

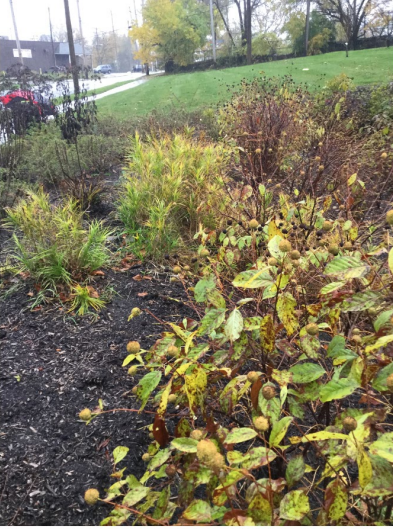
Photo 1.

| Summary: <div> 1. Cell is in good condition and is ponding water correctly. </div> | |

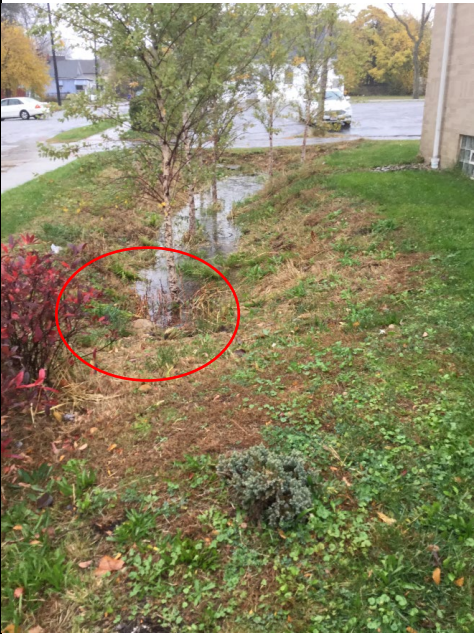
Photo 1.

| Inspection Item | Images |
|--|--|
| Comments: The District needs clarification on how stormwater is getting to the cell (Refer to photo 2). If the inlet goes from the roof to main cell area, the inlet needs to be clear of debris (Refer to photo 1). | |

| Summary: 1. Provide an explanation on how stormwater is getting into the cell. Being on site, it looks like the downspouts are connected. Need clarification on whether they are connected to local storm drains or conveyed to the bioretention cell (Refer to photos 1 & 2). | |
