## Cistern Inspection and Maintenance Checklist

<b>Green Infrastructure Site Location and Address: Family Ministry Center, 3389 Fulton Rd, Cleveland, OH 44109</b>		
<b>Date and Time: August 21, 2019, 11:00am</b>	<b>Weather Conditions: Sunny</b>	<b>Date of Last Inspection: N/A</b>
<b>Inspector and Title: Christopher Hartman, Spencer Nash.</b>		
<b>Site Plan or As-Built Plan Available: YES</b>

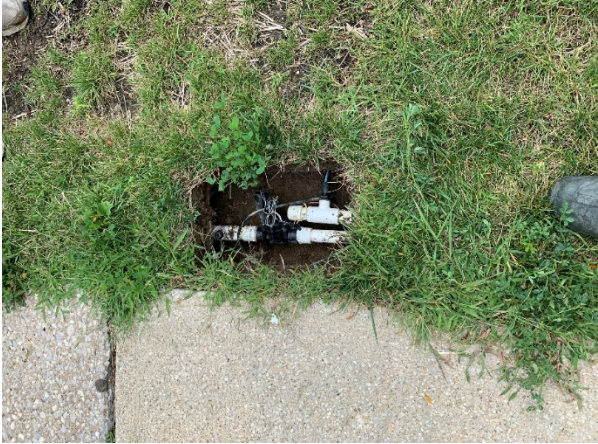
Inspection Item	Images
<b>PRETREATMENT</b>	
Sediment and debris have accumulated in gutter. <input type="checkbox"/> Yes <input checked="" type="checkbox"/> No

<p><b>Photo 1</b></p> <p>-----</p> <p>-----</p>
The screen or trap is clogged or not attached. <input checked="" type="checkbox"/> Yes <input type="checkbox"/> No <input type="checkbox"/> NA	
Action needed. <input type="checkbox"/> Yes <input checked="" type="checkbox"/> No <input type="checkbox"/> NA	
Comments: Sediment and debris has accumulated in the pretreatment filter screen near the eastern portion of the underground detention chambers. Applicant is aware of this and is addressing the problem.	
<b>FOUNDATION</b>	
Barrel foundation is unstable: <input type="checkbox"/> Yes <input checked="" type="checkbox"/> No

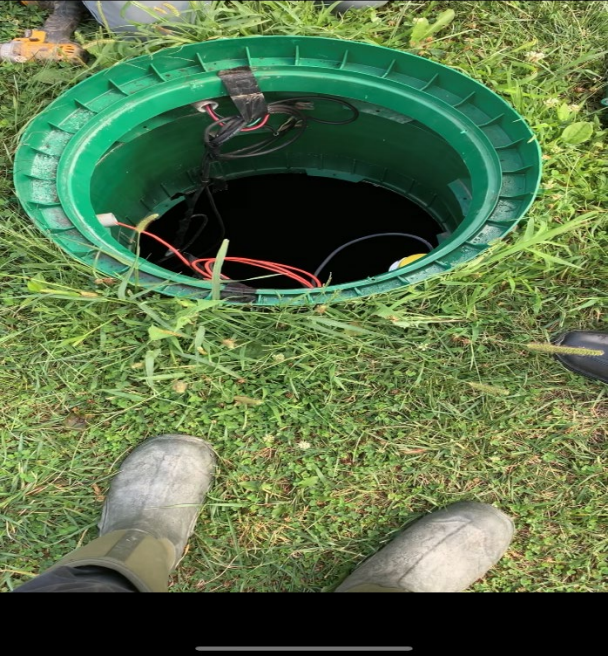
<b>INLETS/DOWNSPOUTS</b>	
Gutters and downspouts joints are disconnected and/or leaks are present: <input checked="" type="checkbox"/> Yes <input type="checkbox"/> No <input type="checkbox"/> NA

<p><b>Photo 2</b></p>
Downspouts are disconnected to barrel and/or leaks are present: <input type="checkbox"/> Yes <input checked="" type="checkbox"/> No <input type="checkbox"/> NA	
Diverter is disconnected and/or leaks are present: <input type="checkbox"/> Yes <input checked="" type="checkbox"/> No <input type="checkbox"/> NA	
Action needed: <input checked="" type="checkbox"/> Yes <input type="checkbox"/> No <input type="checkbox"/> NA

Comments: Applicant needs to re-connect the downspout that leads into the underground detention system. Applicant was made aware of this problem.
<b>Spigot</b>
Visible leaks are present, and connections are not tight. <input checked="" type="checkbox"/> Yes <input type="checkbox"/> No <input type="checkbox"/> NA
Valves and knobs do not turn. <input type="checkbox"/> Yes <input checked="" type="checkbox"/> No <input type="checkbox"/> NA
Action needed. <input checked="" type="checkbox"/> Yes <input type="checkbox"/> No <input type="checkbox"/> NA
Comments: Applicant needs to ensure that spigots for the above-ground cisterns near the permeable pavers are functional.
<b>RAIN BARREL/CISTERN</b>
Sediment accumulated at bottom of barrel. <input type="checkbox"/> Yes <input checked="" type="checkbox"/> No <input type="checkbox"/> NA
Odor of mildew present or algae is visible inside the barrel. <input type="checkbox"/> Yes <input checked="" type="checkbox"/> No <input type="checkbox"/> NA
