Bioretention Area Inspection and Maintenance Checklist

Facility: Fairhill Partners					
Location/Address: 12200 Fairhill Rd, Cleveland, OH 44120					
Date: 7/2/2019	Time: 11:17am	Weather Conditions: Sunny			Date of Last Inspection: N/A
Inspector: Chris Hartman, CPESC, CESSWI, CPSWQ, Stormwater Technical Specialist, Crystal Davis, Watershed Programs Specialist, Spencer Nash, Watershed Programs Intern, Jessica Cotton, GIS Technician				Title: Inspection Report	
Rain in Last 48 Hours <input type="checkbox"/> Yes <input checked="" type="checkbox"/> No If yes, list amount and timing: N/A					
Pavement Type: <input type="checkbox"/> permeable interlocking concrete pavement (PICP) <input type="checkbox"/> asphalt <input type="checkbox"/> concrete <input type="checkbox"/> other, specify:					
Pretreatment: <input type="checkbox"/> vegetated filter strip <input type="checkbox"/> swale <input type="checkbox"/> turf grass <input type="checkbox"/> forebay <input type="checkbox"/> other, specify: <input type="checkbox"/> none

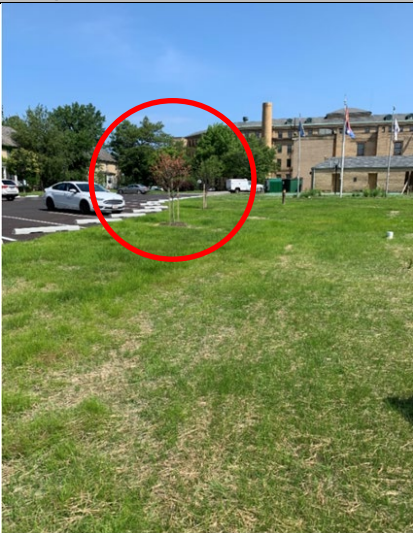
<p>Photo 1 (Refer to action item 1).</p>

4. VEGETATION	
Vegetation is wilting, discolored, or dying due to disease or stress. <input checked="" type="checkbox"/> Yes <input type="checkbox"/> No <input type="checkbox"/> NA	
Vegetation needs to be controlled through mowing or manual removal. <input type="checkbox"/> Yes <input checked="" type="checkbox"/> No <input type="checkbox"/> NA	
Action needed. <input type="checkbox"/> Yes <input checked="" type="checkbox"/> No <input type="checkbox"/> NA	
Comments: Several trees are dying and or are dead.

Comments: Small layer of sediment is present on top of the bioretention cell.	
6. SIDE SLOPES AND EMBANKMENT	
Erosion is evident. <input type="checkbox"/> Yes <input checked="" type="checkbox"/> No <input type="checkbox"/> NA	
Sinkholes or animal borrows are present. <input type="checkbox"/> Yes <input checked="" type="checkbox"/> No <input type="checkbox"/> NA	
Action needed. <input type="checkbox"/> Yes <input checked="" type="checkbox"/> No <input type="checkbox"/> NA	
Comments: No additional comments.

1. Inform applicant that several trees have died and will need to be replaced. Furthermore, a small layer of sediment has been found on top of the middle area of the bioretention cell. The sediment should be removed and disposed of properly **(Refer to photos 1 & 2)**.

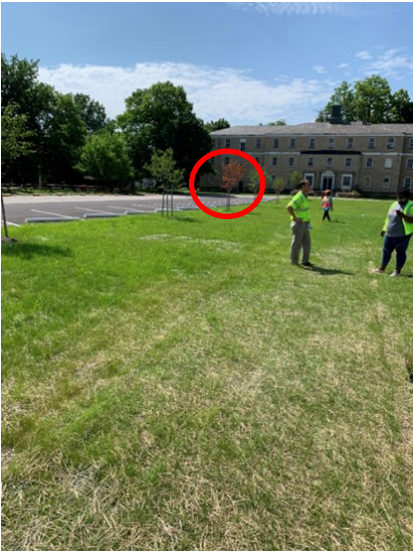
<p>Photo 2 (Refer to action item 1).</p>
