Re: Annual Inspection with Concerns
Project Title: First Unitarian Solar Rain Garden

Rain Barrel/Cistern Inspection and Maintenance Checklist

| Green Infrastructure Site Location and Address: First Unitarian Solar Rain Garden | | |

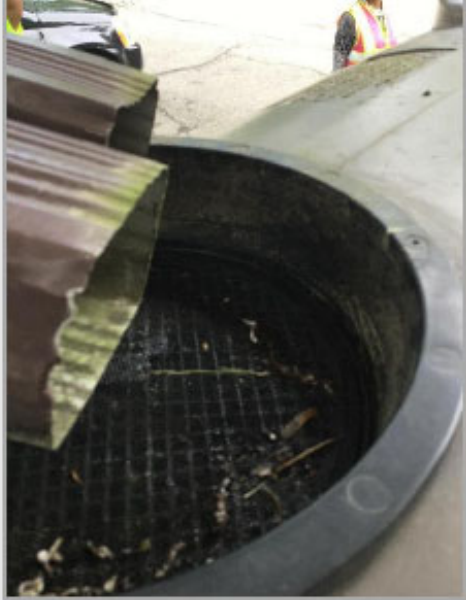
| Inspection Item | Images |
|---|--|
| Gutters and downspouts joints are disconnected and/or leaks are present: <input type="checkbox"/> Yes <input checked="" type="checkbox"/> No <input type="checkbox"/> NA | Photo 1. --- --- |

| Inspection Item | Images |
|---|--|
| The screen or trap is clogged or not attached. <input checked="" type="checkbox"/> Yes <input type="checkbox"/> No <input type="checkbox"/> NA | |
| Comments: Accumulation of debris in the filter for the square cisterns. Remove the debris that is present and dispose of properly. Please refer to photo 1. | |

| SUMMARY Please address the following items: <ol style="list-style-type: none"> Provide verification how the stored water is being utilized and an estimate of how much is utilized. Clear the debris that has deposited in the pretreatment filters (square cisterns) (Refer to photo 1 for location). | |
