Bioretention Area Inspection and Maintenance Checklist

Green Infrastructure Site Location and Address: Fleet Ave Permeable Pavement & Stone Retention		
Date and Time: 07/2/2019 10:18am	Weather Conditions: ☀️ Sunny	Date of Last Inspection:
Inspector and Title: Chris Hartman, CPESC, CESSWI, CPSWQ, Stormwater Technical Specialist, Crystal Davis, Watershed Programs Specialist, Spencer Nash, Watershed Programs Intern, Jessica Cotton, GIS Technician		
Rain in Last 48 Hours No	If yes, list amount and timing: N/A	
Pretreatment: Other, Specify	Other, specify: N/A	
Site Plan or As-Built Plan Available: Yes		
Action items are noted below in SUMMARY section.

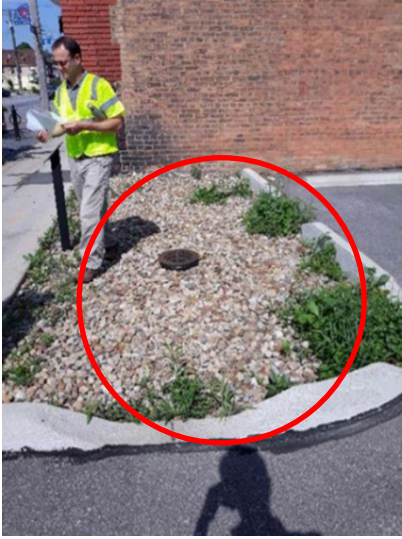
3. INLETS	
Inlets are in poor structural condition. <input type="checkbox"/> Yes <input checked="" type="checkbox"/> No <input type="checkbox"/> NA	
Sediment has accumulated and/or is blocking the inlets. <input checked="" type="checkbox"/> Yes <input type="checkbox"/> No <input type="checkbox"/> NA	
Erosion is occurring around the inlets. <input type="checkbox"/> Yes <input checked="" type="checkbox"/> No <input type="checkbox"/> NA	
Action needed. <input type="checkbox"/> Yes <input checked="" type="checkbox"/> No <input type="checkbox"/> NA	
Comments: Accumulation of debris in curb cut. Recommend to applicant that it is cleaned out and disposed of properly.

4. VEGETATION	
Vegetation is wilting, discolored, or dying due to disease or stress. <input type="checkbox"/> Yes <input checked="" type="checkbox"/> No <input type="checkbox"/> NA	
Vegetation needs to be controlled through mowing or manual removal. <input checked="" type="checkbox"/> Yes <input type="checkbox"/> No <input type="checkbox"/> NA	
Action needed. <input checked="" type="checkbox"/> Yes <input type="checkbox"/> No <input type="checkbox"/> NA	
Comments: Weeding should be conducted.

SUMMARY	
Additional Action Required:	
1. Ensure weeds that are present in photo 1 are removed.

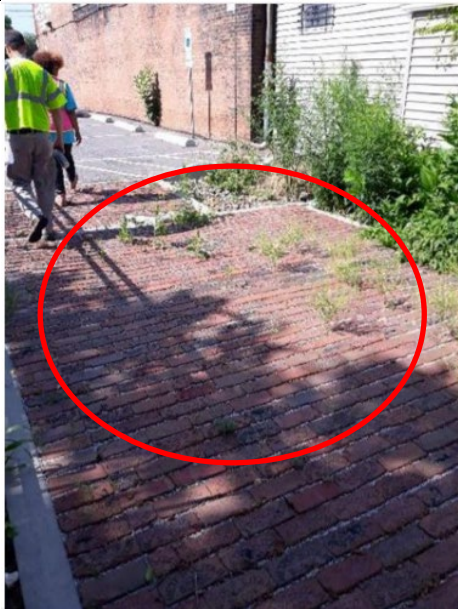
<p>Photo 1. (Refer to action item 2).</p>

Inspection Item	Images
1. PRETREATMENT Sediment has accumulated. <input checked="" type="checkbox"/> Yes <input type="checkbox"/> No <input type="checkbox"/> NA Trash and debris have accumulated. <input checked="" type="checkbox"/> Yes <input type="checkbox"/> No <input type="checkbox"/> NA Action needed. <input checked="" type="checkbox"/> Yes <input type="checkbox"/> No <input type="checkbox"/> NA Comments: Minor sediment accumulation and vegetation has started to settle in the practice. Some areas joints have started to come out of pavers.

1. Fill the joints of the permeable pavers back in. This can be done through the means of a large brush (photo 1, permeable pavers).
2. Remove the vegetation that is growing in-between the joints of the permeable pavers (photo 2, permeable pavers)
3. Remove the debris blocking the curb inlets (photo 3, permeable pavers)

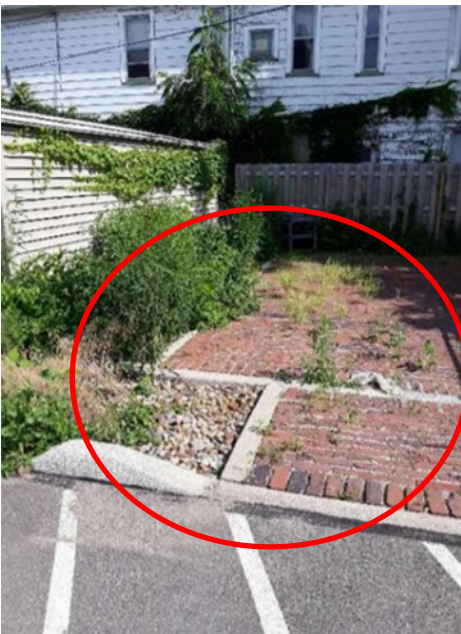
<p>Photo 2. (Refer to action item 2).</p>

Comments: Inform applicant that routine maintenance should be conducted. Clearing of vegetation and sweeping joints back into the paver voids.	
<div style="background-color: #f4a460; padding: 2px; border: 1px solid black;"> Wet weather inspection to be conducted by NEORS </div>	
<div style="border: 1px solid black; padding: 10px;"> <div style="background-color: #f4a460; padding: 2px; border: 1px solid black; margin-bottom: 10px;"> Wet weather inspection to be conducted by NEORS </div> <div> <input type="checkbox"/> Yes <input checked="" type="checkbox"/> No <input type="checkbox"/> NA </div> </div>

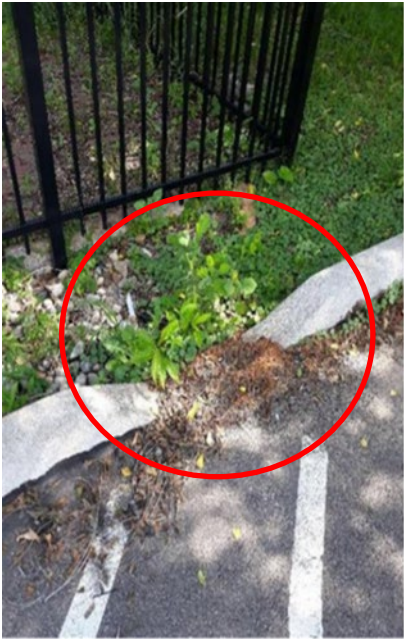
Photo 3. (Refer to action item 3)

4. PAVEMENT SURFACE AND JOINTS Sediment has accumulated on pavement surface. <input checked="" type="checkbox"/> Yes <input type="checkbox"/> No <input type="checkbox"/> NA Trash and debris have accumulated on pavement surface or

around curbing. <input checked="" type="checkbox"/> Yes <input type="checkbox"/> No <input type="checkbox"/> NA	<div style="border-top: 1px dashed black; border-bottom: 1px dashed black; height: 100px; position: relative;">
