## Bioretention Area Inspection and Maintenance Checklist

<b>Green Infrastructure Site Location and Address:</b> Forest Ridge Extension, 3850 Chagrin River Road, Moreland Hills, OH 44022		
<b>Date and Time:</b> 08/20/2019 11:54am	<b>Weather Conditions:</b> ☀ Sunny	<b>Date of Last Inspection:</b>
<b>Inspector and Title:</b> Crystal Davis, Watershed Programs Specialist, Spencer Nash, Watershed Programs Intern, Jessica Cotton, GIS Technician		
<b>Site Plan or As-Built Plan Available:</b> Yes		
<b>Action items are noted below in SUMMARY section.</b>

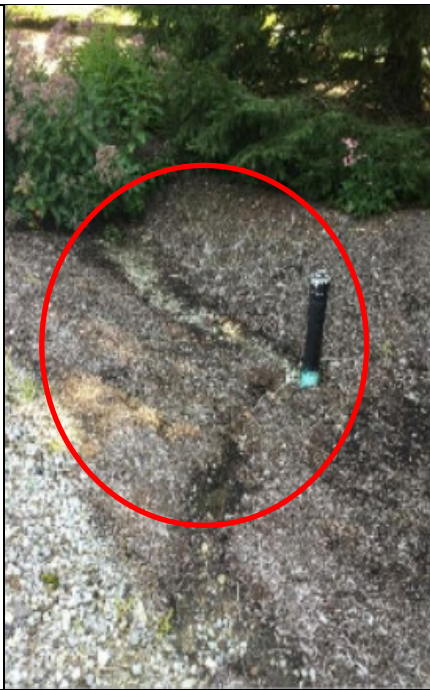
**Photo 5**

Erosion is evident. <input checked="" type="checkbox"/> Yes <input type="checkbox"/> No <input type="checkbox"/> NA
Sinkholes or animal borrows are present. <input type="checkbox"/> Yes <input checked="" type="checkbox"/> No <input type="checkbox"/> NA
Action needed. <input type="checkbox"/> Yes <input checked="" type="checkbox"/> No <input type="checkbox"/> NA
Comments: Applicant needs to ensure that the erosion that is present on the side slope is stabilized ( <b>Western cell, gravel parking lot. Refer to photo 5</b> ).

1. Ensure the sediment and gravel that has deposited in the two cells directly adjacent to Chagrin River Road, are removed and disposed of properly (**Refer to photos 1, 2, 3, and 4**).
2. Ensure the erosion that is present in the cell located in the parking lot is stabilized (**Refer to photo 5**) (Cell to the right of the entrance, facing Chagrin River Road).
