## Bioretention Area Inspection and Maintenance Checklist

<b>Green Infrastructure Site Location and Address:</b> Bioretention Areas at Jefferson Branch Library Project, 850 Jefferson Ave Cleveland, OH, 441113		
<b>Date and Time:</b> 07/9/2019 11:40am	<b>Weather Conditions:</b> ☀ Sunny	<b>Date of Last Inspection:</b>
<b>Inspector and Title:</b> Chris Hartman, CPESC, CESSWI, CPSWQ, Stormwater Technical Specialist, Crystal Davis, Watershed Programs Specialist, Spencer Nash, Watershed Programs Intern		
<b>Rain in Last 48 Hours:</b> No <b>If yes, list amount and timing:</b> N/A		
<b>Site Plan or As-Built Plan Available:</b> Yes

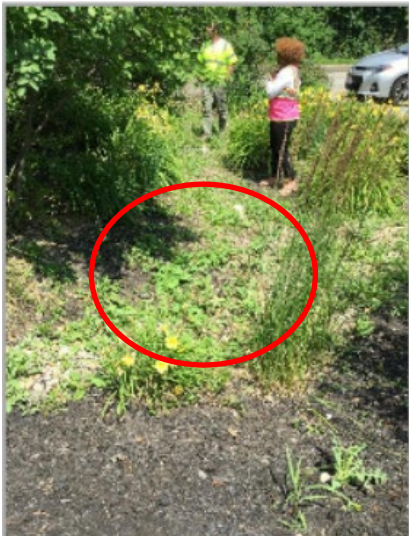
Action needed. <input type="checkbox"/> Yes <input checked="" type="checkbox"/> No <input type="checkbox"/> NA	
Comments: No additional comments.	
<b>VEGETATION</b>	
Vegetation is wilting, discolored, or dying due to disease or stress. <input checked="" type="checkbox"/> Yes <input type="checkbox"/> No <input type="checkbox"/> NA	
Vegetation needs to be controlled through mowing or manual removal. <input checked="" type="checkbox"/> Yes <input type="checkbox"/> No <input type="checkbox"/> NA	
Action needed. <input checked="" type="checkbox"/> Yes <input type="checkbox"/> No <input type="checkbox"/> NA	
Comments: Applicant should weed the entirety of the practice. Both cells ( <b>Refer to photos 1 &amp; 2</b> ).	
<b>BIORETENTION MAIN INFILTRATION AREA</b>	
Trash and debris have accumulated. <input type="checkbox"/> Yes <input checked="" type="checkbox"/> No <input type="checkbox"/> NA	
Sediment has accumulated at the surface. <input checked="" type="checkbox"/> Yes <input type="checkbox"/> No <input type="checkbox"/> NA

1. Ensure the practice is properly weeded (**Photos 1, 2, 4, and 5**).
2. Ensure debris that has deposited on top of the outlet is removed (**Photo 3**).

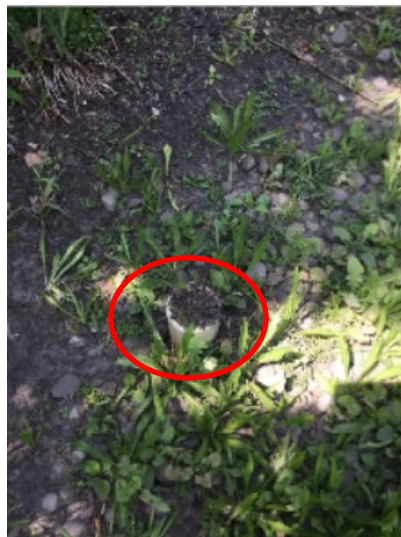
**Photo 3.**

Sediment, trash or debris is blocking the outlets or overflow structure.  
☒ Yes ☐ No ☐ NA

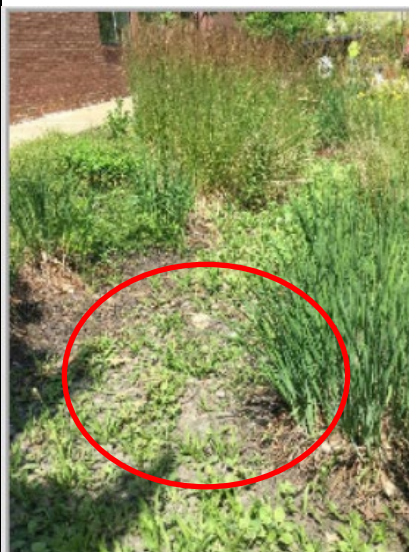
**Photo 4**

Topmost layer is caked or crusted over with sediment.  
☒ Yes ☐ No ☐ NA

Comments: A layer of sediment is currently present on top of the bioretention cell. Instruct applicant to remove the light layer of soil and sediment and re-mulch as needed **(Refer to photo 4).**
