Small Scale Stormwater Demonstration Projects (S3DP)

Maintenance Inspection Checklist

Program Site Name: Key Bank	
Address: 15619 Waterloo Rd, 44110	
Inspector's Name: Christopher Hartman, CPESC, CPSWQ, CESSWI	Date and Time: 06/15/2018 2:21 PM
Overall Notes: <ol style="list-style-type: none"> 1. Runoff was observed entering the storm drain inlet nearest the entrance of the property, thereby bypassing the bioretention cell. 2. Minor amount trash debris in practice near the entrance of the location. Applicant needs to remove. 3. Applicant needs to place solid lids on the parking lot inlets, per the original approved plan. 4. Applicant needs to remove the matting that is clogging the practice. 5. At the rear cell, rocks need to be formed in a concave manner to ensure water flow no longer causes soil erosion.

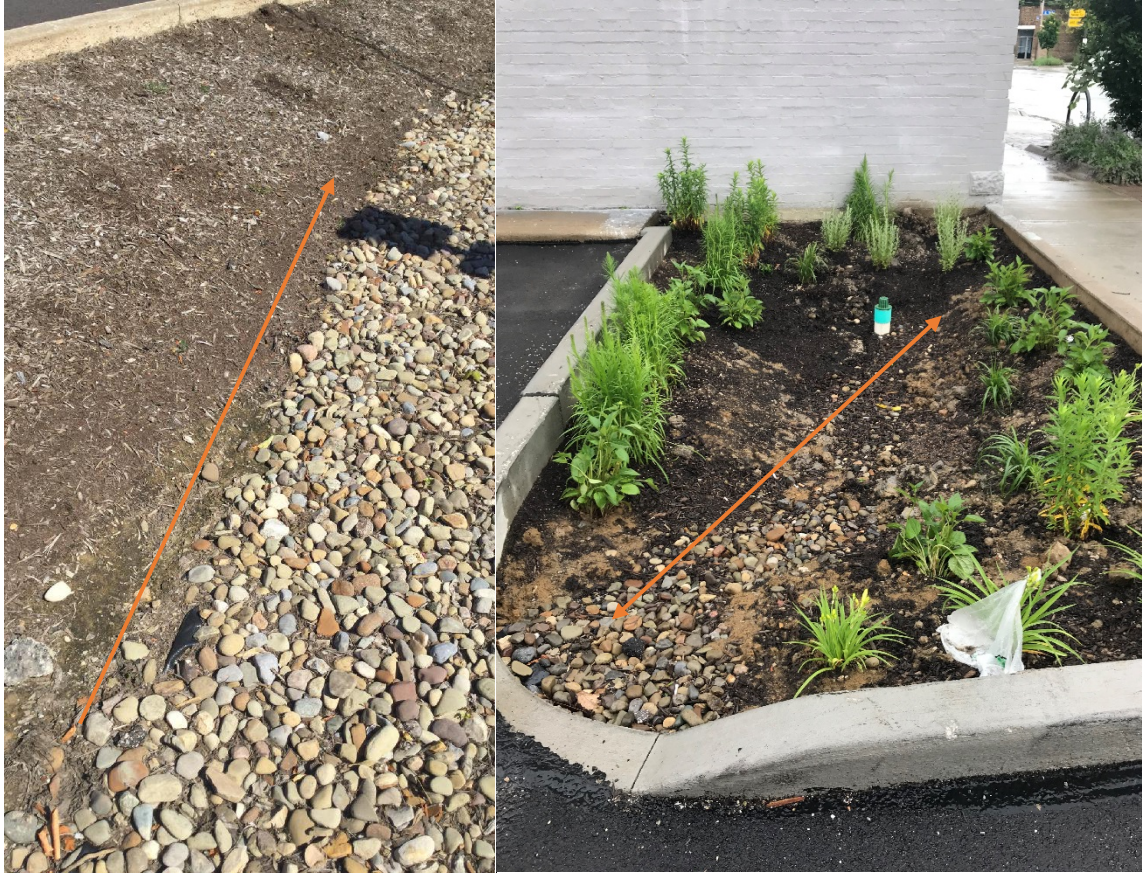
Explanation: Low flow rock channels need to be formed in a concave manner. The applicant will also need to remove debris from the practice that is at the entrance of the property. Ensure runoff is not first entering parking lot drain (just off right-hand photo) prior to entering the cell (i.e., add solid lid, re-grade as necessary, etc.).

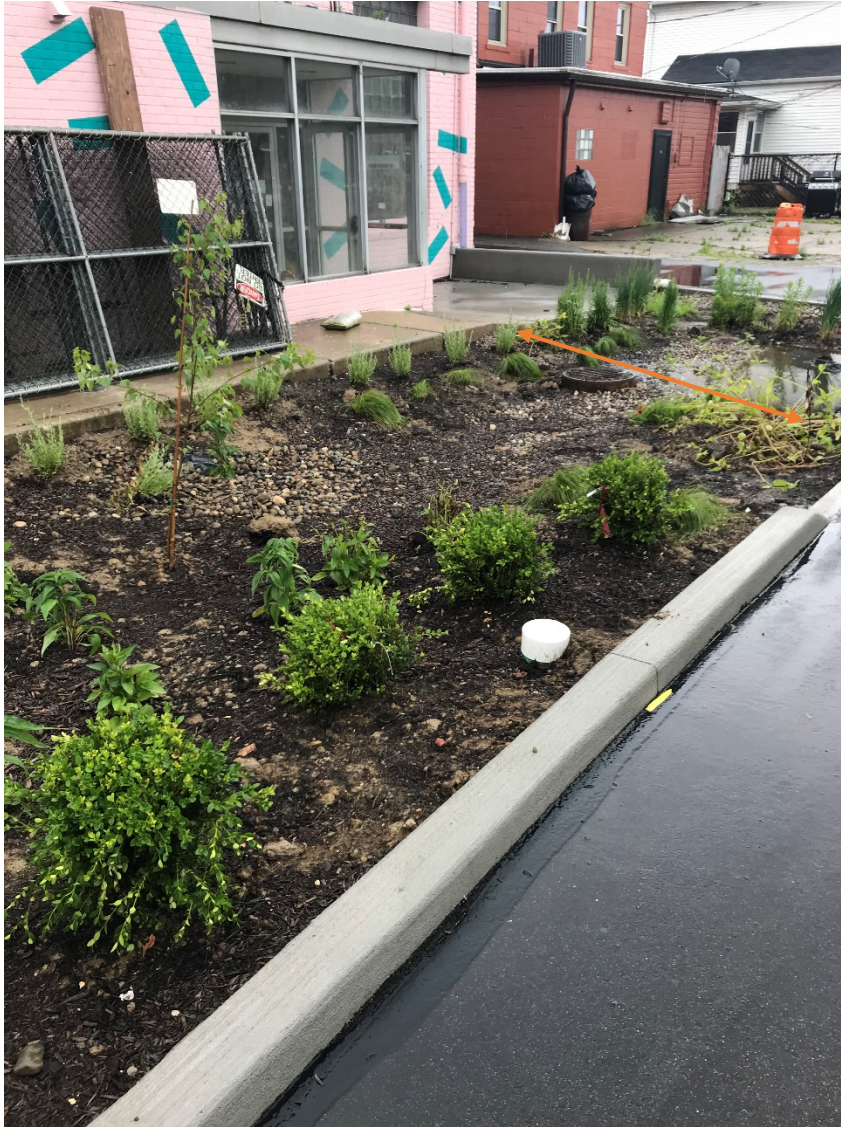
Explanation: During the inspection we noticed the matting that has been placed down has been compromised. Ensure it will not impact the function of the practice.

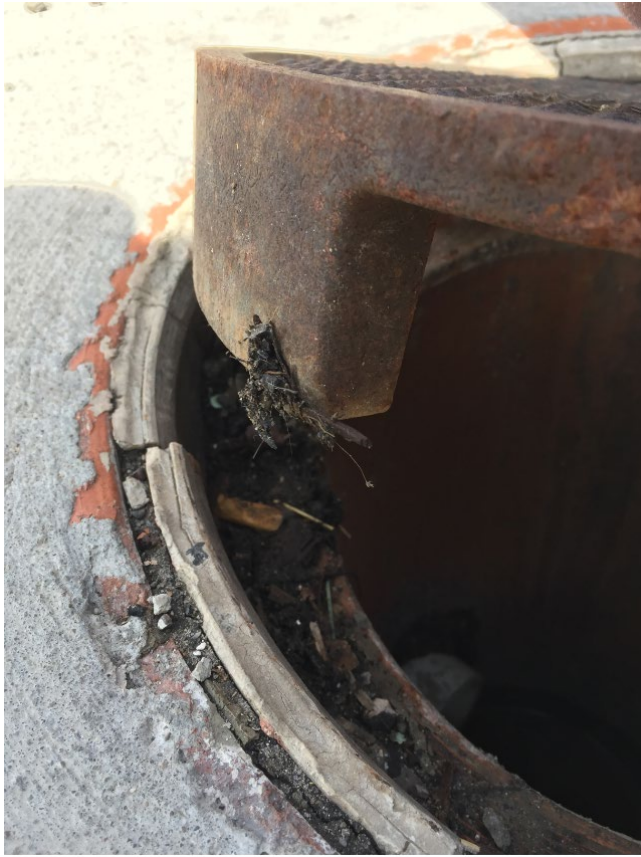
Since last visit the outlet lid had been addressed but flow is still entering the outlet. 4/2/2019

Recommend removing feet from lid and sealing the lid.

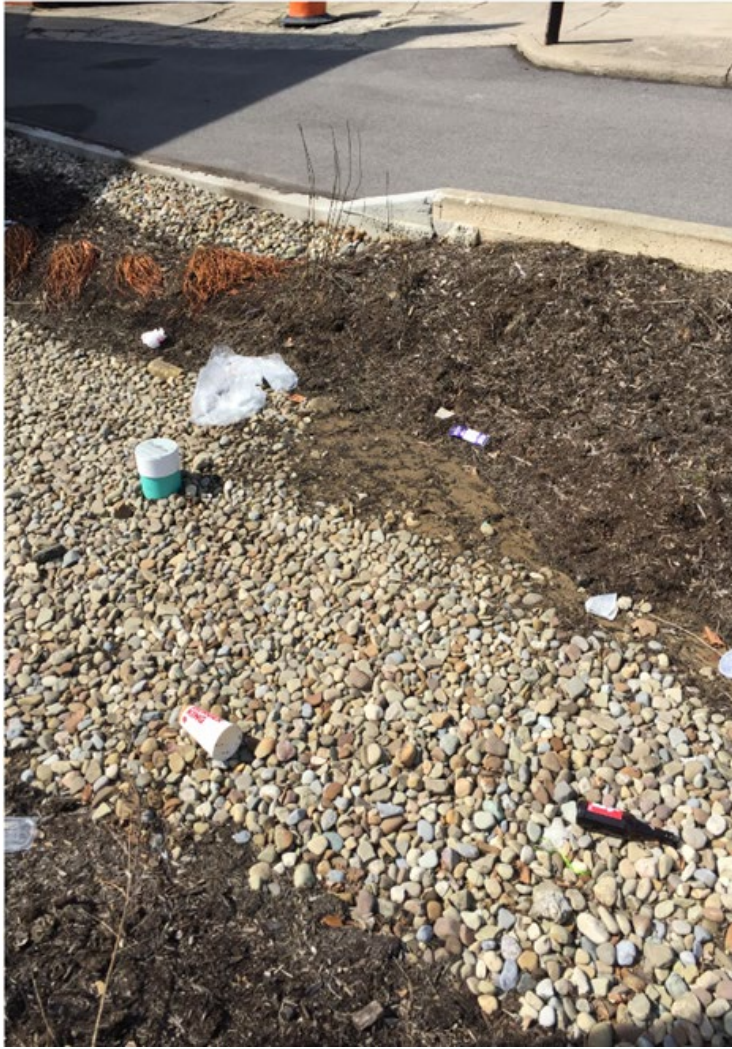
Debris has accumulated in the cell and needs to be removed.
Concave shape regarding the North side of the cell behind the parking lot is recommended.
