Bioretention Area Inspection and Maintenance Checklist

Green Infrastructure Site Location and Address: Kendall & Larchmere GI Parking Retrofit, 12795 Larchmere Boulevard, Shaker Heights OH 44120		
Date and Time: 07/16/2019 10:59am	Weather Conditions: ☀️ Sunny	Date of Last Inspection: N/A
Inspector and Title: Chris Hartman, CPESC, CESSWI, CPSWQ, Stormwater Technical Specialist, Crystal Davis, Watershed Programs Specialist, Spencer Nash, Watershed Programs Intern		
Rain in Last 48 Hours: No If yes, list amount and timing: N/A		
Site Plan or As-Built Plan Available: Yes

Green Infrastructure Site Location and Address: Kendall & Larchmere GI Parking Retrofit, 12795 Larchmere Boulevard, Shaker Heights OH 44120		
Date and Time: 07/16/2019 10:59am	Weather Conditions: ☀ Sunny	Date of Last Inspection: N/A
Inspector and Title: Chris Hartman, CPESC, CESSWI, CPSWQ, Stormwater Technical Specialist, Crystal Davis, Watershed Programs Specialist, Spencer Nash, Watershed Programs Intern		
Pavement Type: Permeable Interlocking Pavers		
Pretreatment: N/A		Other, specify: N/A
Site Plan or As-Built Plan Available: Yes

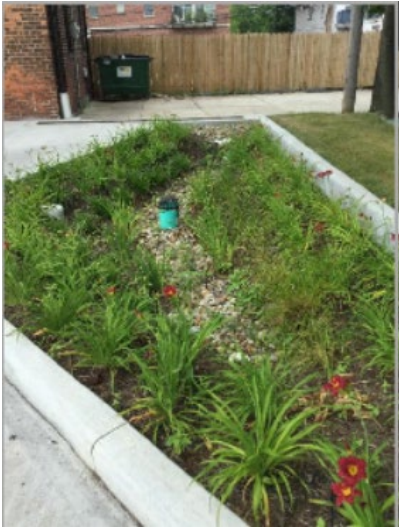
Inspection Item	Images
DEWATERING	
<p>Standing water is present after 24 hours. If yes, describe sheen, color, or smell. <input type="checkbox"/> Yes <input type="checkbox"/> No <input checked="" type="checkbox"/> NA</p>

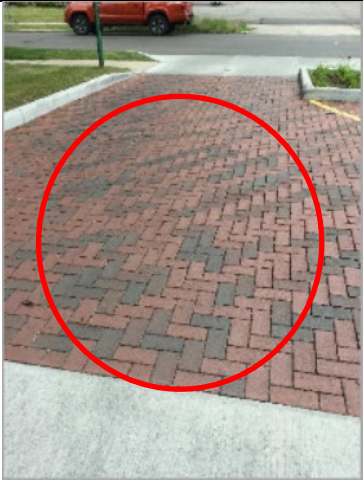
Inspection Item	Images
PAVEMENT TRANSITION AREA Non-permeable transition area at pavement edges is unstable/deteriorating <input type="checkbox"/> Yes <input checked="" type="checkbox"/> No <input type="checkbox"/> NA Action needed. <input type="checkbox"/> Yes <input checked="" type="checkbox"/> No <input type="checkbox"/> NA Comments: There is some slight heaving in the northeast portion of the permeable pavers.

1. There is evidence of a small portion of pavers heaving in the northeast portion of the permeable pavers. See **photo 1** for location. Remove debris that has settled in-between the joints (Replace stone in joints as necessary).
2. Leaves and debris have accumulated in the northeastern portion of the permeable pavers. Recommend to applicant that this area should be clear **(Refer to photo 3).**

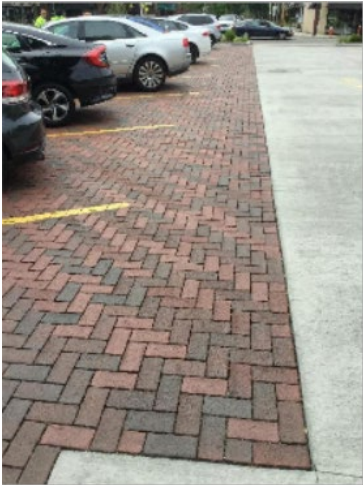
Photo 2. ----- -----

DEWATERING Standing water is present after 24 hours. If yes, describe sheen, color, or smell. Yes <input checked="" type="checkbox"/> No <input type="checkbox"/> NA Action needed. <input type="checkbox"/> Yes <input checked="" type="checkbox"/> No <input type="checkbox"/> NA Comments: No additional comments.	Photo 1. ----- -----
PAVEMENT SURFACE AND JOINTS Sediment has accumulated on pavement surface. <input type="checkbox"/> Yes <input checked="" type="checkbox"/> No <input type="checkbox"/> NA Trash and debris have accumulated on pavement surface or around curbing. <input type="checkbox"/> Yes <input checked="" type="checkbox"/> No <input type="checkbox"/> NA Pavement has deteriorated, cracked, settled, or raveled. <input type="checkbox"/> Yes <input checked="" type="checkbox"/> No <input type="checkbox"/> NA Sediment has accumulated in the joints of PICP. <input checked="" type="checkbox"/> Yes <input type="checkbox"/> No <input type="checkbox"/> NA Vegetation is growing in the joints of PICP. <input type="checkbox"/> Yes <input checked="" type="checkbox"/> No <input type="checkbox"/> NA Gravel is insufficient in the joints of PICP. <input checked="" type="checkbox"/> Yes <input type="checkbox"/> No <input type="checkbox"/> NA Action needed. <input checked="" type="checkbox"/> Yes <input type="checkbox"/> No <input type="checkbox"/> NA

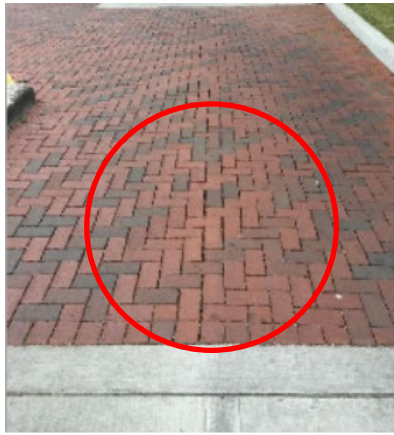
Photo 3.

Comments: Some leaves and debris have accumulated in the northeastern portion of the permeable pavers. Recommend to applicant that this area should be clear **(Refer to photo 3).**
