## Bioretention Area Inspection and Maintenance Checklist

<b>Facility:</b> Link 59			
<b>Location/Address:</b> East 59 <sup>th</sup> Street, Cleveland OH			
<b>Date:</b> 7/2/2019	<b>Time:</b> 11:45am	<b>Weather Conditions:</b> Sunny	<b>Date of Last Inspection:</b> N/A
<b>Inspector:</b> Crystal Davis, Spencer Nash, Christopher Hartman, Jessica Cotton		<b>Title:</b> Inspection Report	
<b>Site Plan or As-Built Plan Available:</b> <input checked="" type="checkbox"/> Yes <input type="checkbox"/> No

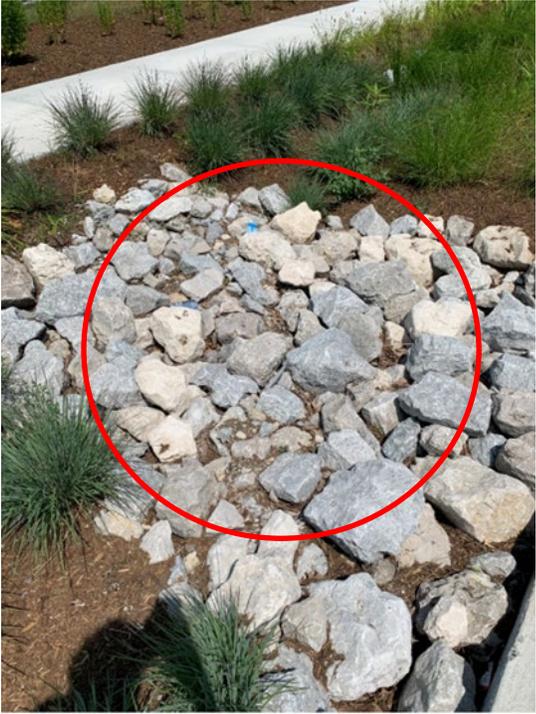
Comments: No additional comments.		
<b>VEGETATION</b>		
Vegetation is wilting, discolored, or dying due to disease or stress. <input type="checkbox"/> Yes <input checked="" type="checkbox"/> No <input type="checkbox"/> NA		
Vegetation needs to be controlled through mowing or manual removal. <input checked="" type="checkbox"/> Yes <input type="checkbox"/> No <input type="checkbox"/> NA		
Action needed. <input checked="" type="checkbox"/> Yes <input type="checkbox"/> No <input type="checkbox"/> NA		
Comments: Applicant needs to weed all of the cells.		
<b>BIORETENTION MAIN INFILTRATION AREA</b>

**Photo 1:** Southeast cell near Vintage tea and Coffee.

1. Regarding all the cells, weeding efforts should take place in all of them.
