Bioretention Area Inspection and Maintenance Checklist

Green Infrastructure Site Location and Address: MLK Carnegie Infrastructure Project, Intersection of MLK Jr. Dr & Carnegie Ave		
Date and Time: 07/16/2019 10:35am	Weather Conditions: ☀️ Sunny	Date of Last Inspection: N/A
Inspector and Title: Chris Hartman, CPESC, CESSWI, CPSWQ, Stormwater Technical Specialist, Crystal Davis, Watershed Programs Specialist, Spencer Nash, Watershed Programs Intern		
Site Plan or As-Built Plan Available: Yes

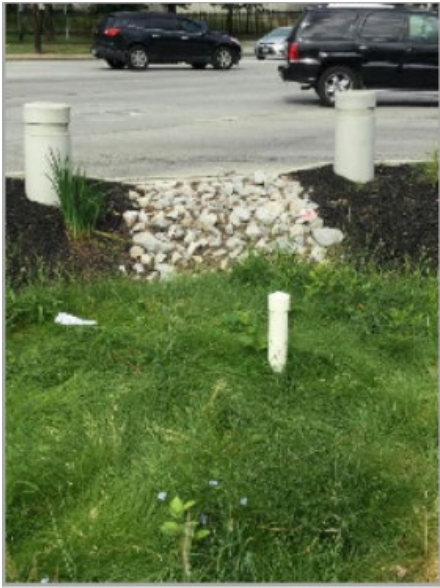
<p>Action needed. <input type="checkbox"/> Yes <input checked="" type="checkbox"/> No <input type="checkbox"/> NA</p>	
<p>Comments: No additional comments</p>	
INLETS	
<p>Inlets are in poor structural condition. <input type="checkbox"/> Yes <input checked="" type="checkbox"/> No <input type="checkbox"/> NA</p>	<p>Photo 1.</p> <p>-----</p> <p>-----</p>

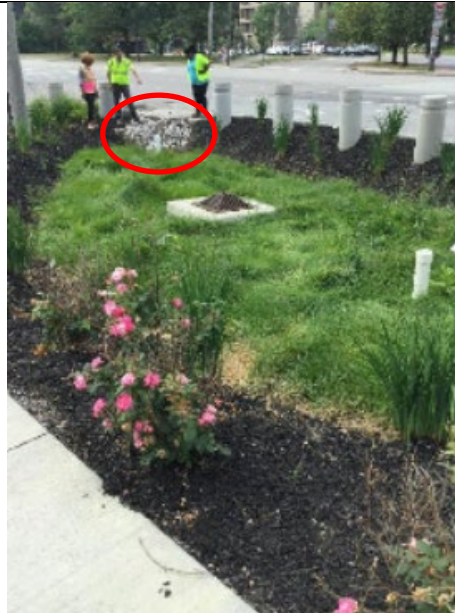
Photo 3.

<p>Comments: Erosion is occurring around the eastern inlet. Applicant will need to stabilize erosion through means of rock inlet protection or re-mulching the area (Refer to photo 3).</p>	
VEGETATION	
<p>Vegetation is wilting, discolored, or dying due to disease or stress. <input type="checkbox"/> Yes <input checked="" type="checkbox"/> No <input type="checkbox"/> NA</p>	<p>Photo 2.</p> <p>-----</p> <p>-----</p>
<p>Vegetation needs to be controlled through mowing or manual removal. <input checked="" type="checkbox"/> Yes <input type="checkbox"/> No <input type="checkbox"/> NA</p>	
<p>Action needed. <input checked="" type="checkbox"/> Yes <input type="checkbox"/> No <input type="checkbox"/> NA</p>

1. Ensure the erosion occurring at the eastern inlet is stabilized (runoff inflow appears to be running along the side of the rock inlet protection...reform the rock into a concave shape).
2. Weed the practice to reduce the amount of invasive species. **Refer to photo 3. for the location that has erosion.**
