Small Scale Stormwater Demonstration Projects (S3DP)

Maintenance Inspection Checklist

Project Site: Collinwood Art District Azure Green Parking Lot (Moon and Stars)	
Address: 15602 Waterloo, 44110	
Inspector's Name: Christopher Hartman, CPESC, CPSWQ, CESSWI	Date and Time: 6/19/18, 10:44am
Overall Notes: 1. Minor cracking of the porous concrete was observed, which should be monitored. 2. Applicant should conduct some minor weeding of all the areas of the practice. 3. Recommend adding mulch to the bioretention cell.

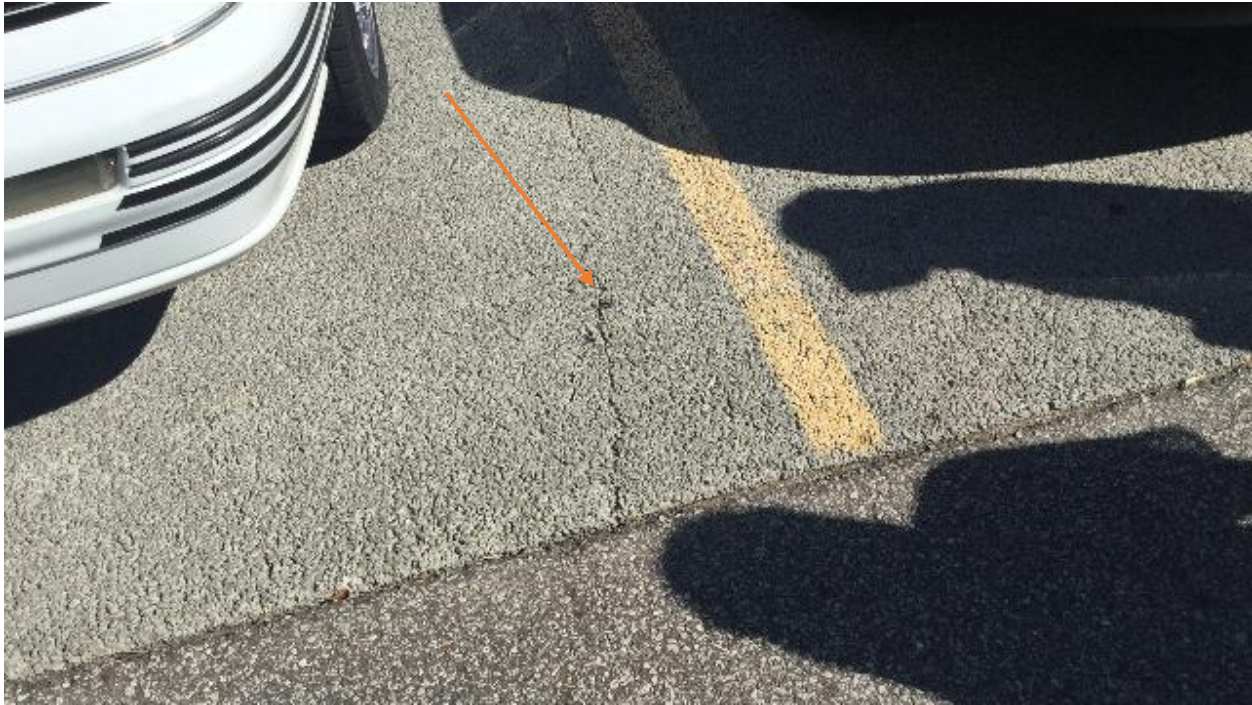
Pavement has deteriorated, cracked, settled, or raveled? Yes	Permeable pavement cracked notes: One crack in western area.
Vegetation is growing in the joints? Yes	Vegetation notes: One small area on western section.
Gravel is insufficient in the joints of the practice? No	Gravel notes: N/A

Explanation: Minor cracking observed within the porous concrete.
