Small Scale Stormwater Demonstration Projects (S3DP)

Maintenance Inspection Checklist

Name: Collinwood Art District Northeast Shores Headquarters Green Parking Lot	
Address: 317 East 156th Street, Cleveland, OH 44110	
Inspector's Name: Christopher Hartman, CPESC, CPSWQ, CESSWI	Date and Time: 06/15/2018 2:50 PM
Overall Notes: 1. The PVC pipe under the walking path (just downslope of the downspout) is clogged and the debris needs to be removed so runoff may flow properly through the entire bioretention cell.

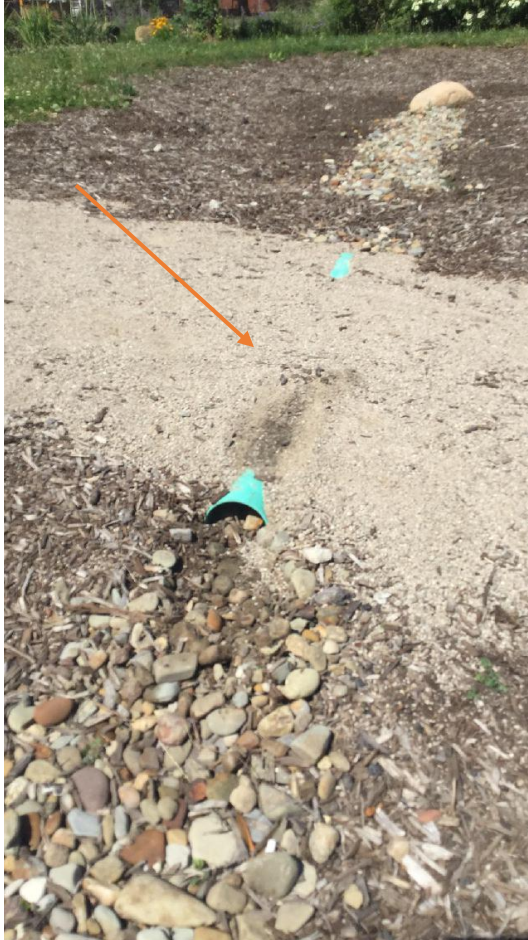
BIORETENTION (Select yes or no to the following maintenance questions)	
Is there debris present? Yes	Debris notes: Debris has accumulated in the PVC pipe.
Is there a layer of sediment? No	Sediment notes: N/A
Do the inlets provide stable conveyance into facility? Yes	Inlet notes: N/A
Presence of invasive species/weeds? No	Invasive notes: N/A
Dead vegetation/exposed soil? No	Soil notes: N/A
Evidence of clogging? Yes	Clogging notes: Pvc pipe conveying runoff from downspout inlet is clogged.

Explanation: This pipe will need to be cleaned out in order to convey stormwater correctly. (This pipe has been removed (10/31).

The Pipe above was removed. No concerns were present on 4/2/19.

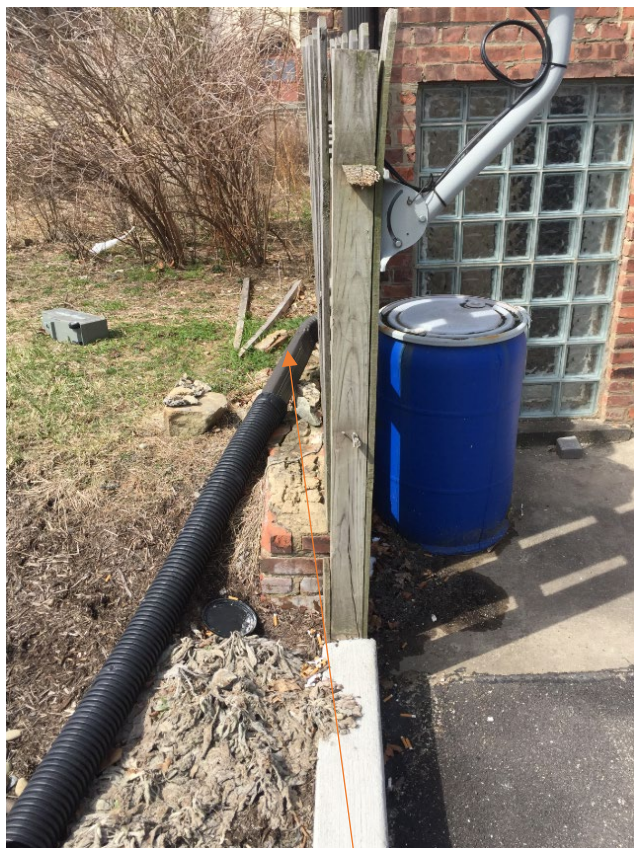
Photo 1: Flow is dispersed to the cell from this downspout.

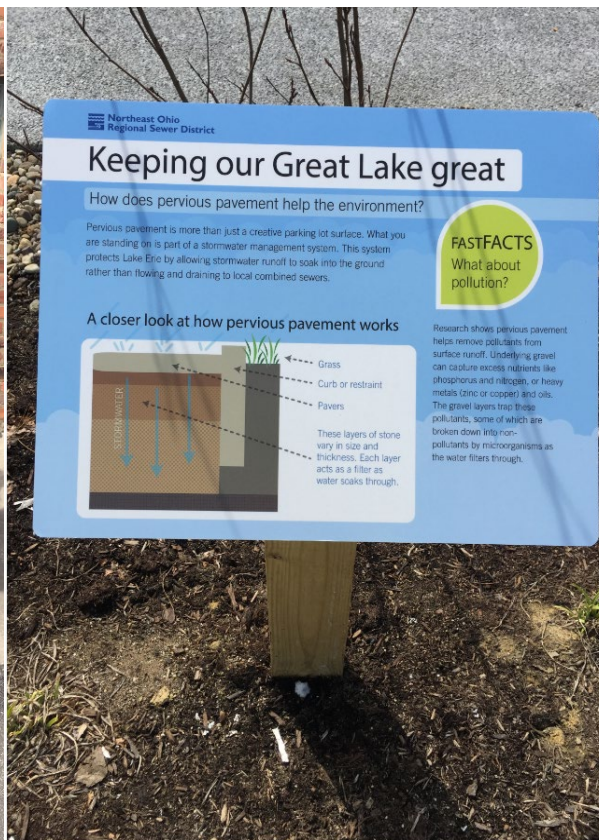
Photo 2: Signage is present.
