Bioretention Area Inspection and Maintenance Checklist

Green Infrastructure Site Location and Address: Corner Lot Demonstration, Park Drive adjacent to West Creek Reservation		
Date and Time: 08/20/2019 10:08am	Weather Conditions: ☀ Sunny	Date of Last Inspection: N/A
Inspector and Title: Crystal Davis, Watershed Programs Specialist, Spencer Nash, Watershed Programs Intern, Jessica Cotton GIS Technician.		
Site Plan or As-Built Plan Available: Yes		
Action items are noted below in SUMMARY section.

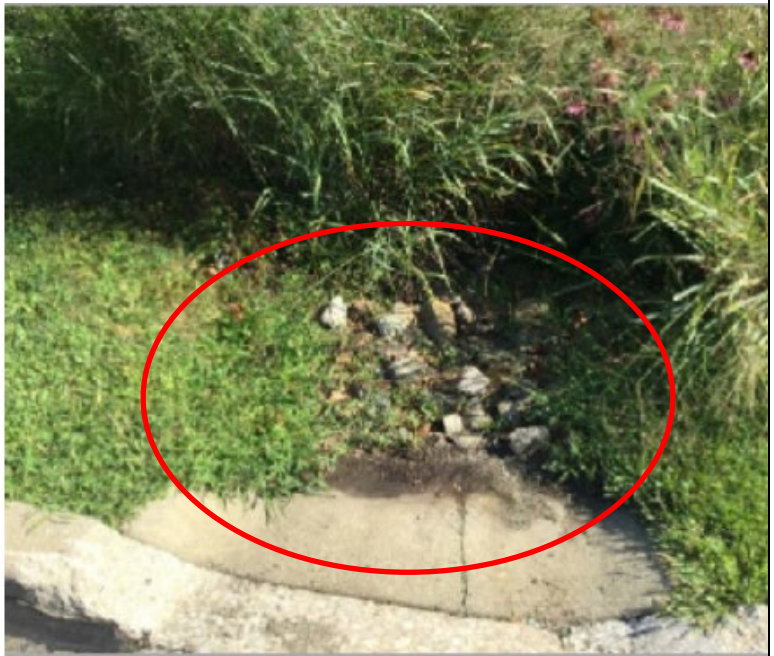
<p>Comments: Accumulation of debris in curb cut. Applicant will need to clean out and dispose of properly (Refer to photo 1.)</p>	
VEGETATION	
<p>Vegetation is wilting, discolored, or dying due to disease or stress. <input type="checkbox"/> Yes <input checked="" type="checkbox"/> No <input type="checkbox"/> NA</p>	
<p>Vegetation needs to be controlled through mowing or manual removal. <input type="checkbox"/> Yes <input checked="" type="checkbox"/> No <input type="checkbox"/> NA</p>	
<p>Action needed. <input type="checkbox"/> Yes <input checked="" type="checkbox"/> No <input type="checkbox"/> NA</p>

Height from surface of practice to top of overflow structure is insufficient to allow for ponding during rain events. <input type="checkbox"/> Yes <input checked="" type="checkbox"/> No <input type="checkbox"/> NA	
Action needed. <input type="checkbox"/> Yes <input checked="" type="checkbox"/> No <input type="checkbox"/> NA	
Comments: No additional comments.	
SUMMARY Please address the following items: 1. Remove sediment and debris that has accumulated in the curb cuts and dispose of it properly (Refer to inlet section).
