Wetland are Area Inspection and Maintenance Checklist

Green Infrastructure Site Location and Address: Towpath Trail Stage 3, Clark Ave & Mary Ct, Cleveland, OH 44113		
Date and Time: 07/23/2019 10:03 AM	Weather Conditions: ☀️ Sunny	Date of Last Inspection:
Inspector and Title: Chris Hartman, CPESC, CESSWI, CPSWQ, Stormwater Technical Specialist		
Site Plan or As-Built Plan Available: Yes

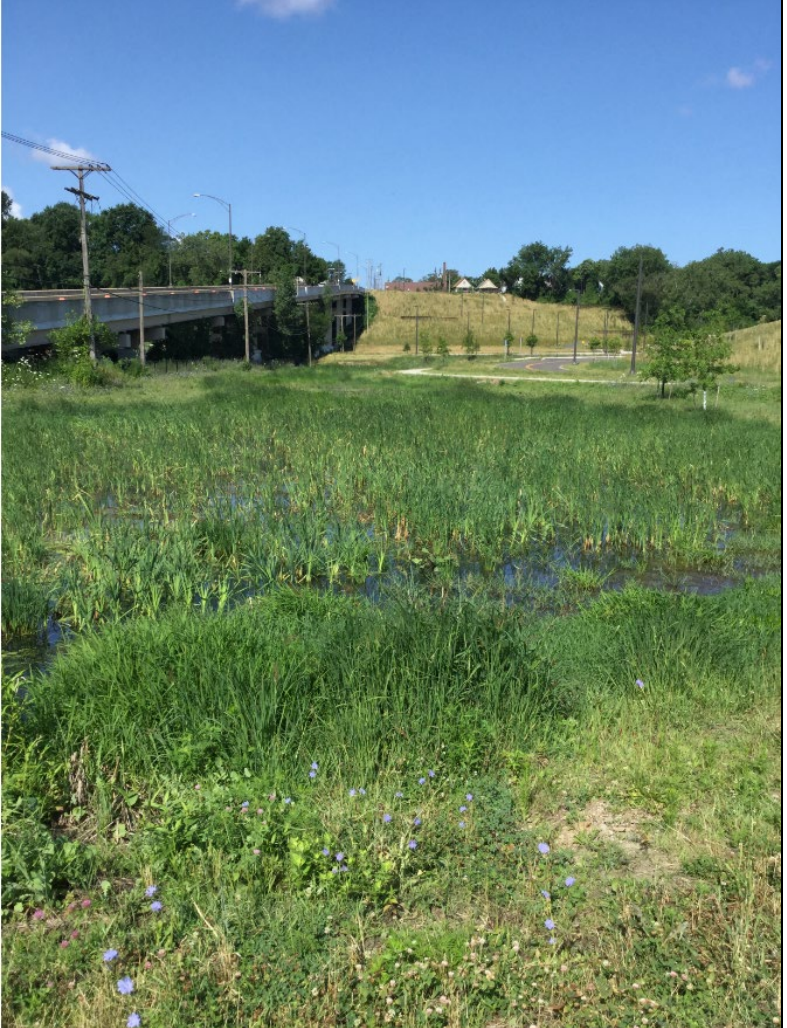
Photo 1.

Comments. Note/Follow up: Outlet near the closed road to the left of the stop sign ask applicant how water is getting out.	
VEGETATION	
Vegetation is wilting, discolored, or dying due to disease or stress. <input type="checkbox"/> Yes <input checked="" type="checkbox"/> No <input type="checkbox"/> NA	
Vegetation needs to be controlled through mowing or manual removal. <input type="checkbox"/> Yes <input checked="" type="checkbox"/> No <input type="checkbox"/> NA	
Action needed. <input type="checkbox"/> Yes <input checked="" type="checkbox"/> No <input type="checkbox"/> NA	
Comments: No additional comments.	
Stormwater Wetland AREA	
Trash and debris have accumulated.

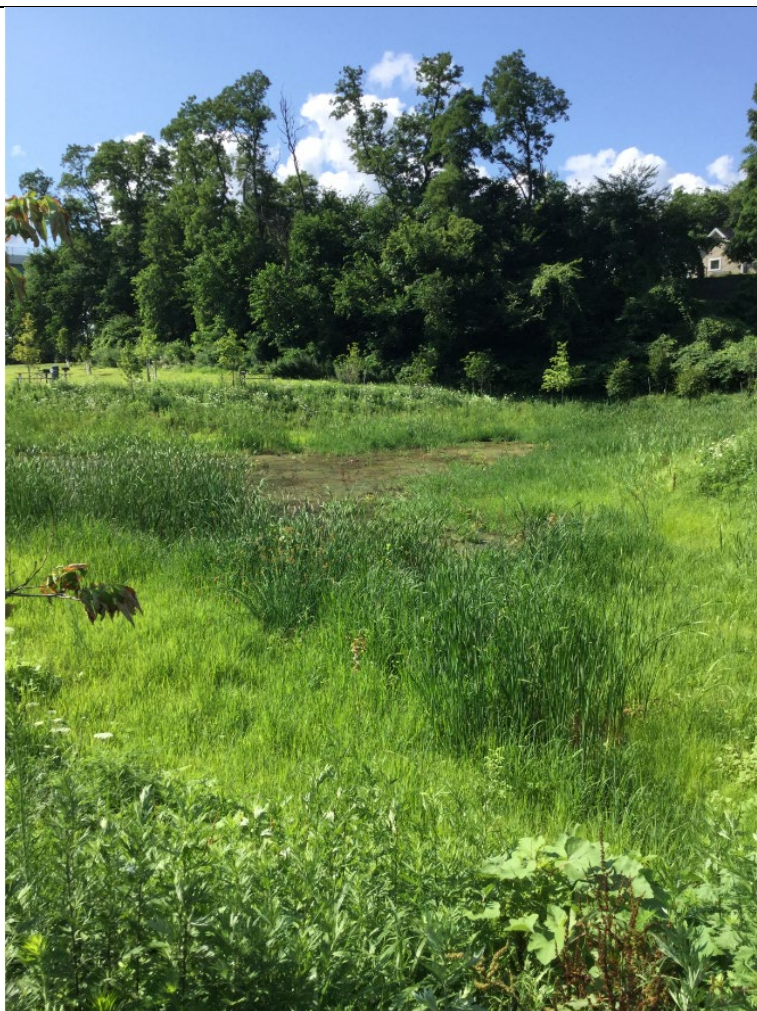
Photo 2.

Action needed. <input checked="" type="checkbox"/> Yes <input type="checkbox"/> No <input type="checkbox"/> NA
Comments: Comments can be found below
SUMMARY Please address the following items: 1. East wetland outlet structure is not working properly (normal water line is not being maintained). Investigate the cause and develop/implement corrective measures. Eastern outlet structure is not holding water correctly. Not sealed properly (location is the Eastern outlet structure near the construction entrance, facing north).
