Bioretention Area Inspection and Maintenance Checklist

Green Infrastructure Site Location and Address: West 19 th Green Alley, West 19 th Place, 44113		
Date and Time: 07/9/2019 11:40am	Weather Conditions: ☀ Sunny	Date of Last Inspection: N/A
Inspector and Title: Chris Hartman, CPESC, CESSWI, CPSWQ, Stormwater Technical Specialist, Crystal Davis, Watershed Programs Specialist, Spencer Nash, Watershed Programs Intern		
Site Plan or As-Built Plan Available: Yes

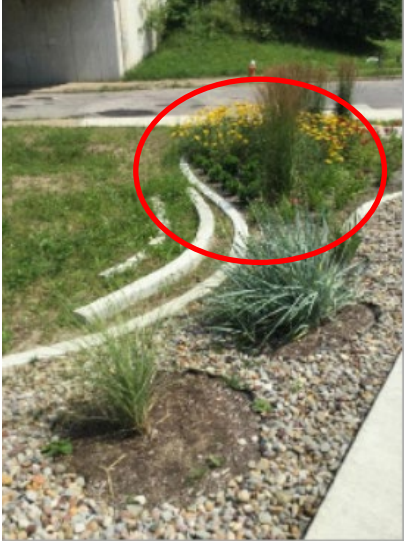
Inspection Item	Images
DEWATERING	
<p>Standing water is present after 24 hours. If yes, describe sheen, color, or smell. <input type="checkbox"/> Yes <input type="checkbox"/> No <input checked="" type="checkbox"/> NA</p>

<p>Action needed. <input type="checkbox"/> Yes <input checked="" type="checkbox"/> No <input type="checkbox"/> NA</p>	
<p>Comments: No additional comments.</p>	
INLETS	
<p>Inlets are in poor structural condition. <input type="checkbox"/> Yes <input checked="" type="checkbox"/> No <input type="checkbox"/> NA</p>

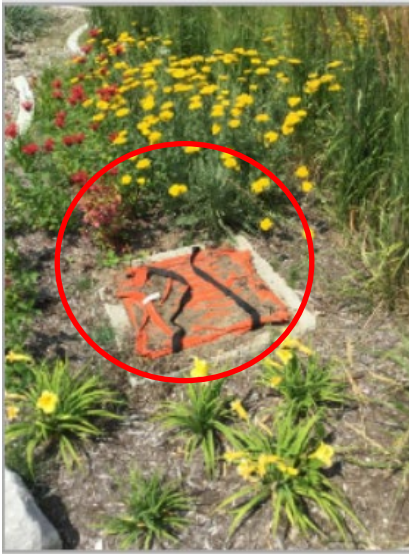
<p>Sediment has accumulated and/or is blocking the inlets. <input type="checkbox"/> Yes <input checked="" type="checkbox"/> No <input type="checkbox"/> NA</p>	
<p>Erosion is occurring around the inlets. <input type="checkbox"/> Yes <input checked="" type="checkbox"/> No <input type="checkbox"/> NA</p>	
<p>Action needed. <input checked="" type="checkbox"/> Yes <input type="checkbox"/> No <input type="checkbox"/> NA</p>

<p>Comments: Inlet to the biocell does not convey water into cell.</p>	
VEGETATION	
<p>Vegetation is wilting, discolored, or dying due to disease or stress. <input type="checkbox"/> Yes <input checked="" type="checkbox"/> No <input type="checkbox"/> NA</p>	<p>Photo 2 .</p> <p>-----</p> <p>-----</p> <p>-----</p> <p>-----</p>
<p>Vegetation needs to be controlled through mowing or manual removal. <input type="checkbox"/> Yes <input checked="" type="checkbox"/> No <input type="checkbox"/> NA</p>	
<p>Action needed. <input type="checkbox"/> Yes <input checked="" type="checkbox"/> No <input type="checkbox"/> NA</p>	
<p>Comments: No additional comments.</p>	
BIORETENTION MAIN INFILTRATION AREA	
<p>Trash and debris have accumulated. <input type="checkbox"/> Yes <input checked="" type="checkbox"/> No <input type="checkbox"/> NA</p>
