Permeable Pavement Inspection and Maintenance Checklist

Facility: Western Reserve Historical Society			
Location/Address: 10824 East Blvd Cleveland, OH 44106			
Date: 7/2/2019	Time: 12:55pm	Weather Conditions: Sunny	Date of Last Inspection: N/A
Inspector: Crystal Davis, Spencer Nash, Christopher Hartman		Title: Inspection Report	
Site Plan or As-Built Plan Available: <input type="checkbox"/> Yes <input checked="" type="checkbox"/> No

Bioretention Area Inspection and Maintenance Checklist

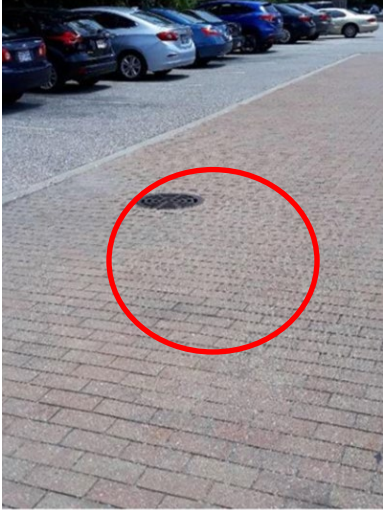
<p>Pavement has deteriorated, cracked, settled, or raveled. <input type="checkbox"/> Yes <input checked="" type="checkbox"/> No <input type="checkbox"/> NA</p>	
<p>Sediment has accumulated in the joints of PICP. <input checked="" type="checkbox"/> Yes <input type="checkbox"/> No <input type="checkbox"/> NA</p>	
<p>Vegetation is growing in the joints of PICP. <input checked="" type="checkbox"/> Yes <input type="checkbox"/> No <input type="checkbox"/> NA</p>	
<p>Gravel is insufficient in the joints of PICP. <input type="checkbox"/> Yes <input checked="" type="checkbox"/> No <input type="checkbox"/> NA</p>	
<p>Action needed. <input checked="" type="checkbox"/> Yes <input type="checkbox"/> No <input type="checkbox"/> NA</p> <p>Comments: Sedimentation has occurred towards the middle area of the permeable pavers.</p>

Wet weather inspection to be conducted by NEORS	
<input type="checkbox"/> Yes <input checked="" type="checkbox"/> No <input type="checkbox"/> NA	
SUMMARY Please address the following items: 1. Permeable pavers in the back of Historical Society in the paid parking are to be cleaned (Refer to photo 1). The pavers in the roundabout area are in good condition.

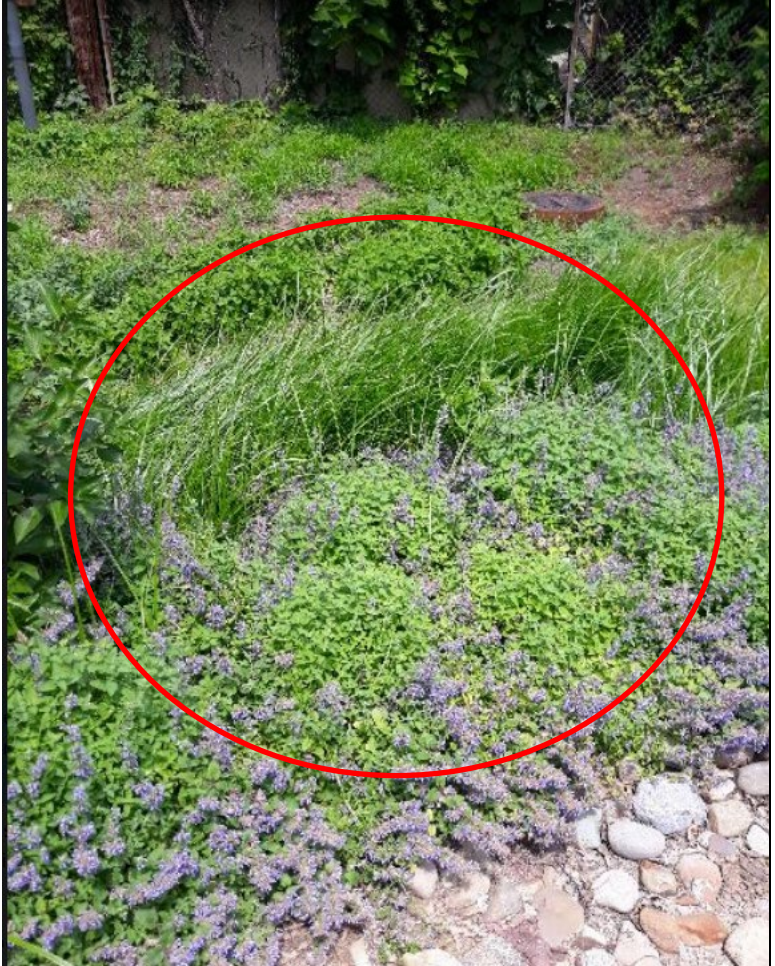
Photo 1.

<p>Comments: No additional comments.</p>	
VEGETATION	
<p>Vegetation is wilting, discolored, or dying due to disease or stress. <input type="checkbox"/> Yes <input checked="" type="checkbox"/> No <input type="checkbox"/> NA</p>	
<p>Vegetation needs to be controlled through mowing or manual removal. <input checked="" type="checkbox"/> Yes <input type="checkbox"/> No <input type="checkbox"/> NA</p>	
<p>Action needed. <input checked="" type="checkbox"/> Yes <input type="checkbox"/> No <input type="checkbox"/> NA</p>	
<p>Comments: Applicant needs to weed the entirety of the cell.</p>	
BIORETENTION MAIN INFILTRATION AREA

Height from surface of practice to top of overflow structure is insufficient to allow for ponding during rain events. <input type="checkbox"/> Yes <input checked="" type="checkbox"/> No <input type="checkbox"/> NA	
Action needed. <input type="checkbox"/> Yes <input checked="" type="checkbox"/> No <input type="checkbox"/> NA	
Action needed. Note: No additional comments.	
SUMMARY Please address the following items: 1. Regarding the bioretention cell, weeding efforts for the entirety of the practice should occur.
