## Bioretention Area Inspection and Maintenance Checklist

<b>Facility:</b> Cozad-Bates House			
<b>Location/Address:</b> 11508 Mayfield Road, Cleveland, OH 44106			
<b>Date:</b> 05/19/2021	<b>Time:</b> 10:30	<b>Weather Conditions:</b> Sunny	<b>Date of Last Inspection:</b> N/A
<b>Inspector:</b> Brian Uhlenbrock		<b>Title:</b> Landscape Architect	
<b>Rain in Last 48 Hours</b> <input type="checkbox"/> Yes <input checked="" type="checkbox"/> No <b>If yes, list amount and timing:</b>			
<b>Pretreatment:</b> <input type="checkbox"/> vegetated filter strip <input type="checkbox"/> swale <input type="checkbox"/> turf grass <input type="checkbox"/> forebay <input type="checkbox"/> other, specify: <input checked="" type="checkbox"/> none			
<b>Site Plan or As-Built Plan Available:</b> <input checked="" type="checkbox"/> Yes <input type="checkbox"/> No

## Permeable Pavement Inspection and Maintenance Checklist

# POST CONSTRUCTION MAINTENANCE PLAN

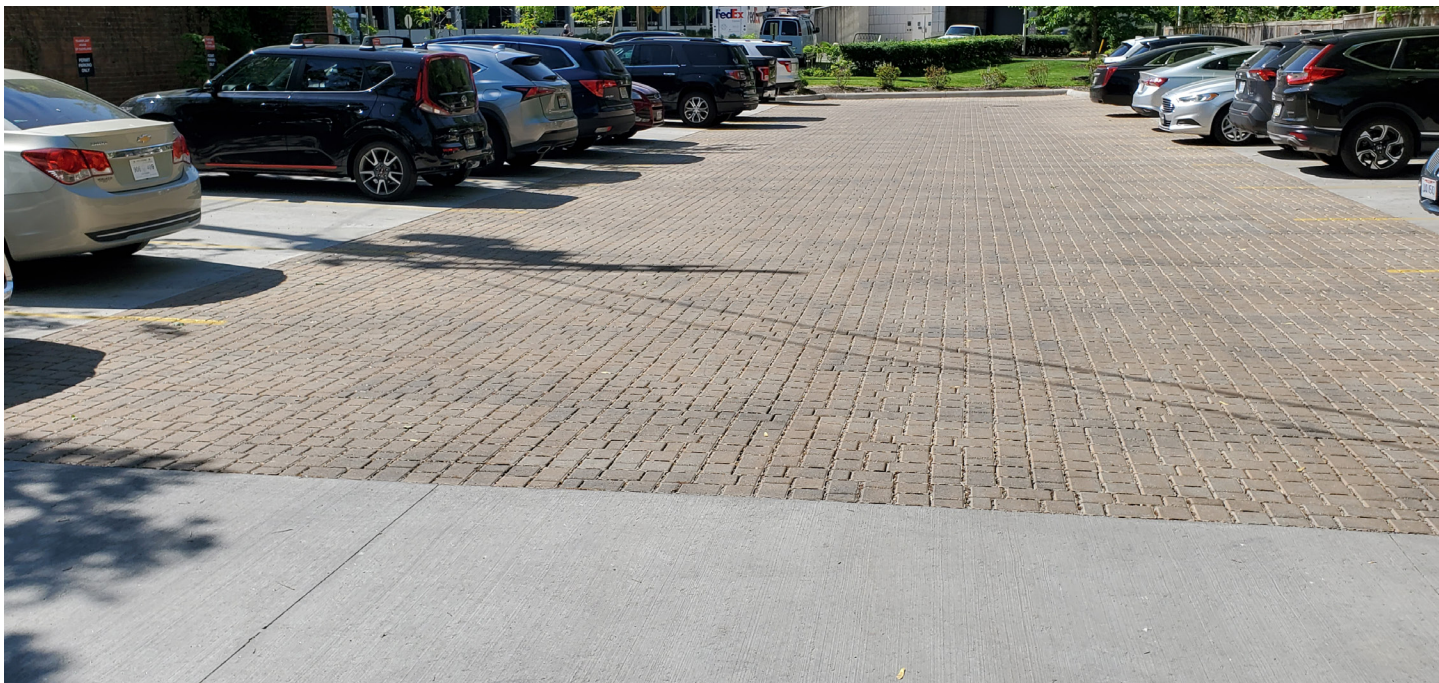
1. Permeable paver parking lot

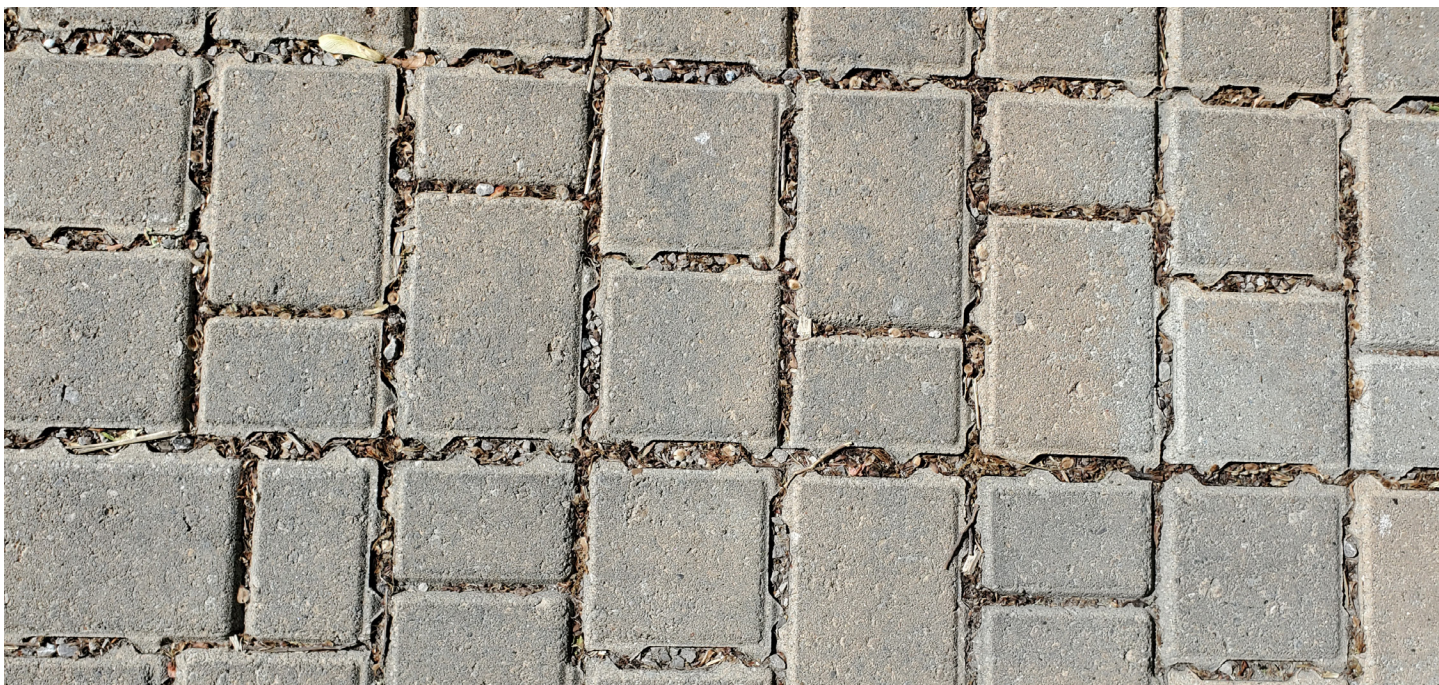
<b>4. PAVEMENT SURFACE AND JOINTS</b>			
Sediment has accumulated on pavement surface.	<input type="checkbox"/> Yes <input checked="" type="checkbox"/> No <input type="checkbox"/> N/A		<input type="checkbox"/> Yes <input checked="" type="checkbox"/> No
Trash and debris have accumulated on pavement surface or around curbing.	<input type="checkbox"/> Yes <input checked="" type="checkbox"/> No <input type="checkbox"/> N/A		<input type="checkbox"/> Yes <input checked="" type="checkbox"/> No
Pavement has deteriorated, cracked, settled, or raveled.	<input type="checkbox"/> Yes <input checked="" type="checkbox"/> No <input type="checkbox"/> N/A		<input type="checkbox"/> Yes <input checked="" type="checkbox"/> No
Sediment has accumulated in the joints of PICP.	<input checked="" type="checkbox"/> Yes <input type="checkbox"/> No <input type="checkbox"/> N/A	Minimal sediment from tree litter - scheduled to be vacuumed	<input checked="" type="checkbox"/> Yes <input type="checkbox"/> No

2. Permeable pavers (close-up) w/ minor debris - vacuuming scheduled

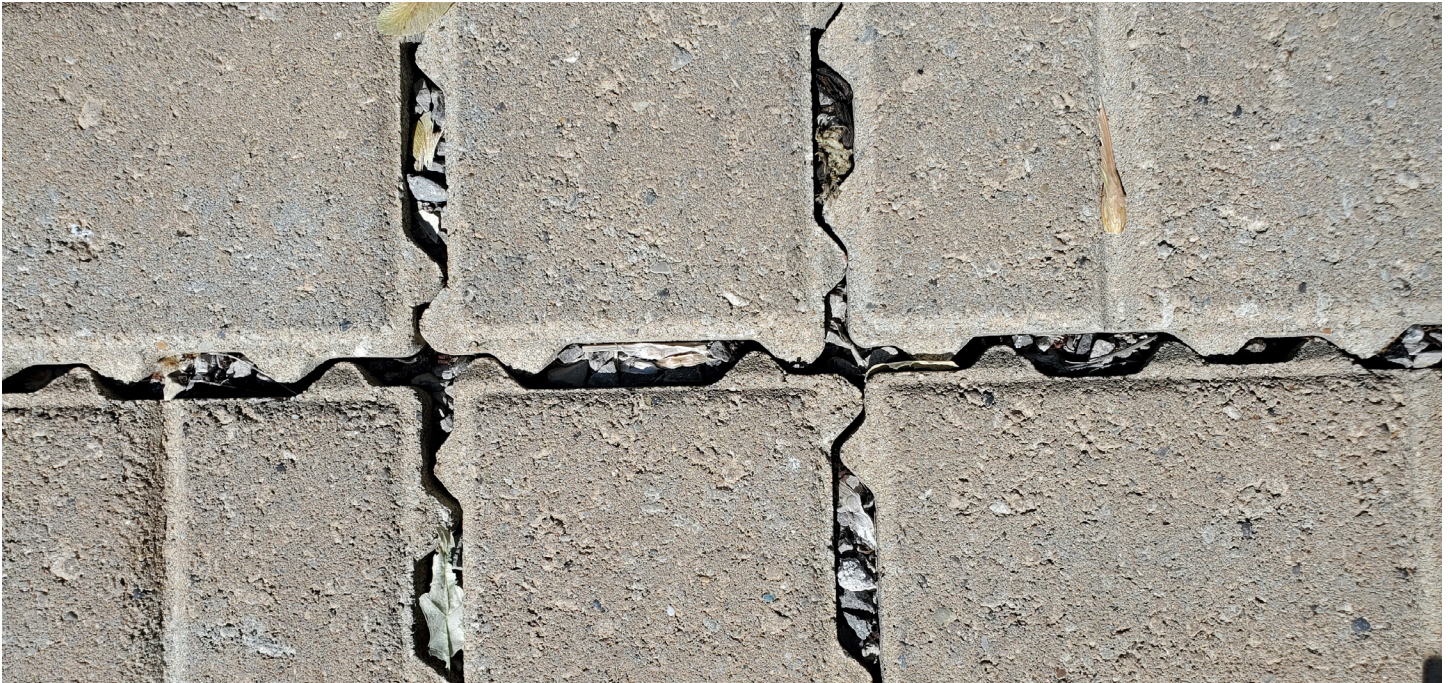
3. Permeable pavers (close-up) clean

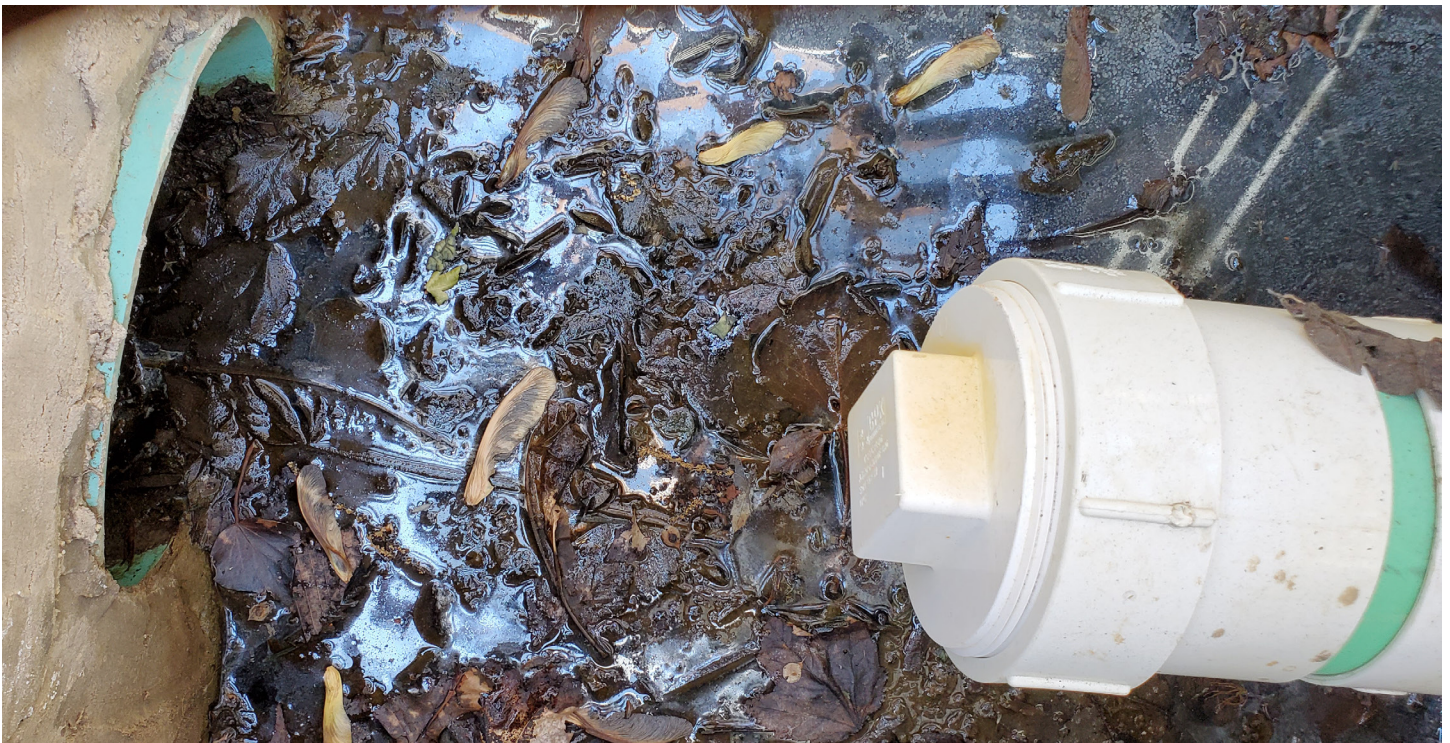
4. Permeable paver outlet structure - starting to accumulate debris (expected w/ no outlet flow) - yearly cleaning discussed with owner

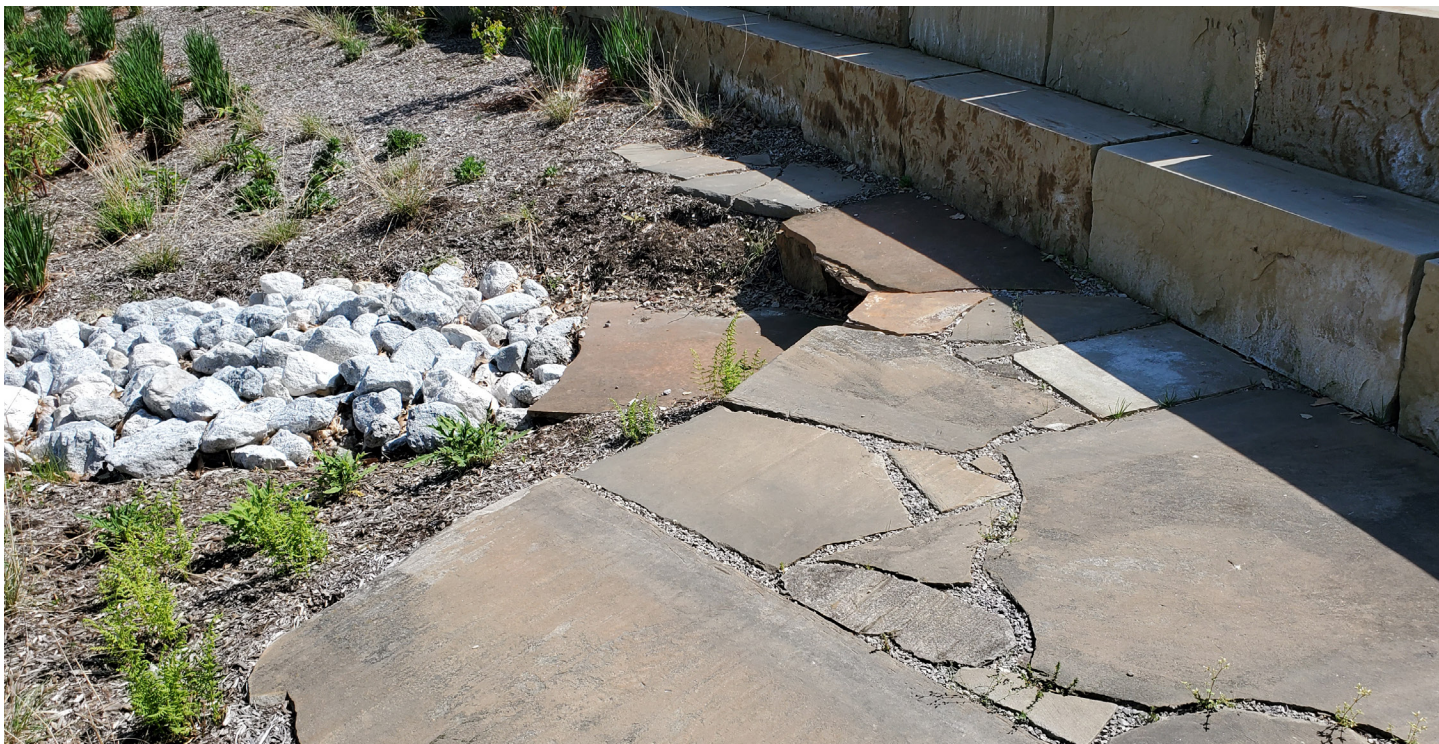
5. No erosion observed at outlet structure

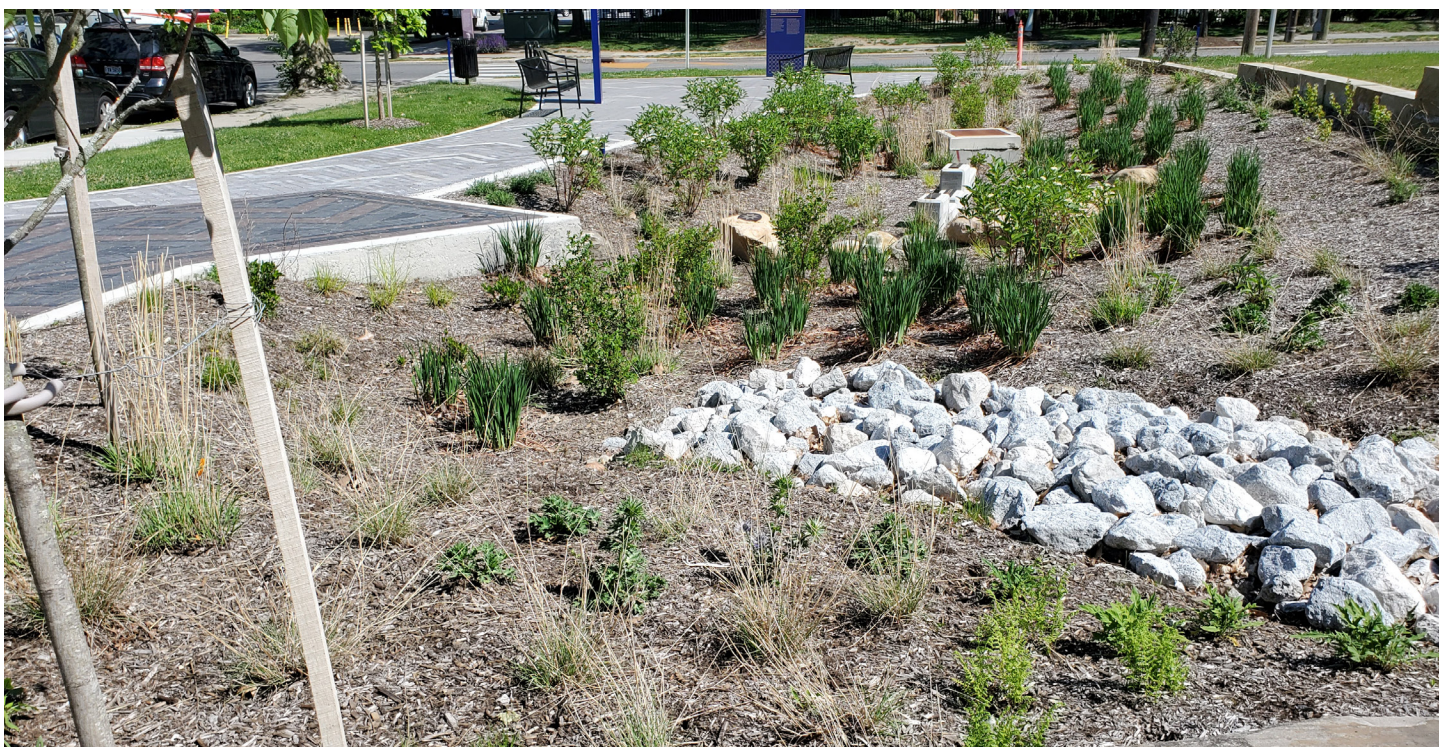
6. Bioretention basin

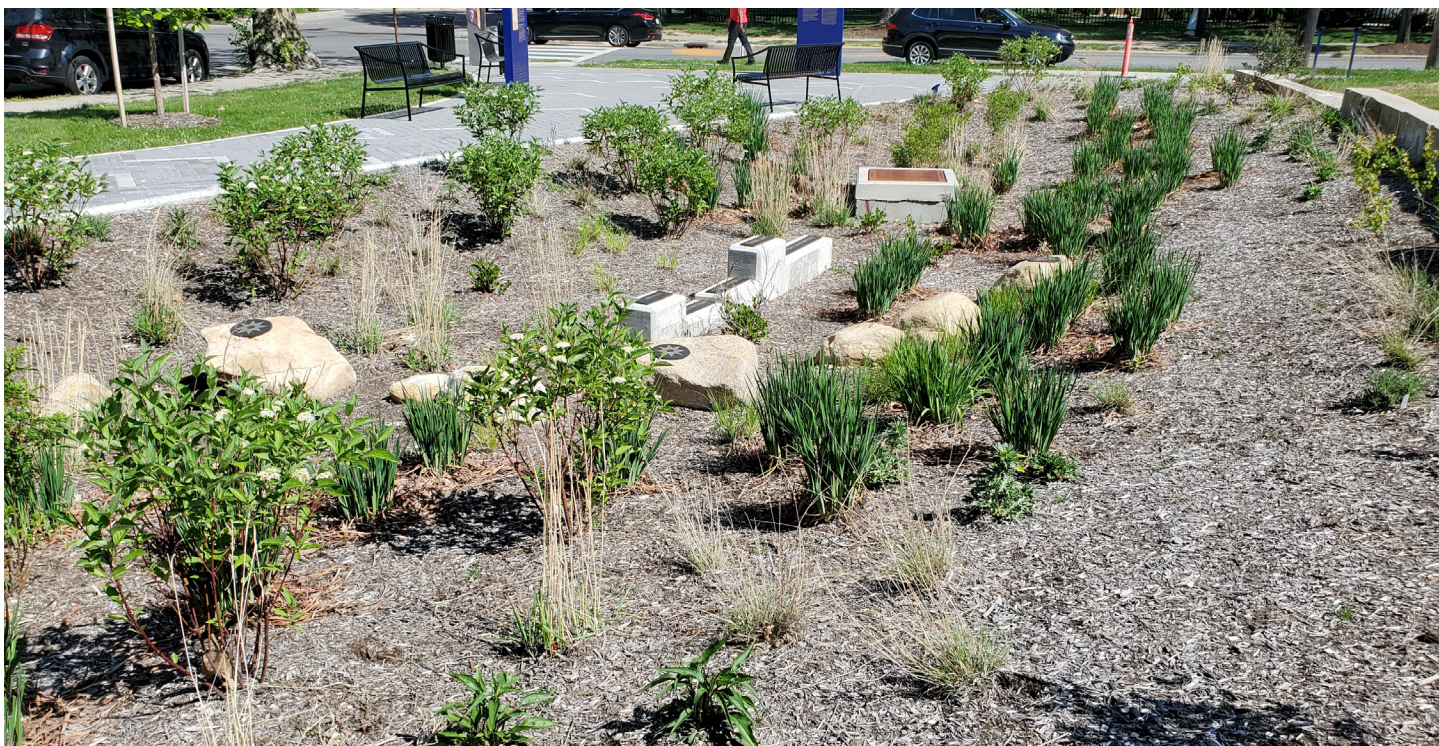
7. Vegetation successfully planted in and around bioretention basin

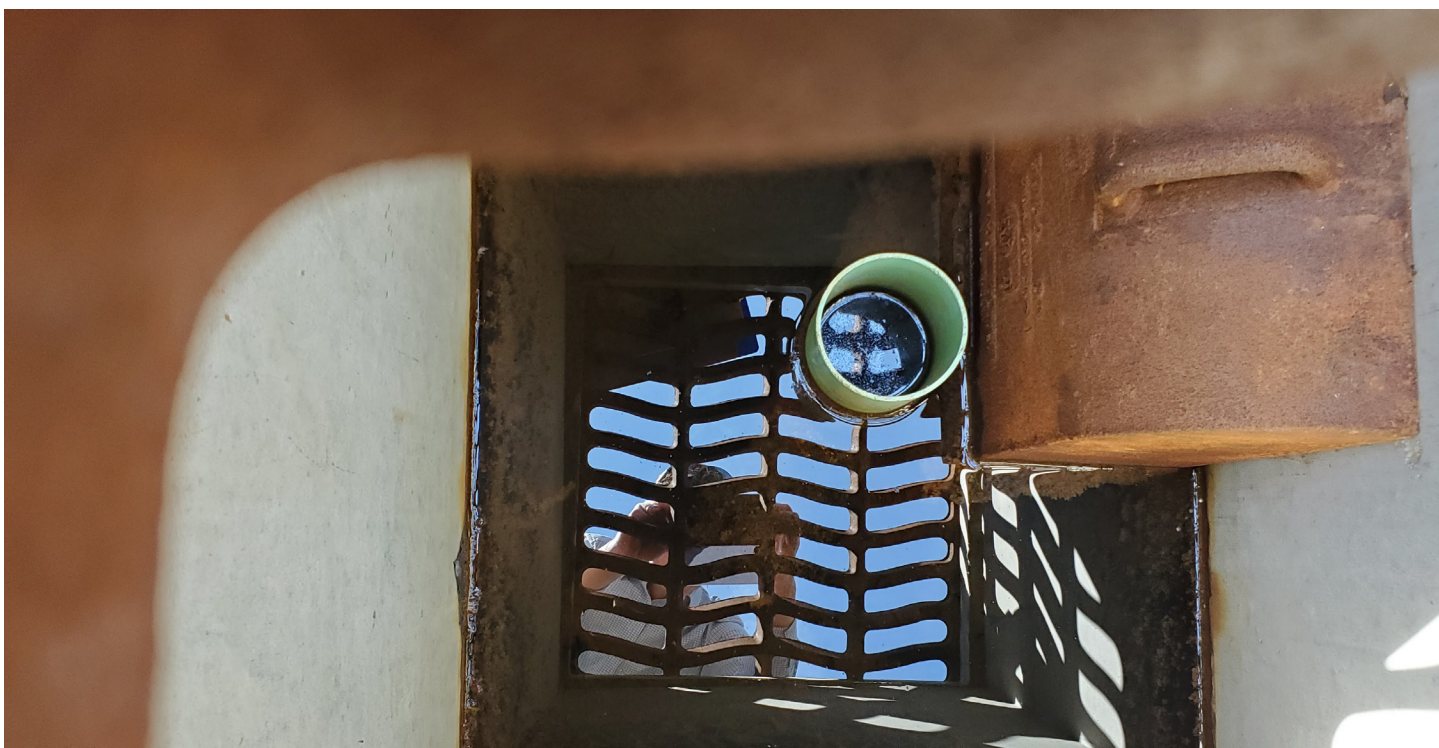
8. Bioretention outlet structure - clean, no debris

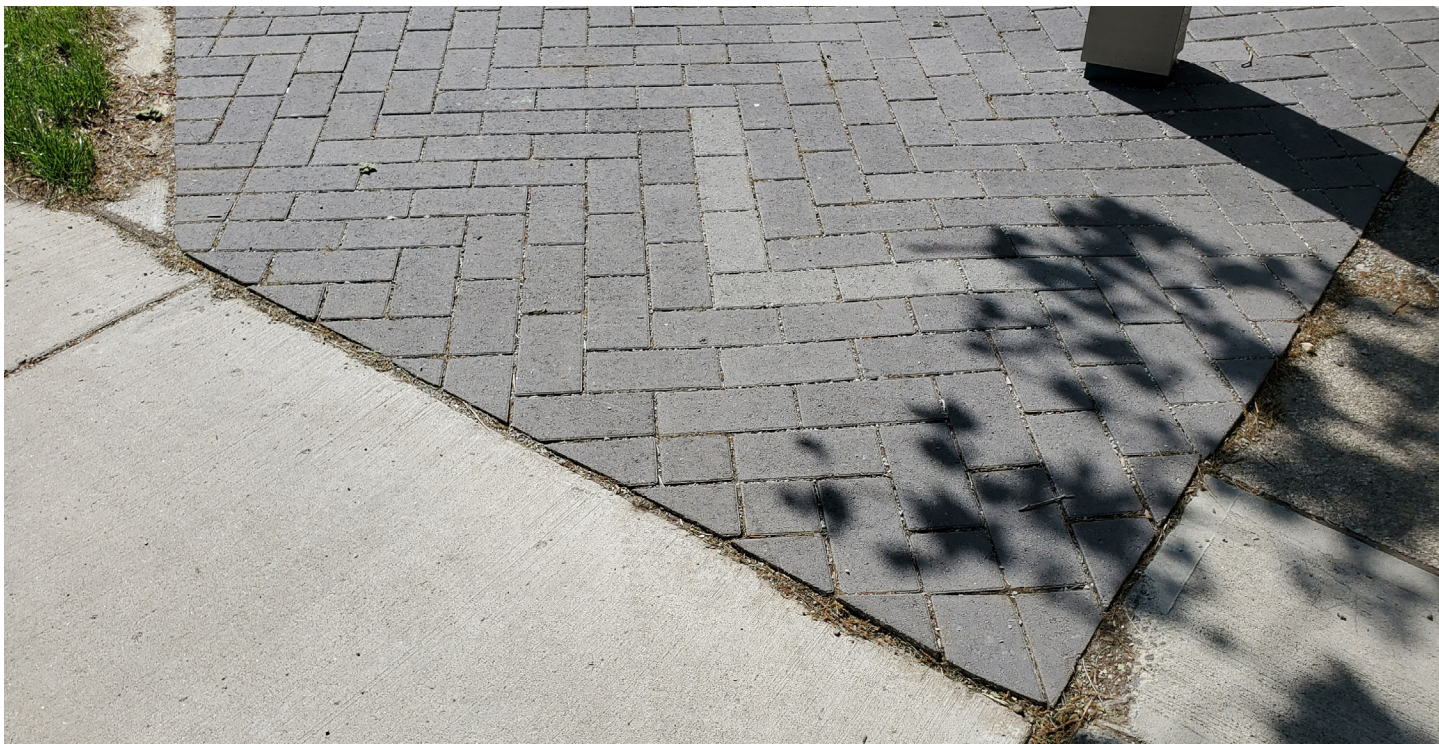
9. Minor sediment observed at corner of pedestrian walk due to unstabilized adjacent area - vacuuming scheduled

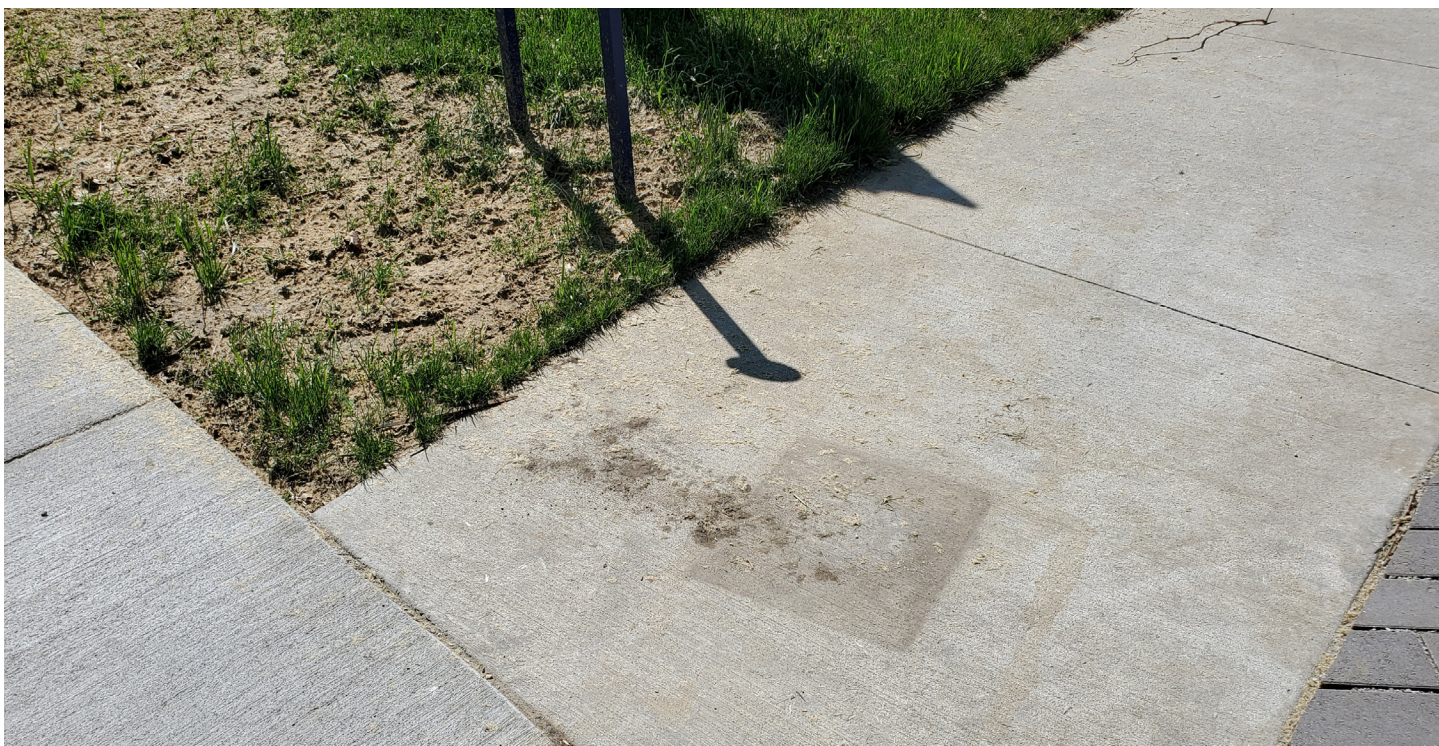
10. Up-stream stabilized to prevent future sediment in permeable paver pedestrian walk
