## Bioretention Area Inspection and Maintenance Checklist

<b>Facility:</b> Brow Avenue Green Infrastructure Project					
<b>Location/Address:</b> Northwest corner of Brow Avenue and E 55 <sup>th</sup> Street					
<b>Date:</b> 6-1-2021		<b>Time:</b> 11:30 am		<b>Weather Conditions:</b> Cloudy 75°	
				<b>Date of Last Inspection:</b> 3-24-2021	
<b>Inspector:</b> James Sickels				<b>Title:</b> Village Engineer, CPESC	
<b>Rain in Last 48 Hours    Yes   X   No                  If yes, list amount and timing:</b>					
<b>Pretreatment:</b> <input type="checkbox"/> vegetated filter strip   X swale <input type="checkbox"/> turf grass <input type="checkbox"/> forebay <input type="checkbox"/> other, specify: _____ <input type="checkbox"/> none					
<b>Site Plan or As-Built Plan Available:</b> X Yes <input type="checkbox"/> No Plans on file at NEORSD and Village of Newburgh Heights

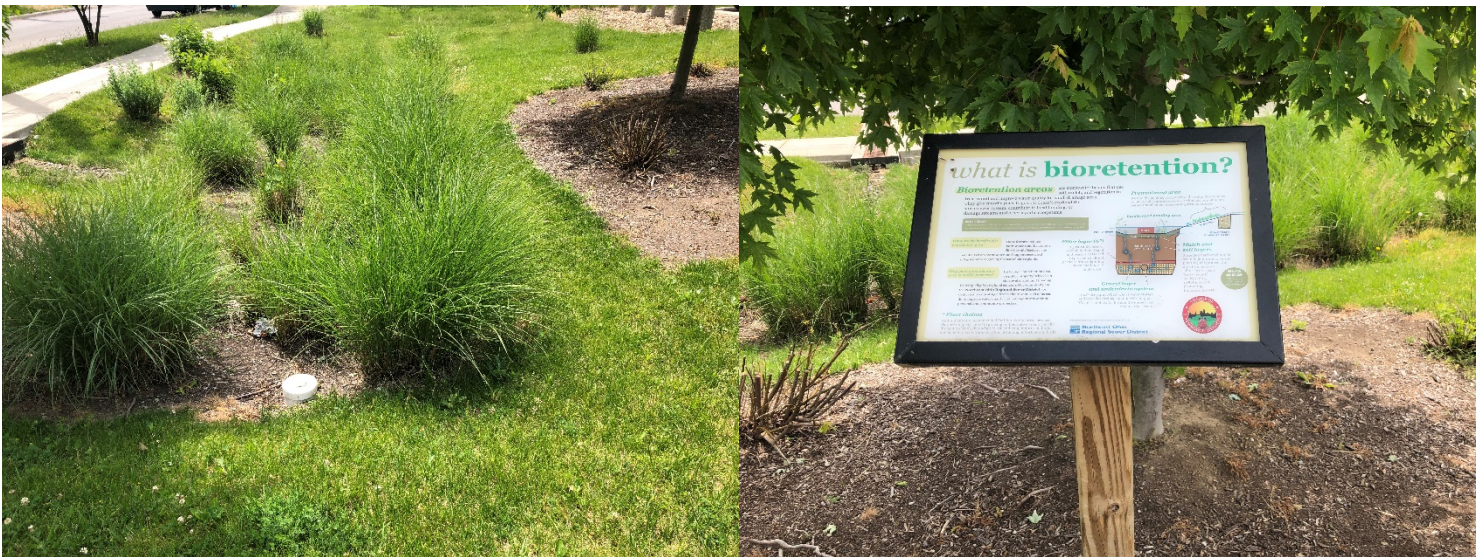
Photos taken 6-1-2021

The project was completed late in 2015. The Bio-retention cell is working well. The plantings look healthy. A sewer was constructed in 2017 to the bio-retention cell so the storm water will now drain into a separate storm system instead of entering the combined sewer system.
