# Bioretention Area Inspection and Maintenance Checklist (EAST BASIN)

# Bioretention Area Inspection and Maintenance Checklist (WEST BASIN)

## Permeable Pavement Inspection and Maintenance Checklist

## Rain Barrel/Cistern Inspection and Maintenance Checklist

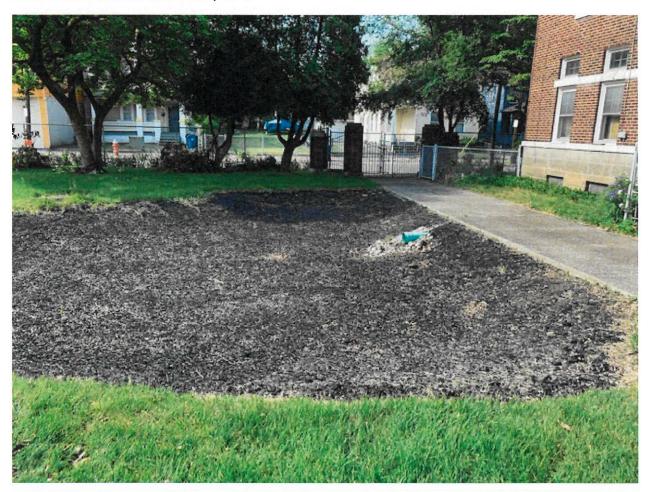
## East Basin (Behind Rectory and Church) Photo taken 5-26-21

Basin with new mulch added June/ 2020

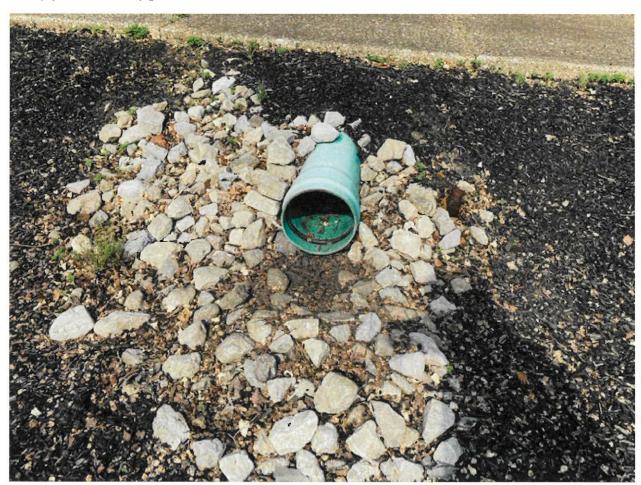
East Basin (Behind Rectory and Church) Photo taken 5-26-21 Inlet pipe from rectory gutters

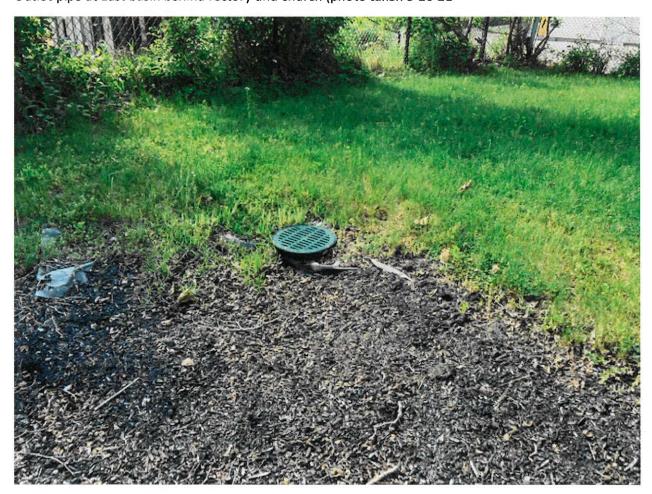
Outlet pipe at East basin behind rectory and church (photo taken 5-26-21

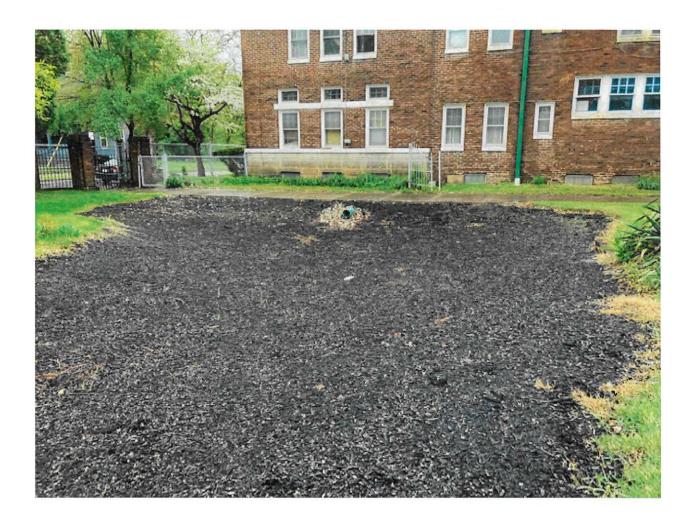
East Basin-Photo taken 5/9/21 during 1.8" rainfall event showing complete infiltration

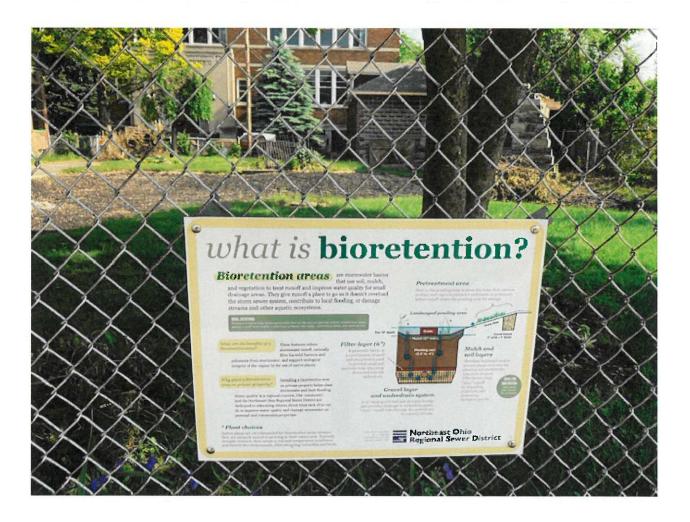
# East basin signage in good shape

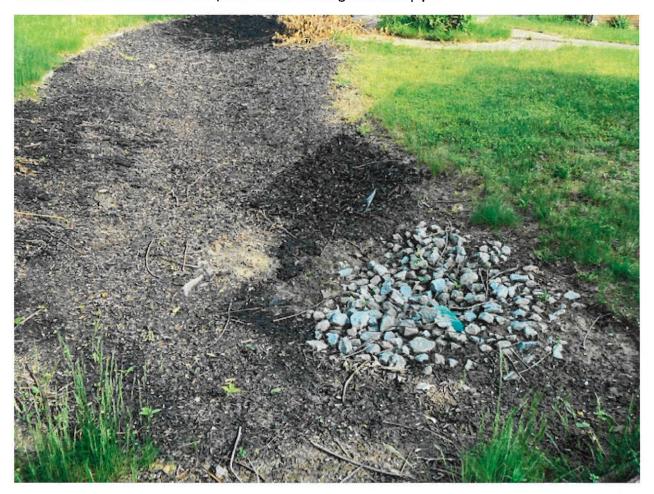
West Basin (behind old convent building) Photo taken 5/26/2021

2. DEWATERING			
Standing water is present after 24 hours. If yes, describe sheen, color, or smell.  3. INLETS	□Yes □N0 □N/A		□Yes □No
		<u></u>	
Inlets are in poor structural condition.	□Yes ☑No □N/A		□Yes ☑No
Sediment has accumulated and/or is blocking the inlets.	□Yes ☑No □N/A		□Yes ☑No
Erosion is occurring around the inlets.	✓Yes □No □N/A	MINOR-REPLACE	□Yes □No

New mulch was added June 2020 (some minor scouring near inlet pipe

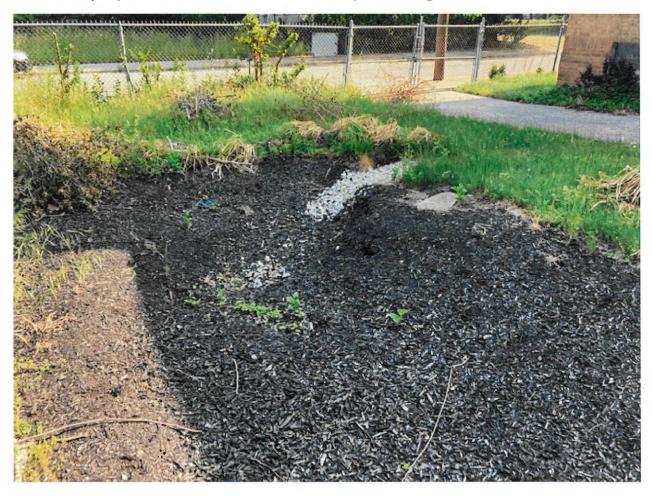
West Basin (behind old convent building) Photo taken 5/26/2021

4. BIORETENTION MAIN INFILTRAT	TION AREA		
Trash and debris have accumulated.	□Yes □Xo □N/A		□Yes □No
Sediment has accumulated at the surface.	□Yes □No □N/A		□Yes ☑No
Topmost layer is caked or crusted over with sediment.	□Yes ☑No □N/A		□Yes □No
Erosion is evident.	□Yes ☑No □N/A		□Yes □No
Mulch is compacted.	□Yes ZNo □N/A	, ,	□Yes ☑No
Sinkholes or animal borrows are present.	✓Yes □No □N/A	SINKHOLE WAS REPAIRED BY ADDING ROCK IN 2019	□Yes ☑No

Noting area of repair made in 2019 where rock was placed in area that was sinking )-still appears stable). This area may require future maintenance to monitor any new sinking.

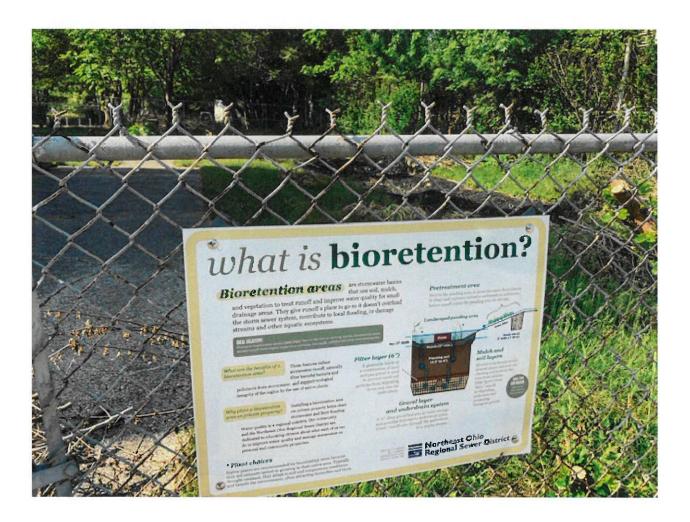
Showing west basin signage still in place-photo taken 5-26-2021

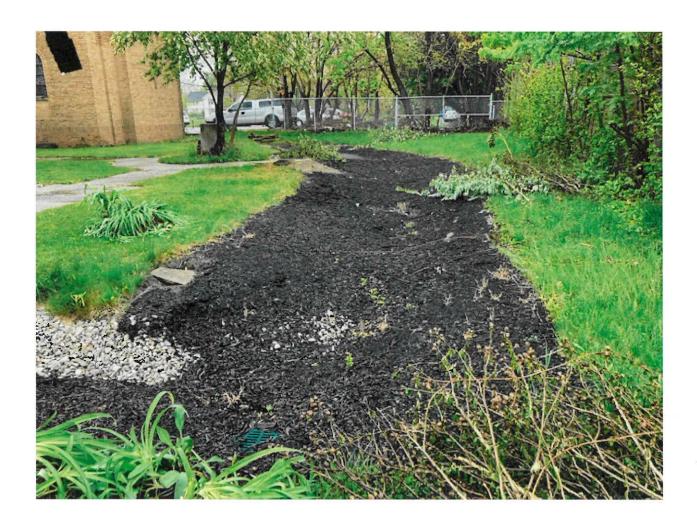
Showing West Basin on May 9, 2021 during 1.8" rainfall event.

Positive Infiltration /Outlet ok

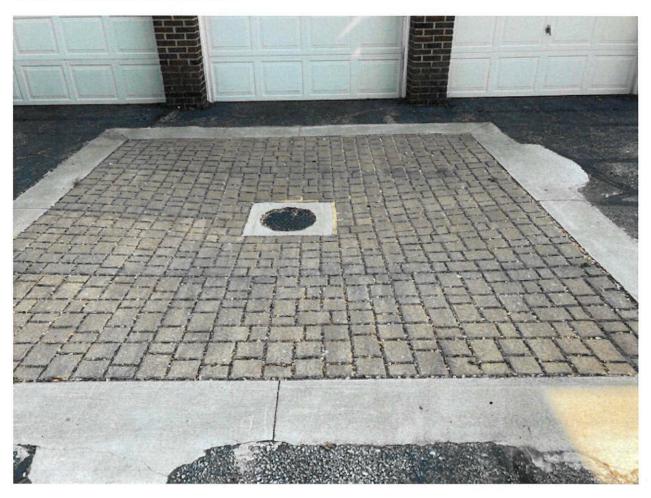
Inlet with surrounding pavers-photo taken 5-26-21. Additional cleaning would help between pavers. Pavers were cleaned November 2020.

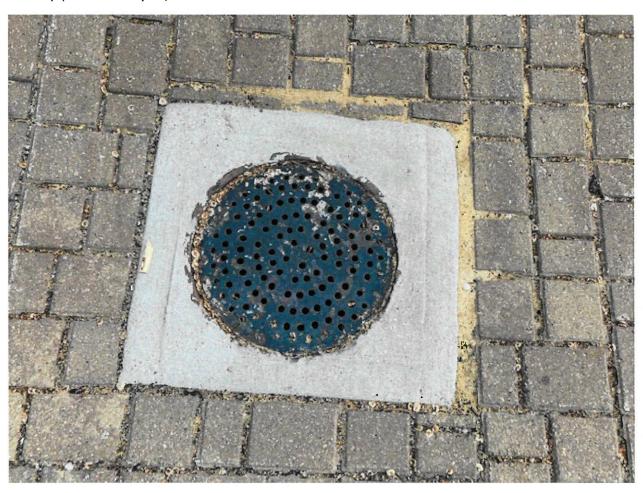
Close up photo on May 26, 2021

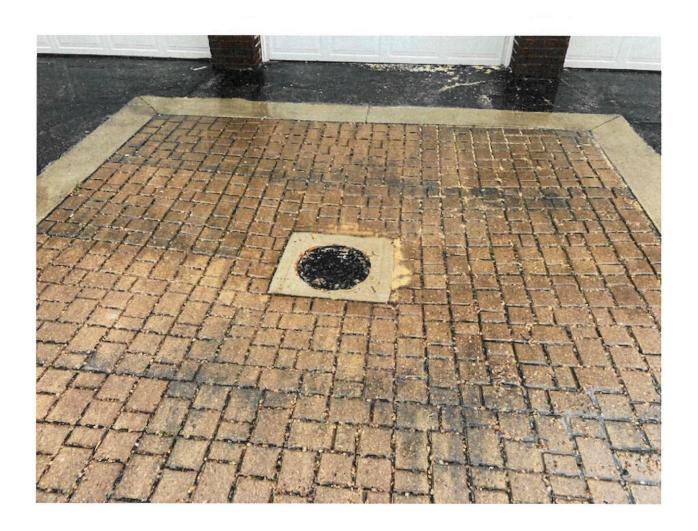
Inlet with surrounding pavers-photo taken May 9, 2021 during 1.8" rain event . Infiltration is occurring.

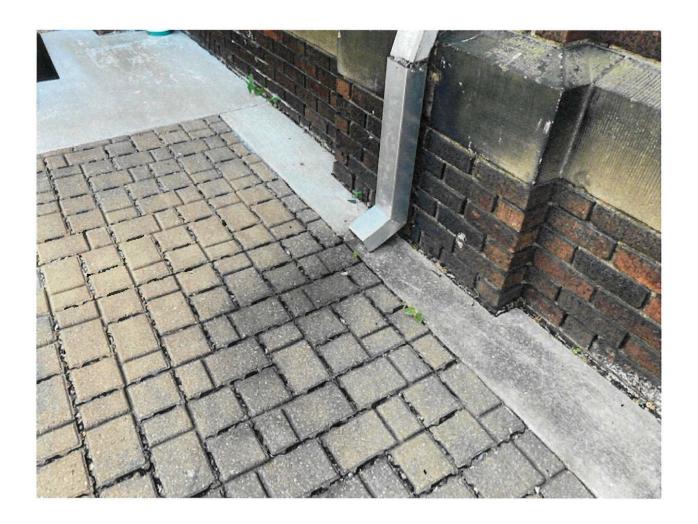
East Lot-Showing where gutters outlets on pavers

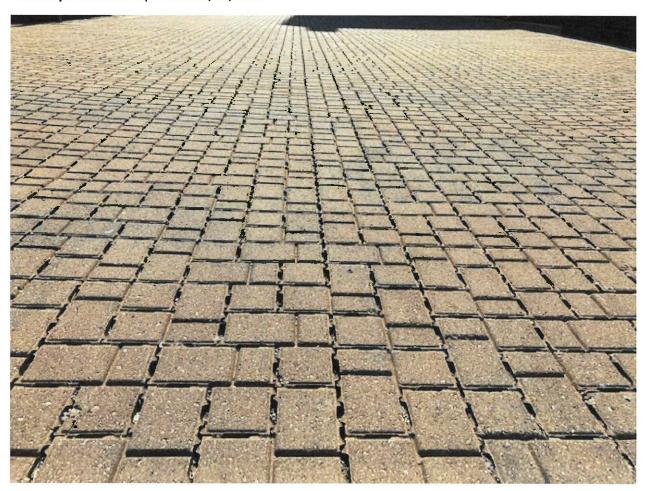
East lot pavers close-up Photo: 5/26/2021

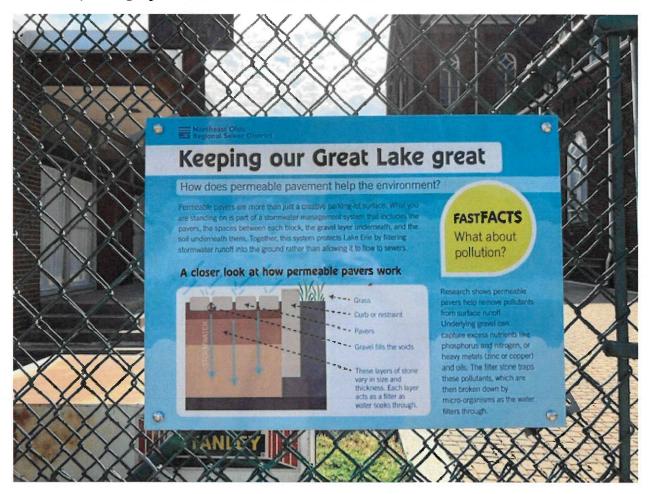
Permeable paver signage for both lots Photo taken 5-26-2021

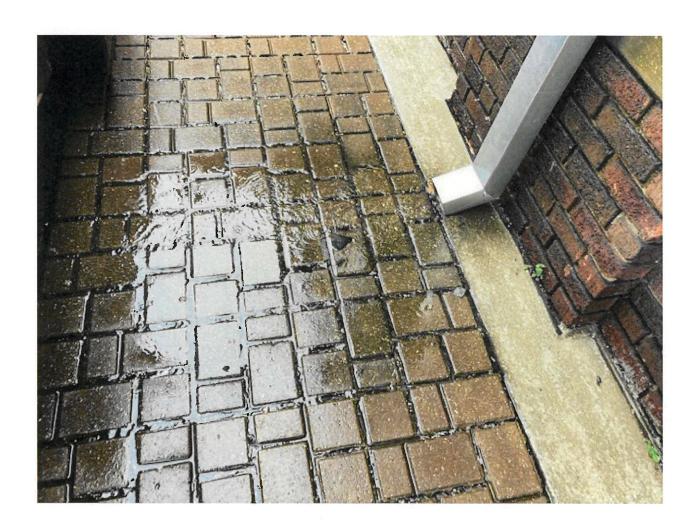
May 9, 2021 photo of East lot pavers during 1.8' rainfall event

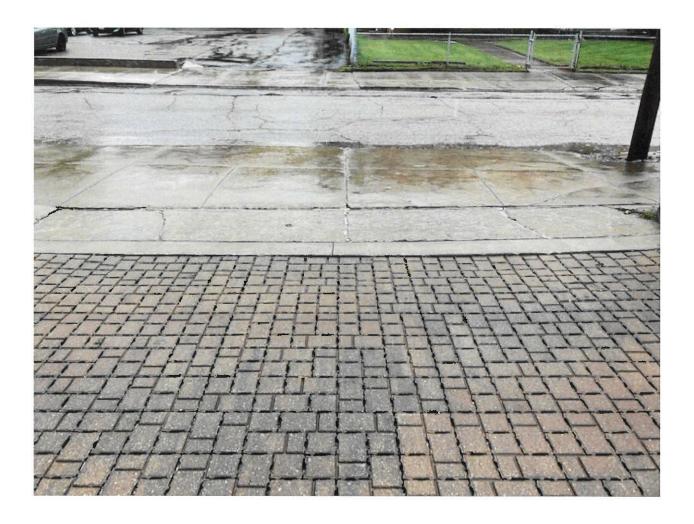
Showing East Lot on May 9, 2021 1.8" rainfall event near outlet of lot where all rain appears to have infiltrated with no offsite runoff observed

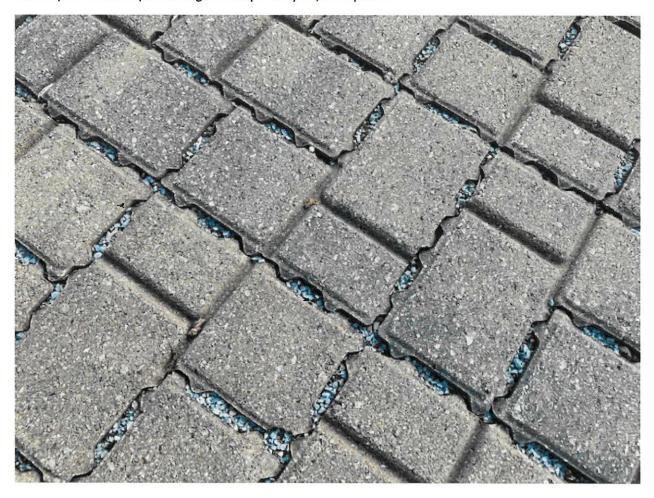
Close up of West lot pavers in good shape May 26,2021 photo

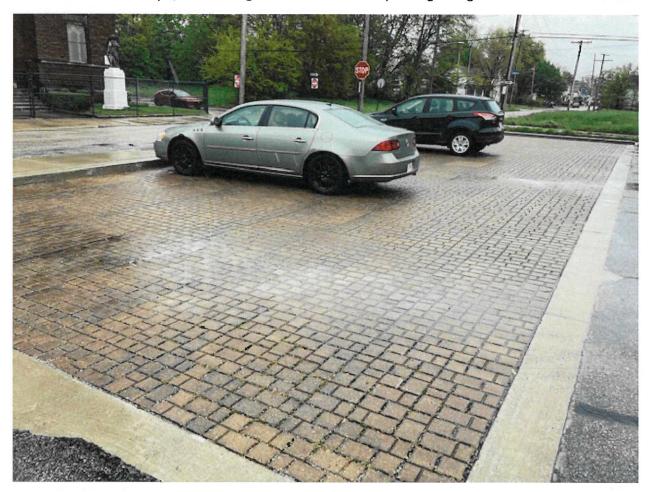
View of West Lot on May 9, 2021 during 1.8" rain event-minor ponding with good infiltration still visible

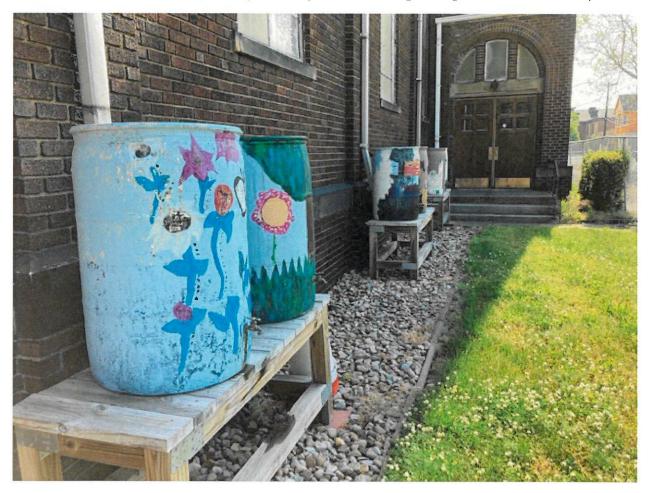
View of rain barrels 5/26/2021 (Paintings made by students at neighboring Willson Public School)

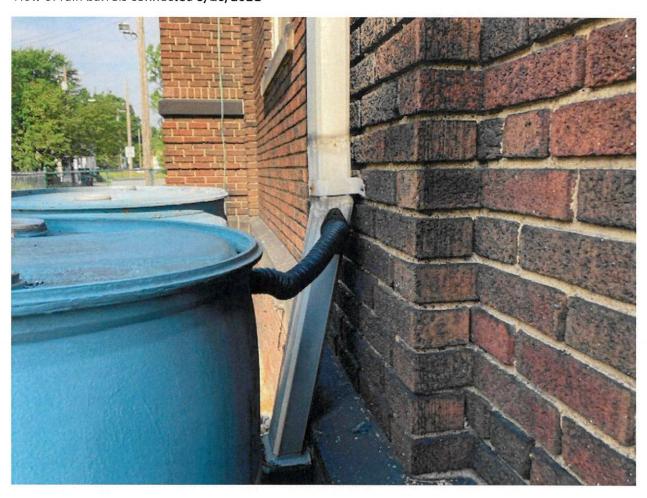
View of rain barrels connected 5/26/2021

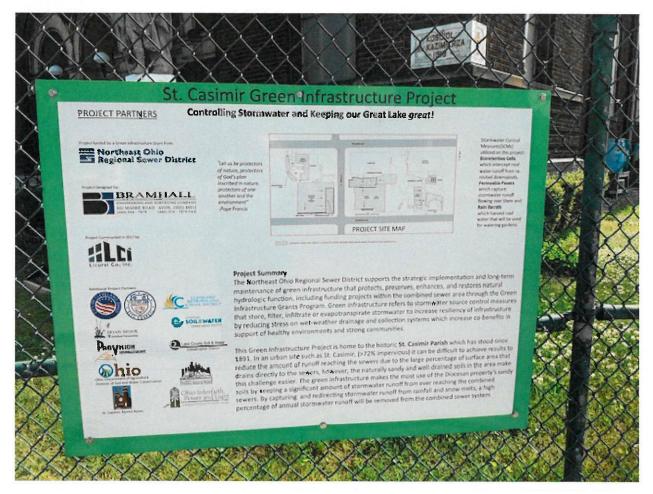
#### Overall Project sign still in good shape 5/26/2021
