Field Review

Technical Advisory Report

Long-Term Operation & Maintenance

Site Name:	Centric - Site Improvements	Report Date:	2021-06-15
Location:	Cleveland (East)	Inspection Date:	2021-06-15
Permit Holder:	Midwest Development Partners-Centric	Reviewed By:	Kelly Parker, CPESC, CESSWI
Contact:	Ryan Fair	Site NPDES Number:	N/A
Address:	2191 Murray Hill Road Cleveland, Ohio 44106, Cuyahoga	Application No:	B16004430

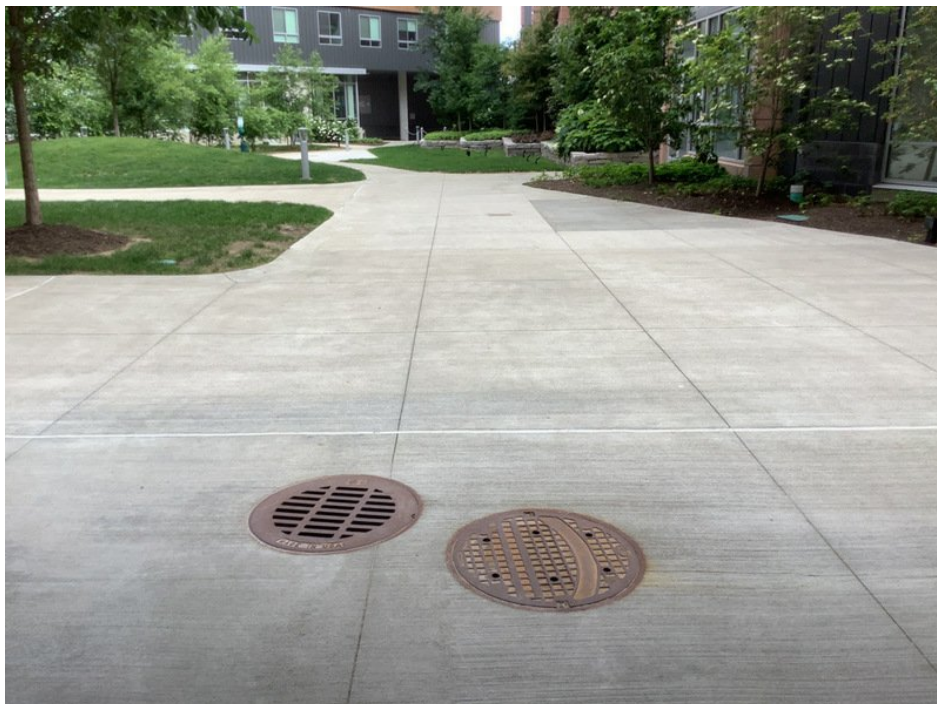
Overall view of the location of the underground detention system area (facing north). The underground detention system is maintained with routine maintenance. Ensure that the filter sock with Osorb Media is in place at the inflows from the garage and the eastern portion of the site.

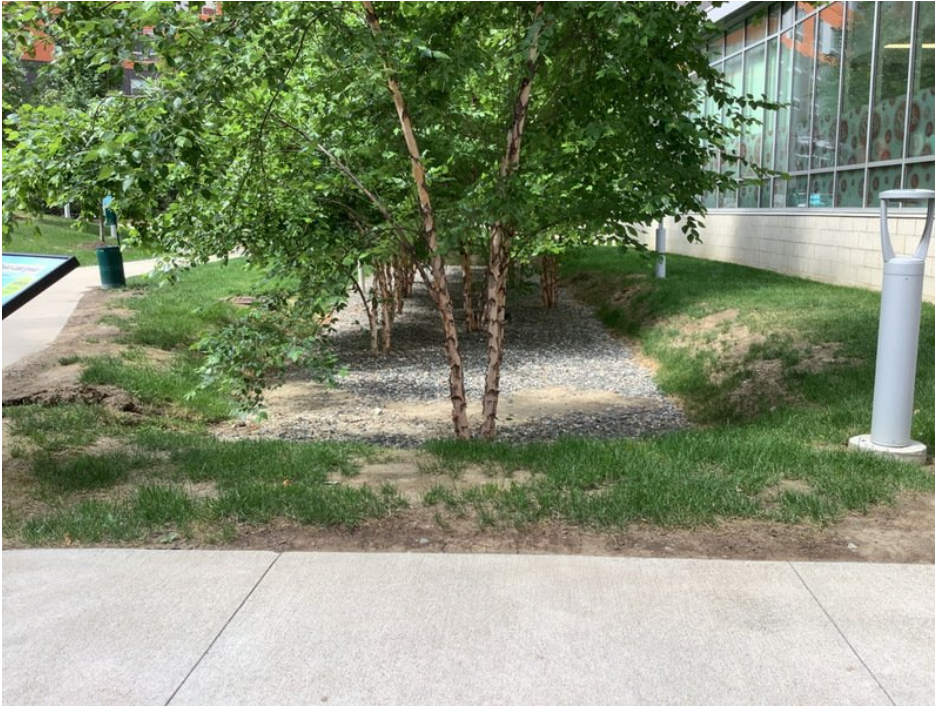
Overall view of the bioretention cell (facing southwest). The bioretention cell is maintained with regular landscaping. Exposed soil was observed throughout the area. Erosion of the embankment has resulted in accumulation of sediment in several areas of the bioretention cell, especially at the north end.

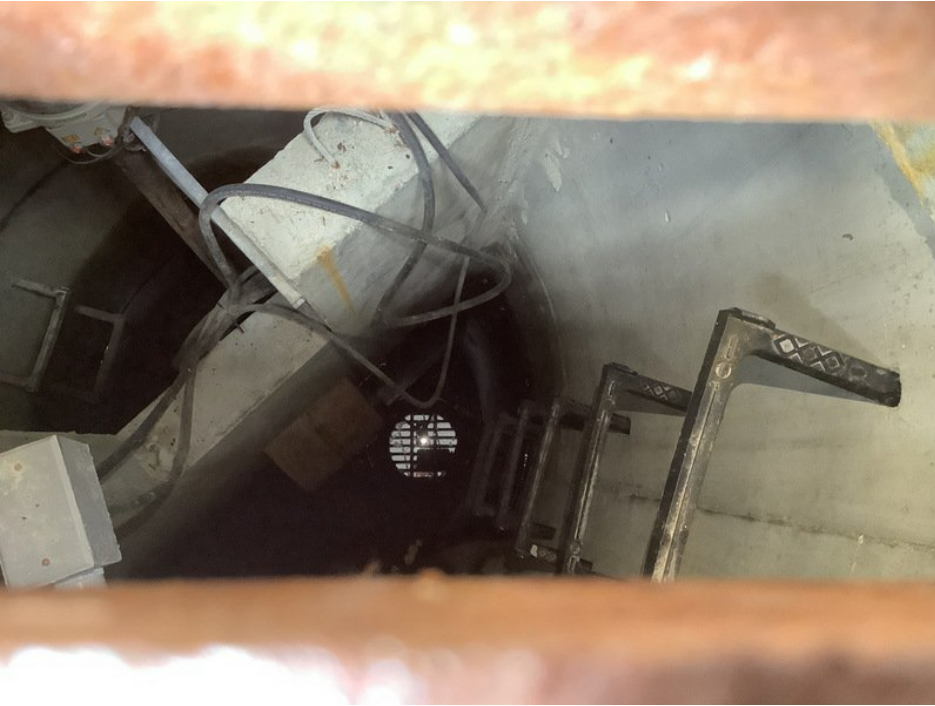
View of the interior of the underground detention outlet structure.

Plans call for a 6 inch pipe with a 9/16 inch orifice at the bottom. Ensure this water quality orifice is in place. Regularly inspect this small orifice to ensure it does not get clogged. Also plans call for a filter sock filled with Osorb Media to be placed at the inflow from the garage and the east. Ensure this is in place and functioning as designed.

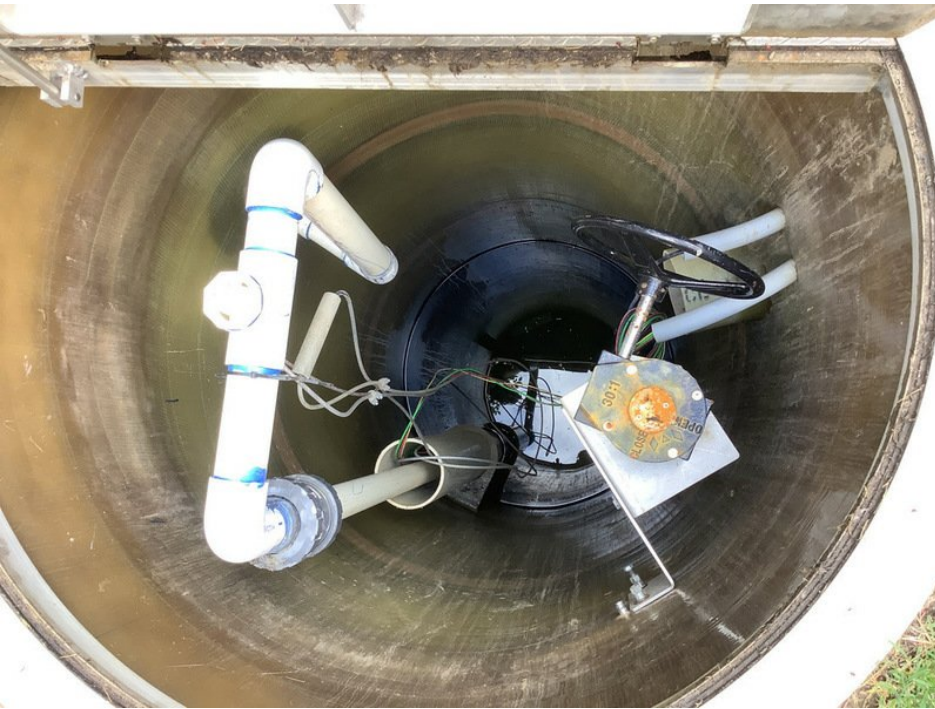
View of the interior of the manhole with water control valve for rainwater harvesting.

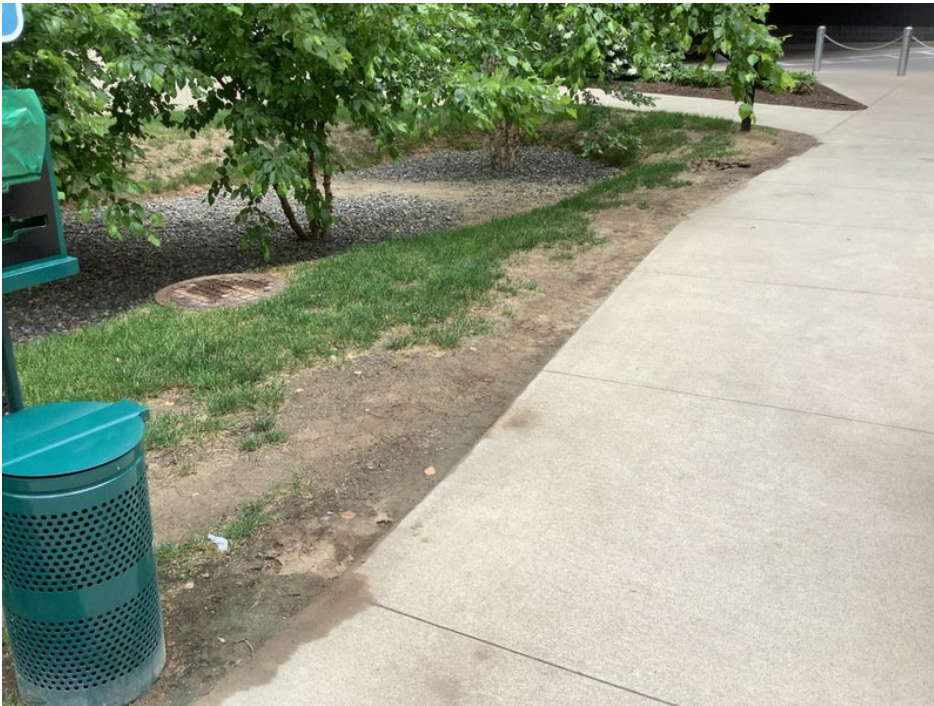
View of exposed soil along the east side of the bioretention cell (facing north).

Stabilize eroding areas to prevent further erosion and sedimentation of the stormwater control measure.

Provide stabilization as needed in areas with exposed soil to prevent erosion from clogging the stormwater control measure. Use rock along inflows and add mulch or vegetation around edges, and within the stormwater control measure to prevent erosion.

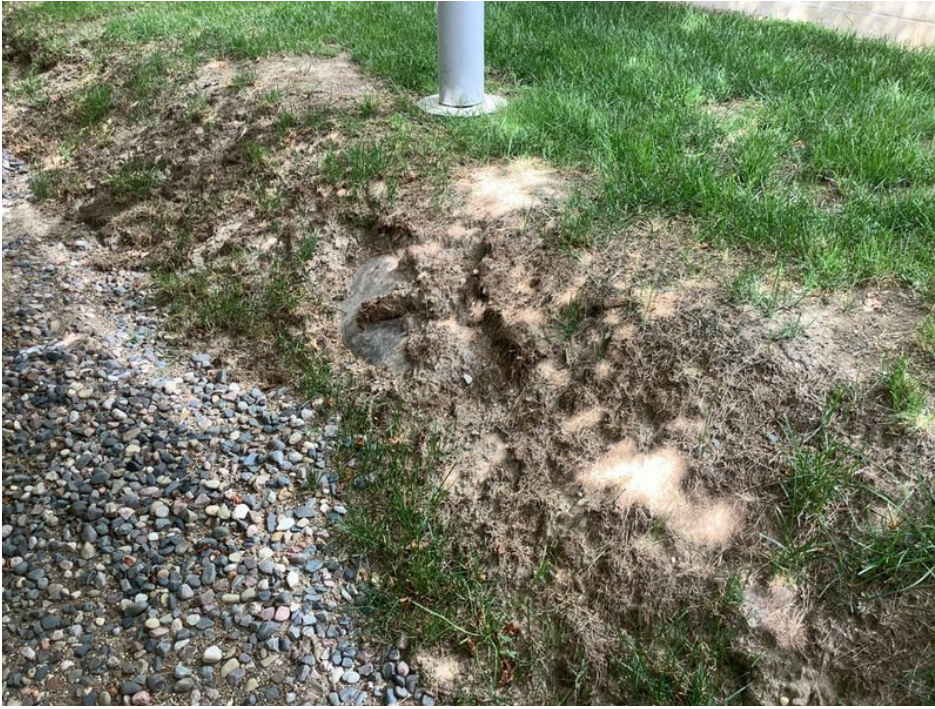
View of erosion and exposed liner on the west embankment of the bioretention cell (facing southwest).

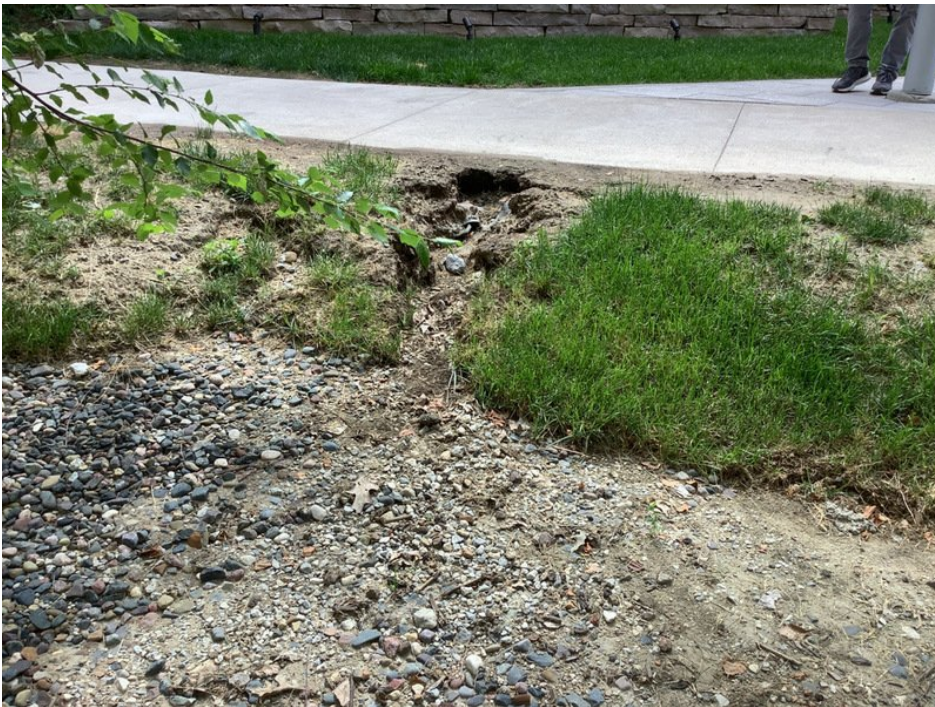
View of erosion and accumulated sediment on the north end of the bioretention cell (facing east).

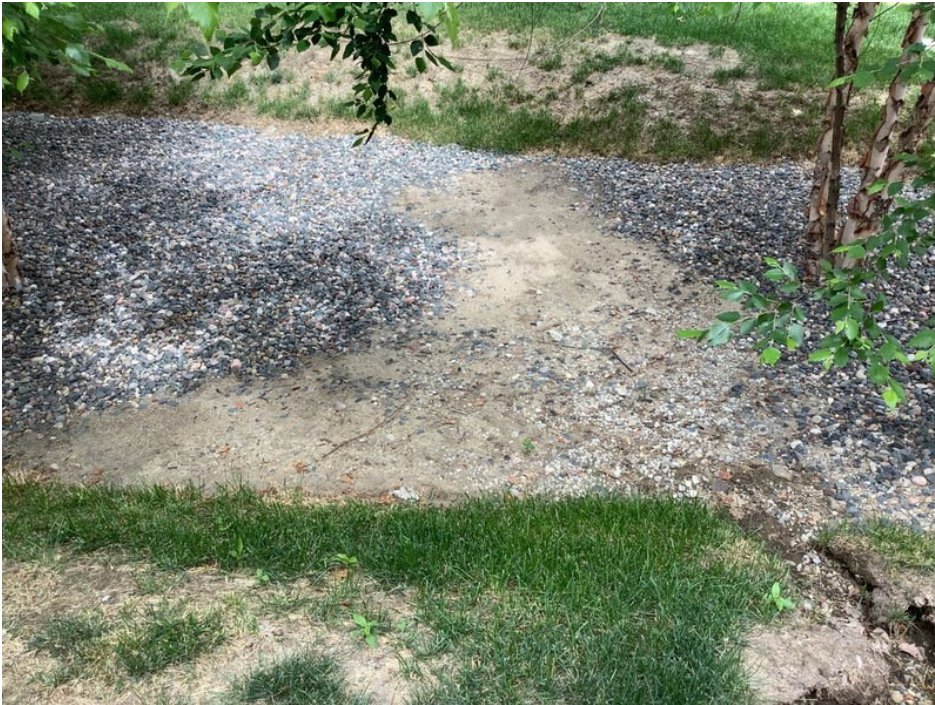
View of a large of accumulated sediment on the north end of the bioretention cell due to erosion of the embankments and other areas of exposed soil (facing west).

Remove accumulated fine sediment (clay/silt) as necessary for proper function of the stormwater control measure.
Replenish mulch to stabilize areas after sediment removal is completed.

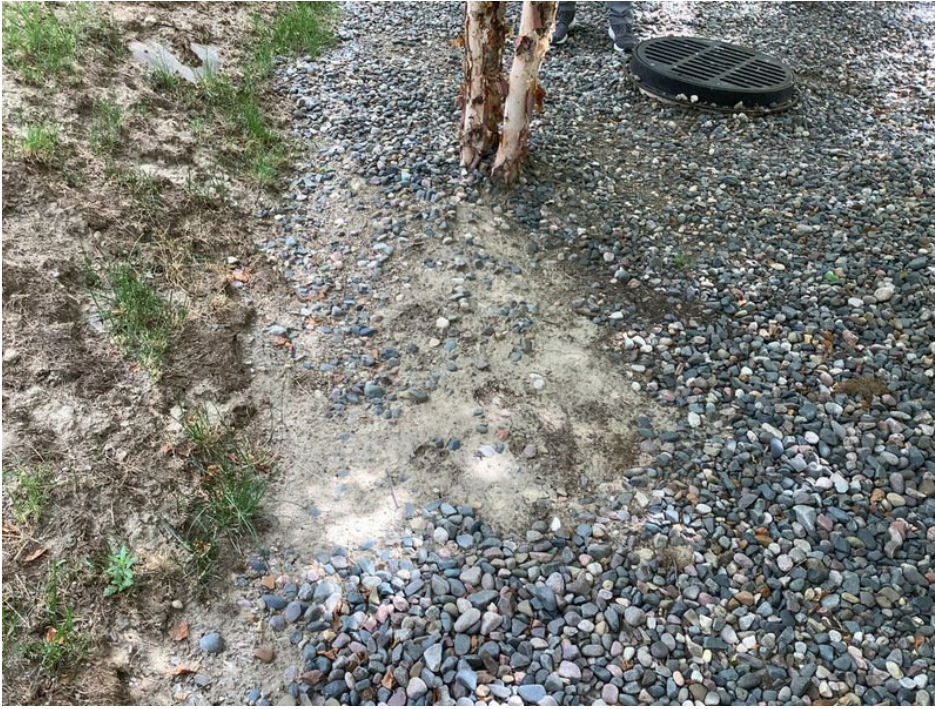
View of accumulated sediment on the west side of the bioretention cell due to erosion of the embankments and other areas of exposed soil (facing north).

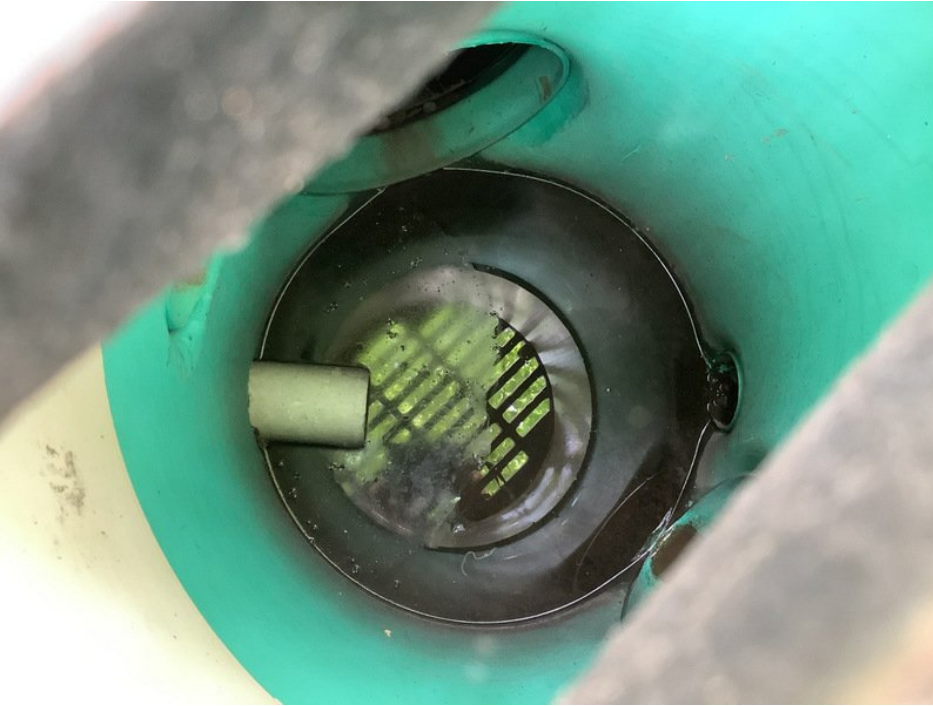
View of the interior of the bioretention cell outlet structure.

The outlet overflow grate should be 6-12 inches above the top of the mulch/basin to allow for ponding during rain events. Pre-cast risers can be purchased at a store like HD Supply. (The overflow grate height should not be above the surrounding parking lot.)

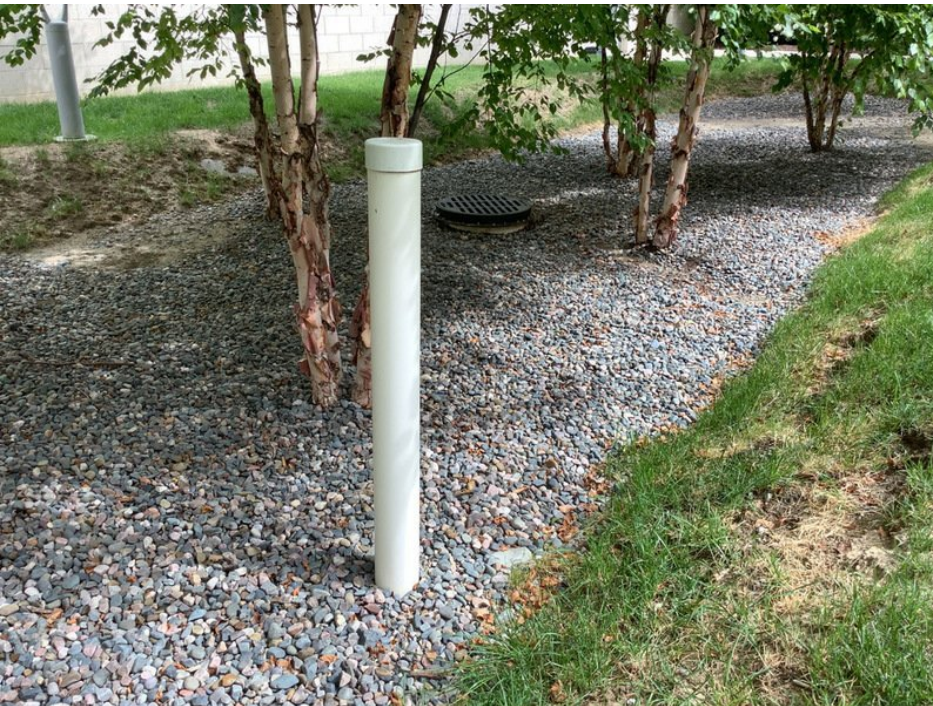
View of the bioretention cell outlet structure in the background (facing north).

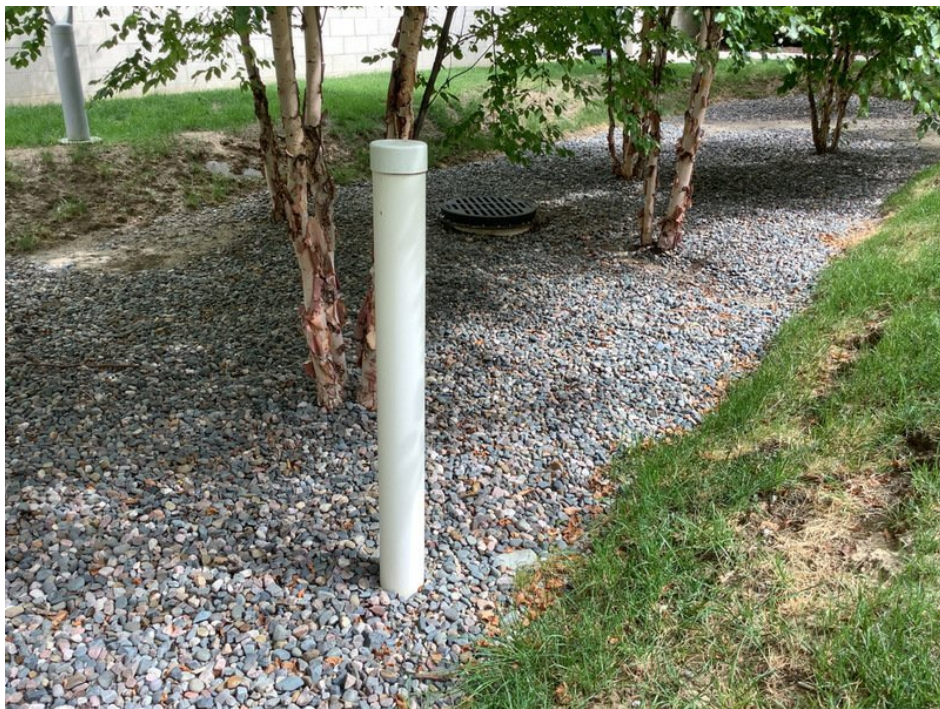
View of the cleanout pipe in the bioretention cell (facing north).

Clean out pipe within the bioretention area can be cut down to about 1 foot tall.
