Bioretention Area Inspection and Maintenance Checklist

Facility: Fairhill Partners			
Location/Address: 12200 Fairhill Rd, Cleveland, OH 44120			
Date: 5/13/21	Time: 9:30 AM	Weather Conditions: Sunny	Date of Last Inspection: 7/8/20
Inspector: Paul Sokell		Title: Maintenance Team Leader	
Rain in Last 48 Hours <input type="checkbox"/> Yes <input checked="" type="checkbox"/> No If yes, list amount and timing:			
Pretreatment: <input type="checkbox"/> vegetated filter strip <input type="checkbox"/> swale <input type="checkbox"/> turf grass <input type="checkbox"/> forebay <input type="checkbox"/> other, specify: <input checked="" type="checkbox"/> none			
Site Plan or As-Built Plan Available: <input checked="" type="checkbox"/> Yes <input type="checkbox"/> No

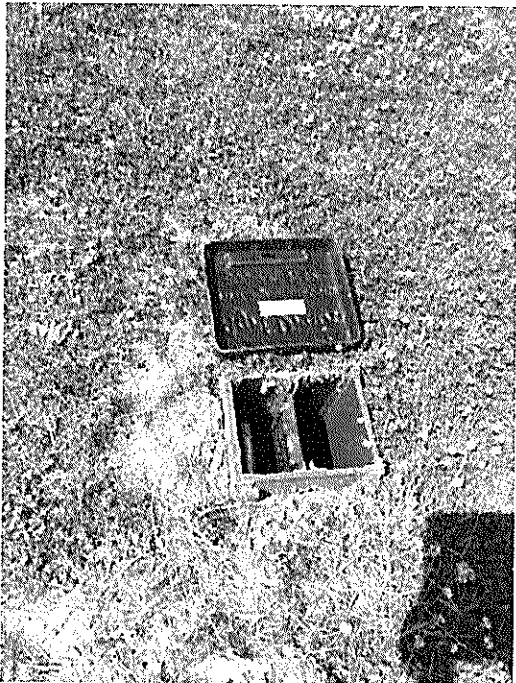
Comments: The top stoplog elevation of the adjustable Agridrain Inline Water Level Control Structure is to be set at 876.80. The associated underdrain is set at 875.22 (per design). At the time of the inspection, the stoplog was not set at the bottom of the structure. Please do so. See photo below.
