**Christian Maier**  
**Assistant Director of Public Works**  
**City of Shaker Heights**  
**3400 Lee Road**  
**Shaker Heights, Ohio 44120**

## Larchmere Kendall Parking Lot Green Infrastructure Inspection

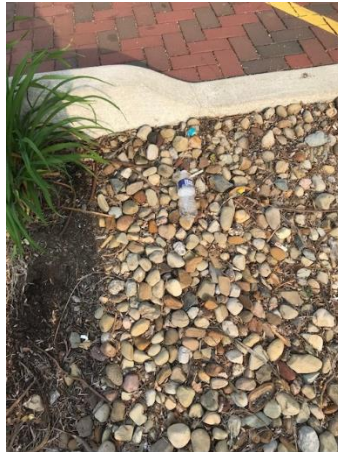
On Tuesday May 25<sup>th</sup>, 2021 a thorough inspection of the green infrastructure at Larchmere Kendall Parking Lot was conducted and noted some minor issues with the control measures. The first issue noticed upon inspection was the trash and litter found on the bottom and sides of the bioretention basin on the East side of the parking lot, see **Picture 1** below. All trash and litter must be cleaned to protect the integrity of the bioretention areas to ensure it functions as designed and to limit the possibility of any trash from clogging the outlet structures and drains during a storm event.

***Picture 1: Garbage and Litter Found in Bioretention Pond to the East***

<b>4. BIORETENTION MAIN INFILTRATION AREA</b>		
Trash and debris have accumulated.	<input checked="" type="checkbox"/> Yes <input type="checkbox"/> No <input type="checkbox"/> N/A	Some trash has accumulated in the bottom of the bioretention area <input checked="" type="checkbox"/> Yes <input type="checkbox"/> No
Sediment has accumulated at the surface.	<input type="checkbox"/> Yes <input checked="" type="checkbox"/> No <input type="checkbox"/> N/A	<input type="checkbox"/> Yes <input checked="" type="checkbox"/> No
Topmost layer is caked or crusted over with sediment.	<input type="checkbox"/> Yes <input checked="" type="checkbox"/> No <input type="checkbox"/> N/A	<input type="checkbox"/> Yes <input checked="" type="checkbox"/> No
Erosion is evident.	<input type="checkbox"/> Yes <input checked="" type="checkbox"/> No <input type="checkbox"/> N/A	<input type="checkbox"/> Yes <input checked="" type="checkbox"/> No

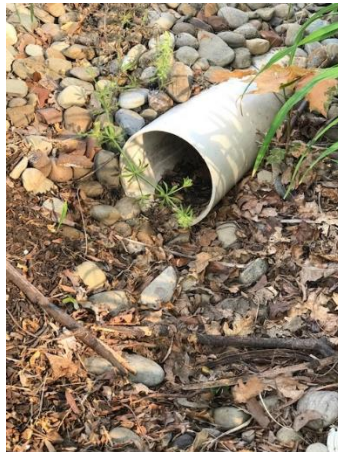
Another issue identified during the inspection is the inlet pipe for the North West bioretention area. It has a small build up of debris inside of the pipe, see **Picture 2** below. All debris found inside of the pipe must be cleaned out to reduce the chance of the inlet pipe of clogging and not allowing water to enter the basin as designed. The clogging of the inlet pipe could cause water to surcharge and potentially flood the upstream area of the inlet pipe. To ensure these problems don't occur, regular cleaning and maintenance on the inlet pipe should be conducted.

***Picture 2: Debris in the Inlet Pipe of the Bioretention Pond to the North West***

The inlet pipe for the bioretention area to the North West of the parking lot has some debris/dirt that needs to be cleaned to prevent future build up.

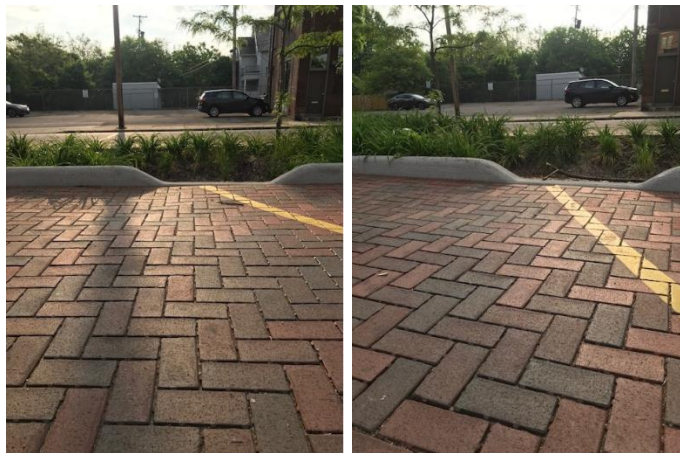
Lastly, it was observed that low points in the pervious pavers have formed near the curb inlets of the bioretention area on the east side of the parking lot, see **Pictures 3 & 4** below. The low are very minor and should be monitored if they continue to settle then they should be reset to the desired grade.

***Picture 3 & 4: Low Points in Pervious Pavers to the East of the Parking Lot***

Low points were identified to the East of the parking lot near the inlets into the bioretention area.
