Bioretention Area Inspection and Maintenance Checklist

Facility: MLK-Carnegie Bioretention Cell			
Location/Address: Intersection of Martin Luther King Jr. Drive and Carnegie Ave			
Date: 5/24/21	Time: 10 a.m.	Weather Conditions: Sunny, dry	Date of Last Inspection: October 2020
Inspector: Julie Ross, CESSWI, OIM18013		Title: Civil Associate, Michael Baker	
Rain in Last 48 Hours <input type="checkbox"/> Yes <input checked="" type="checkbox"/> No If yes, list amount and timing:			
Pretreatment: <input type="checkbox"/> vegetated filter strip <input type="checkbox"/> swale <input type="checkbox"/> turf grass <input type="checkbox"/> forebay <input type="checkbox"/> other, specify: <input checked="" type="checkbox"/> none			
Site Plan or As-Built Plan Available: <input checked="" type="checkbox"/> Yes <input type="checkbox"/> No

LANDSCAPE PLAN
CARNEGIE AVENUE/MLK JR. DRIVE
INTERSECTION IMPROVEMENTS

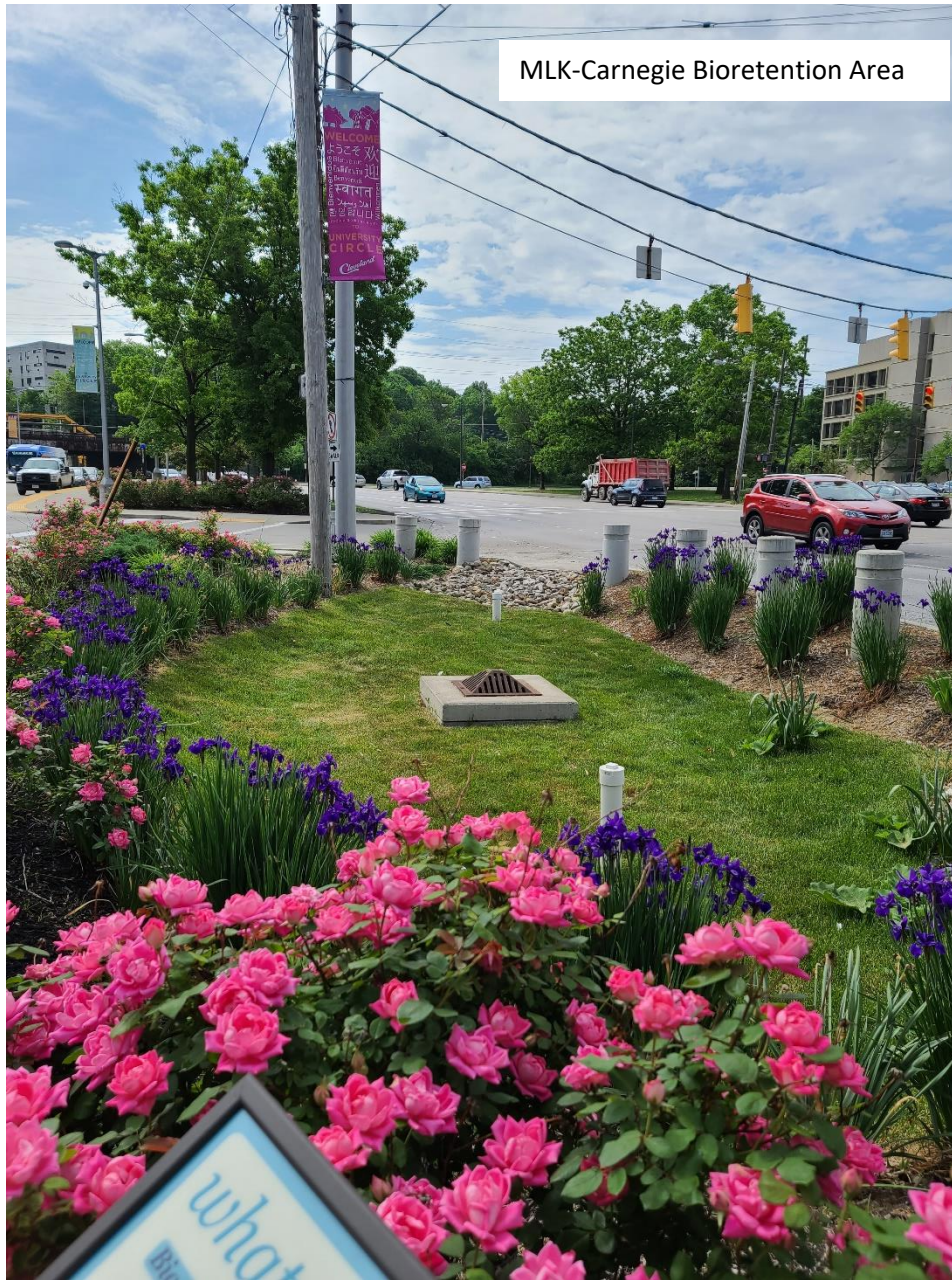
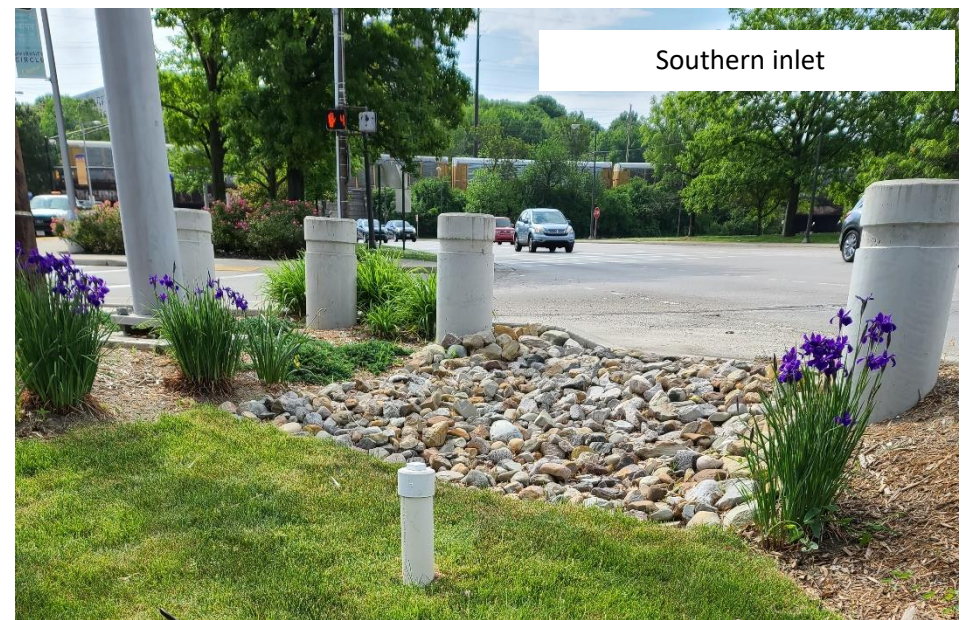
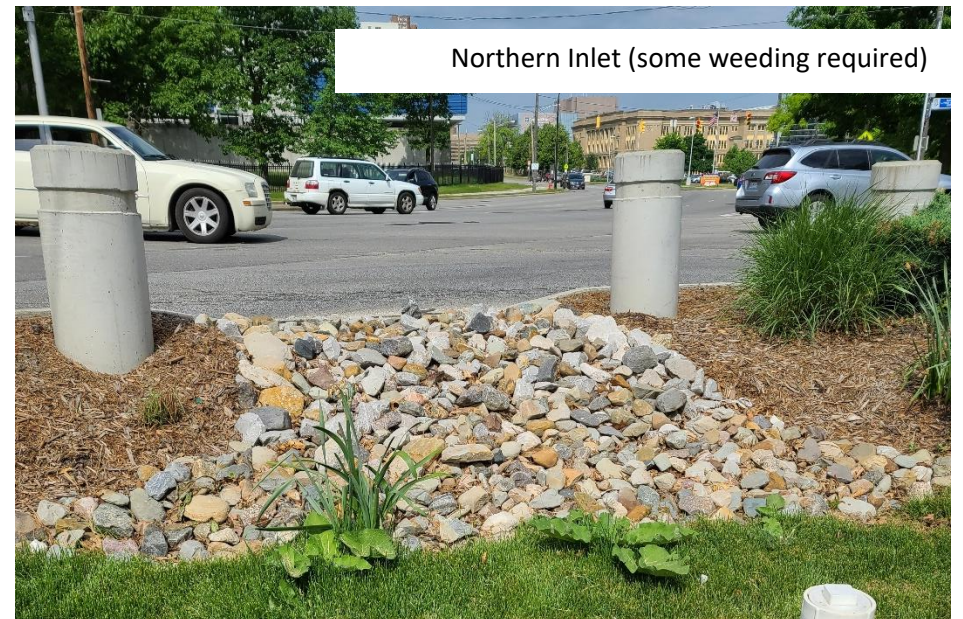
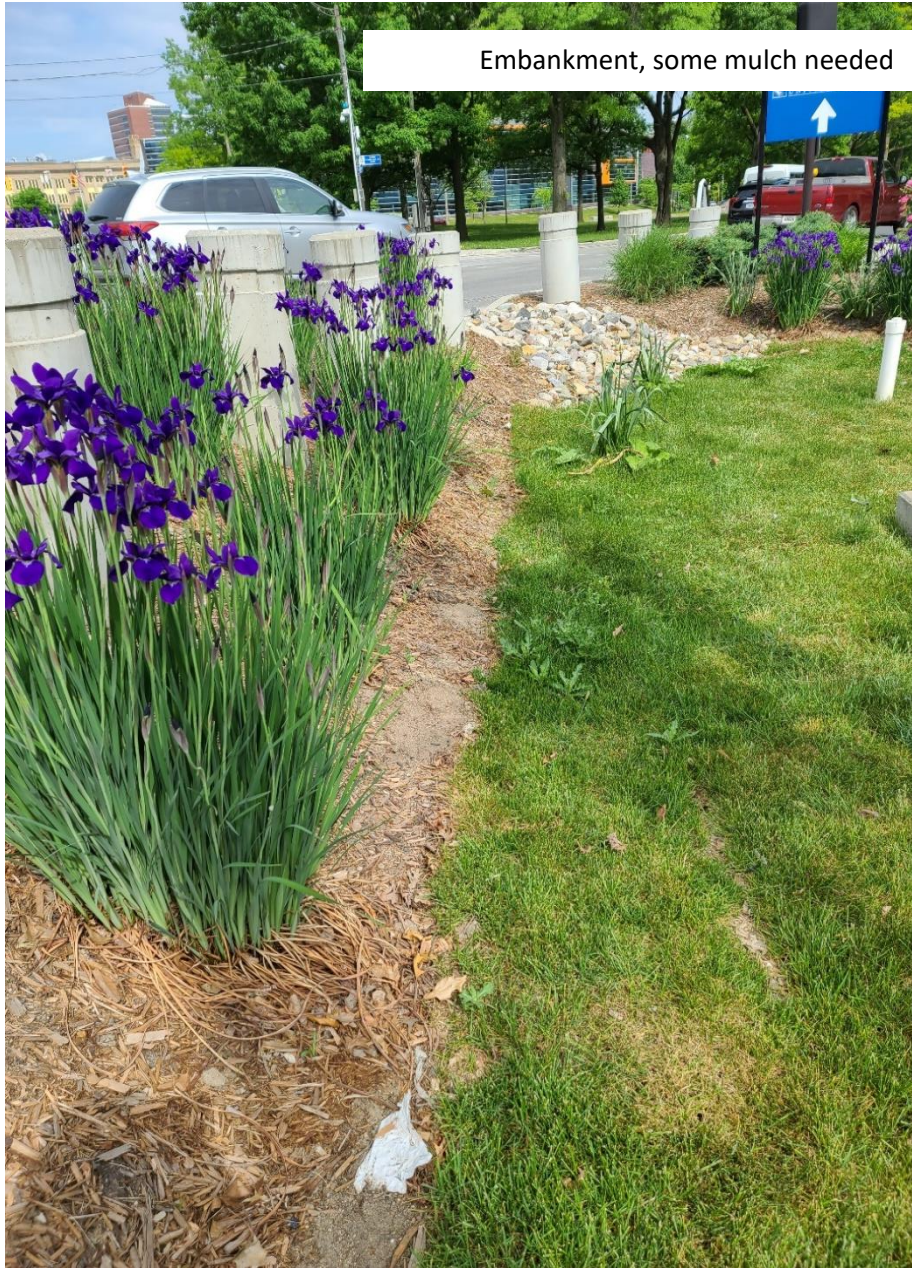
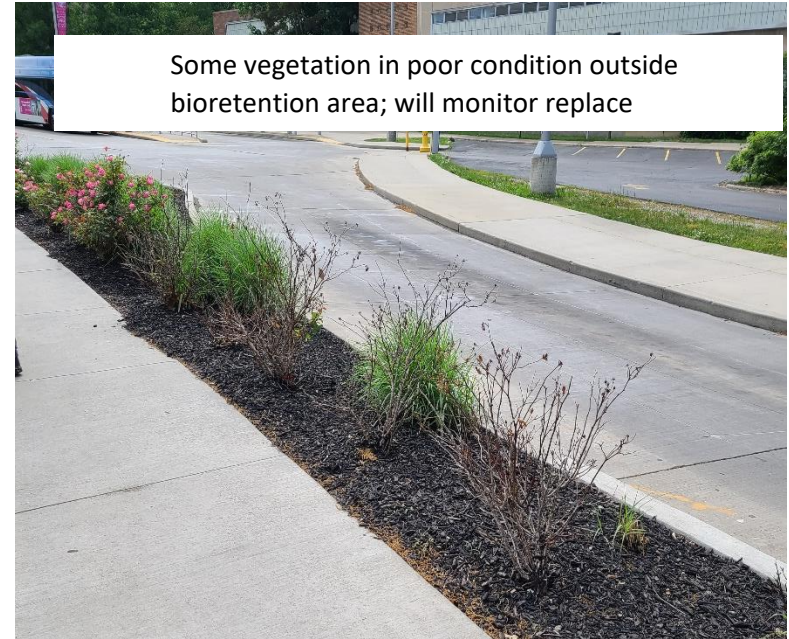
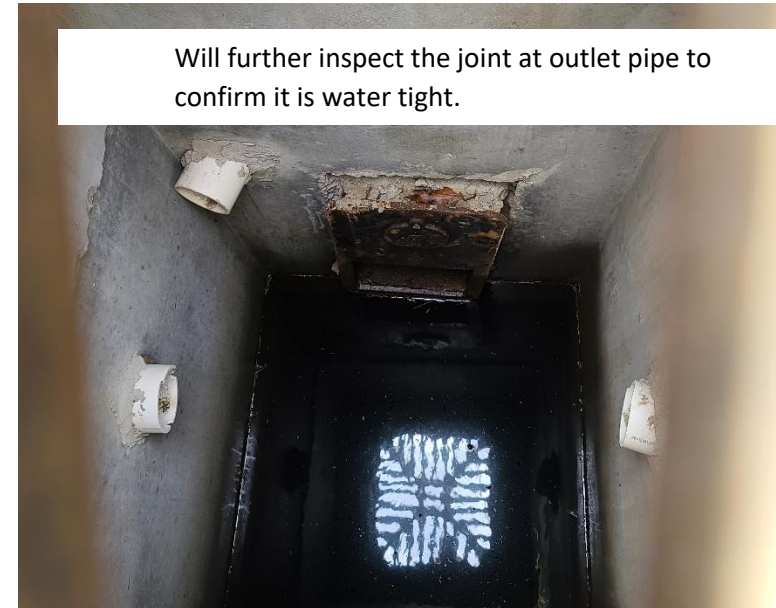
Overall, bioretention area appears to be in good condition along with the associated educational signage.
See attached photos for further documentation.

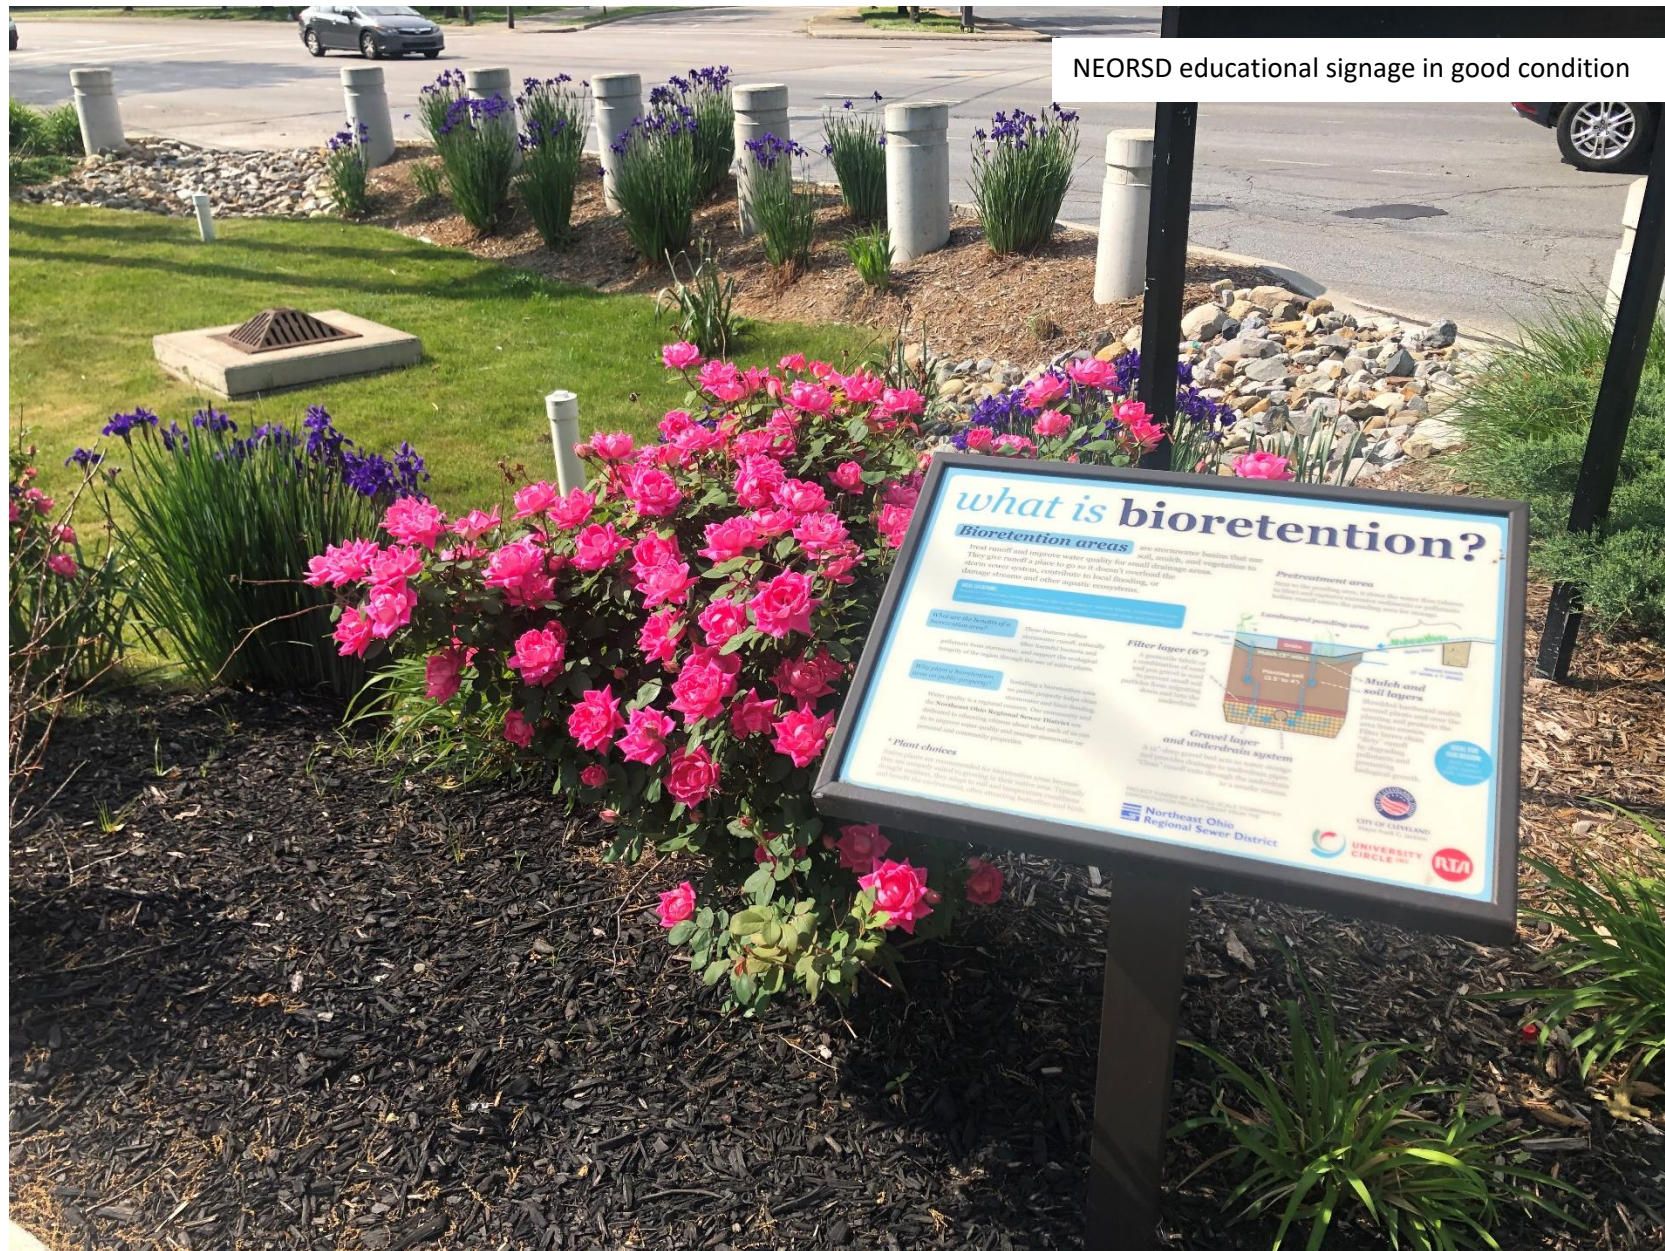
NEORSRD educational signage in good condition
