## Permeable Pavement Inspection and Maintenance Checklist

| <b>Facility:</b> City of Cleveland Division of Water Pollution Control | | | |
| <b>Location/Address:</b> 12302 Kirby Ave | | | |
| <b>Date:</b> 04/29/2021 | <b>Time:</b> 8:30 am | <b>Weather Conditions:</b> Rain | <b>Date of Last Inspection:</b> 08/27/2020 |

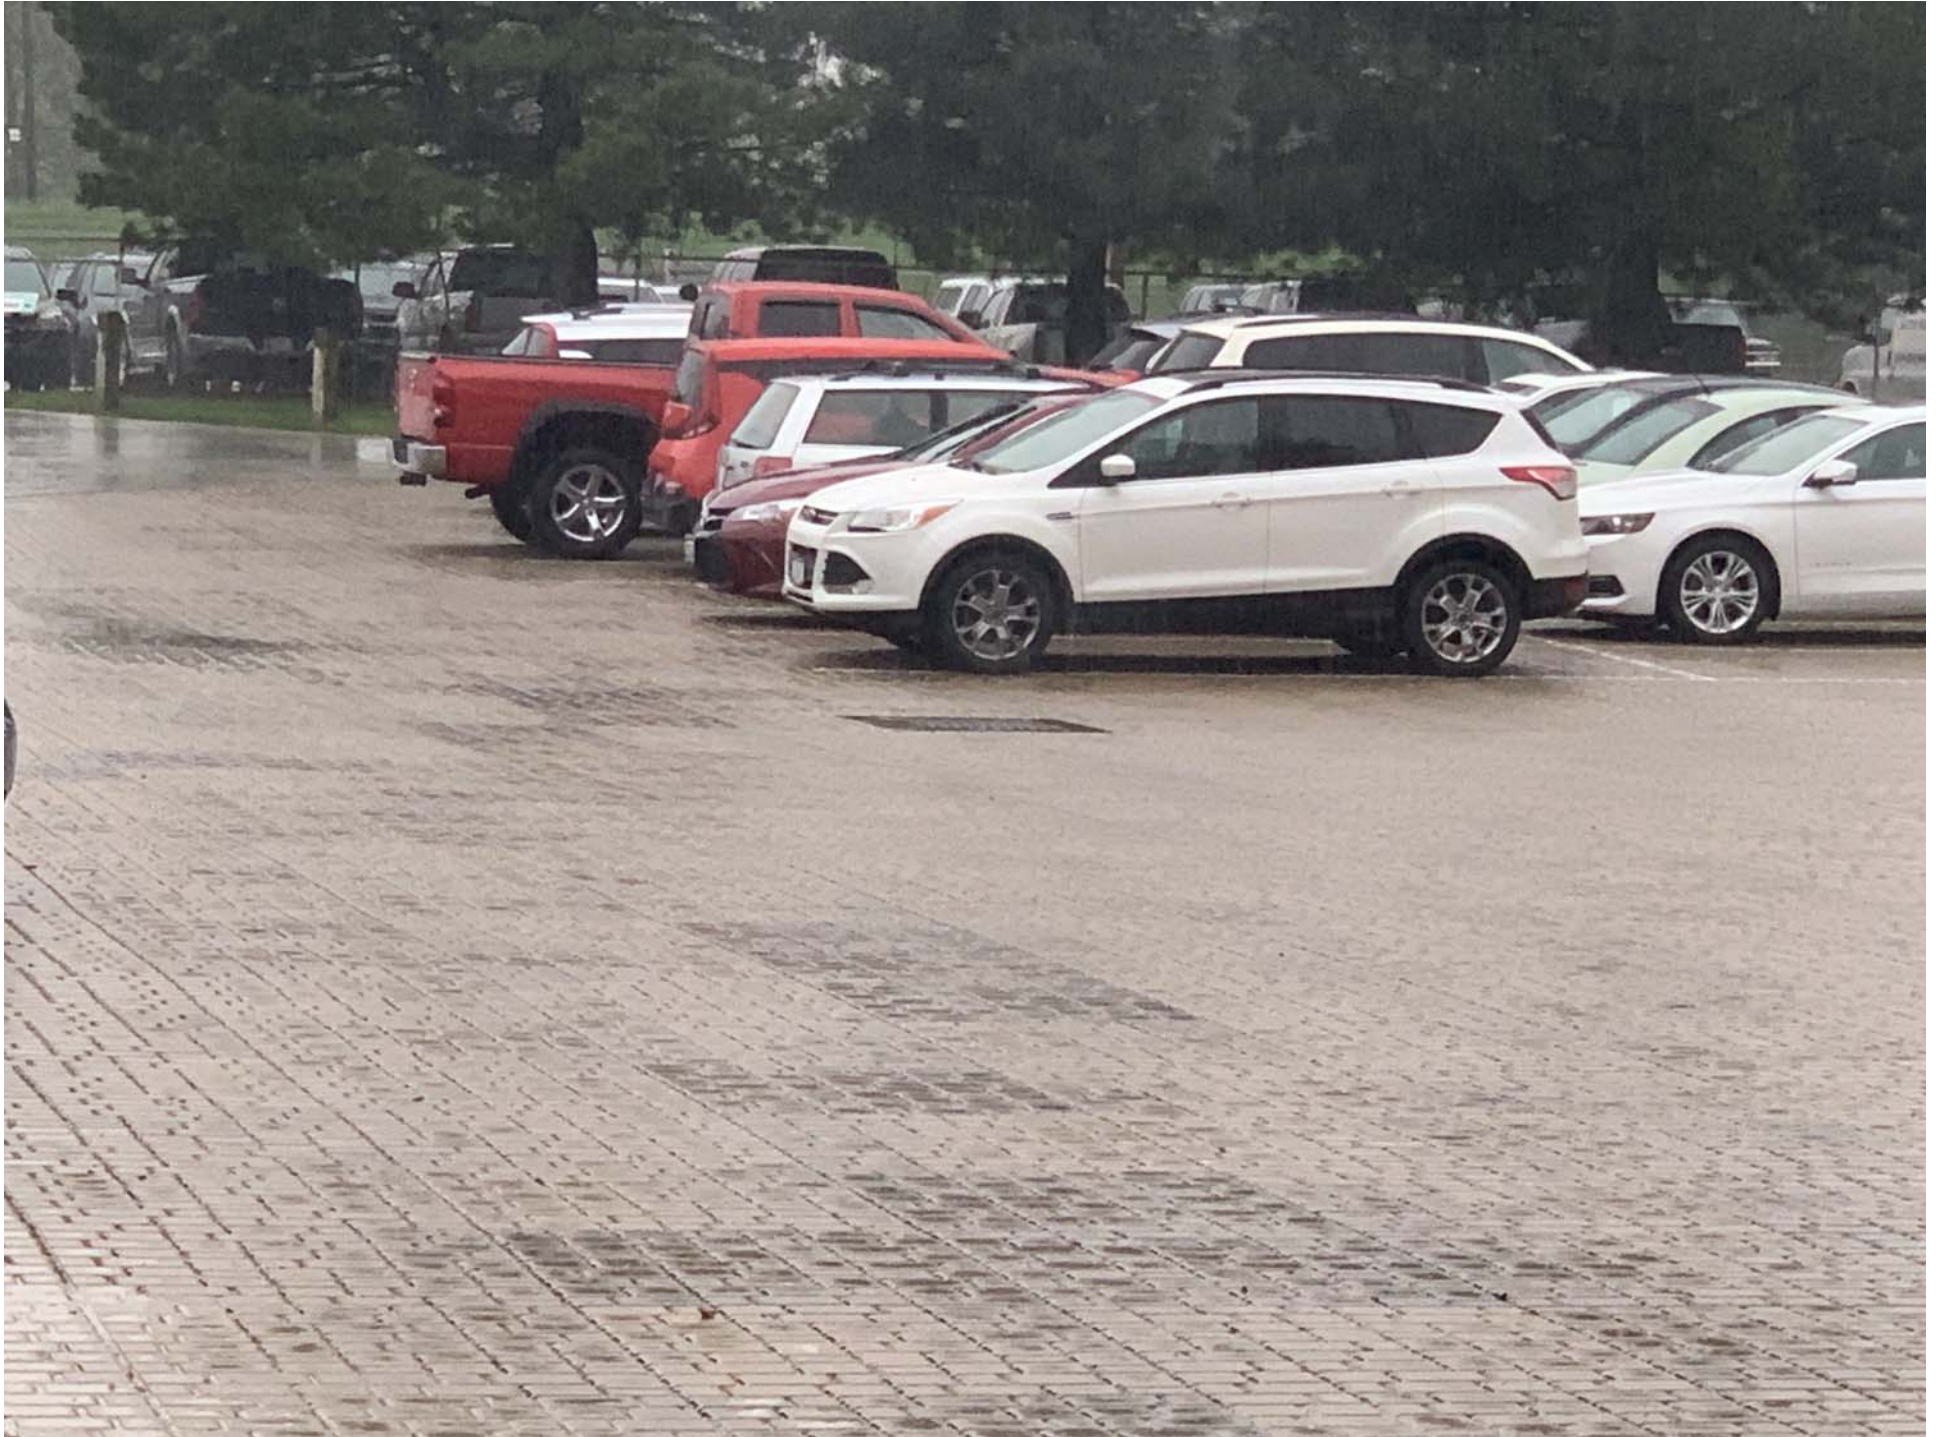
| Inspection Item | | Comment | Action Needed |
|---|---|---|---|
| Standing water is visible on the surface after a rain event. | <input type="checkbox"/> Yes <input checked="" type="checkbox"/> No <input type="checkbox"/> N/A | photos attached | <input type="checkbox"/> Yes <input checked="" type="checkbox"/> No |

Photo taken during rain event (4/29/2021)

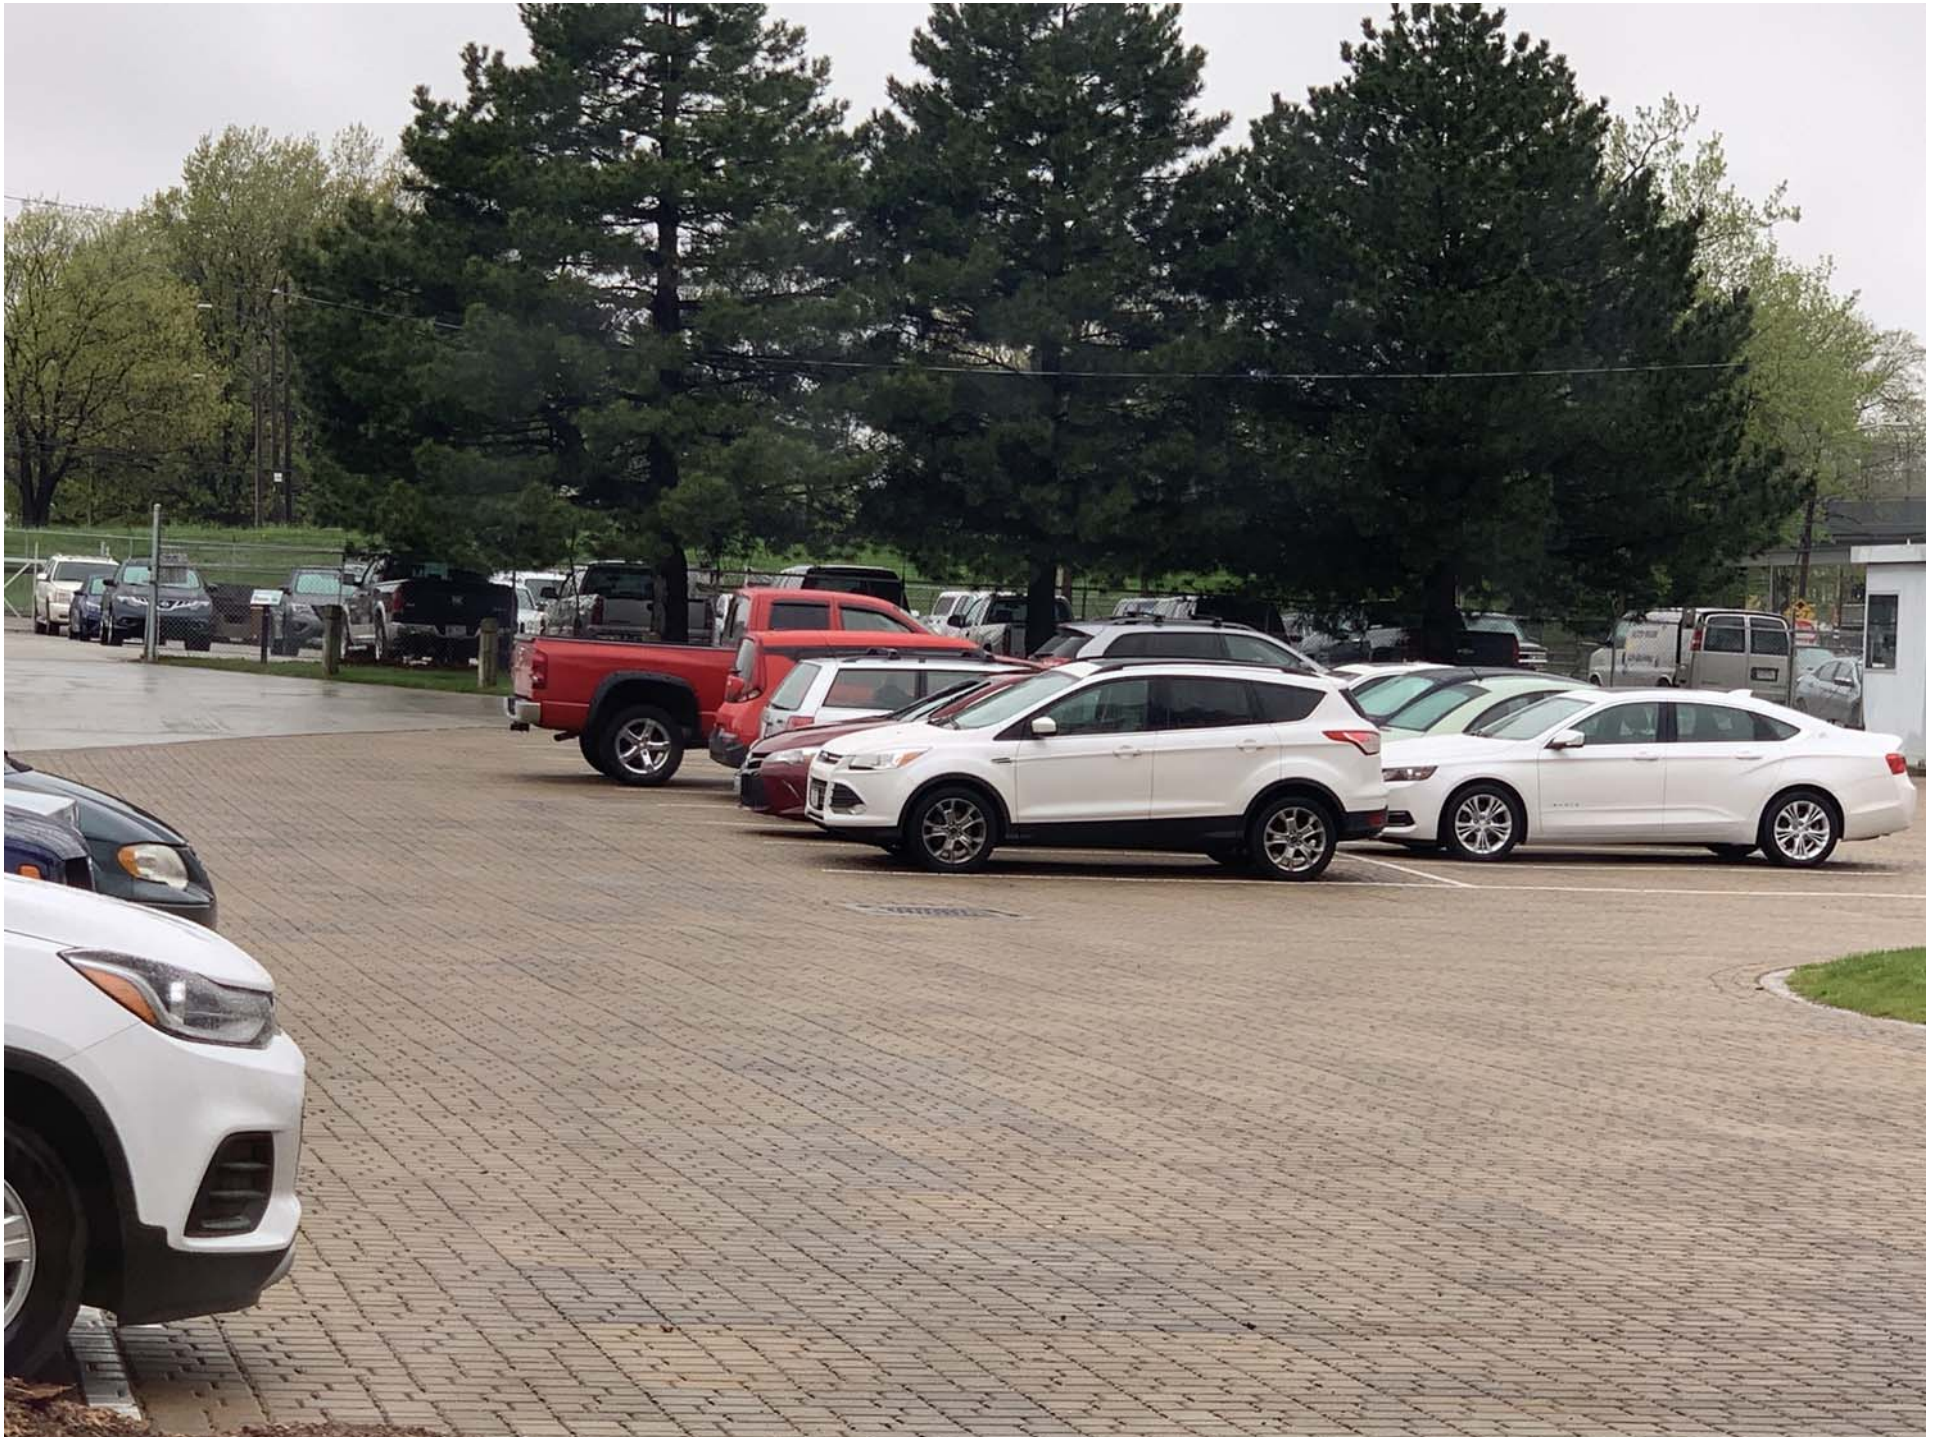
Photo taken after rain event (4/29/21)
