## Green Infrastructure Grant Program (GIGP)

### Maintenance Inspection Checklist

<b>Site Name: Western Reserve Land Conservancy</b>	
<b>Address: 3850 Chagrin River Road, 44022</b>	
<b>Inspectors Name:</b> Christopher Hartman, CPESC, CPSWQ, CESSWI	<b>Date and Time:</b> 06/19/2018 4:23 PM
<b>Overall Notes:</b> <ol style="list-style-type: none"> <li>1. Within the bioretention cell nearest to the SE corner of the building, the concrete lid that makes up the overflow structure has not been properly sealed, thereby reducing the effective ponding area by a depth of approximately 6-inches. Ensure this seam is sealed watertight.</li> <li>2. The 2 bioretention cells along east side of the parking lot (on each side of the main entrance) appear to be filled with gravel and sediments from the gravel parking lot. The cells should be restored to original design elevations and additional precautions should be put in place to minimize sediment contribution from the gravel lot. Outlet structures should be checked to ensure they are watertight along all seams.</li> </ol>

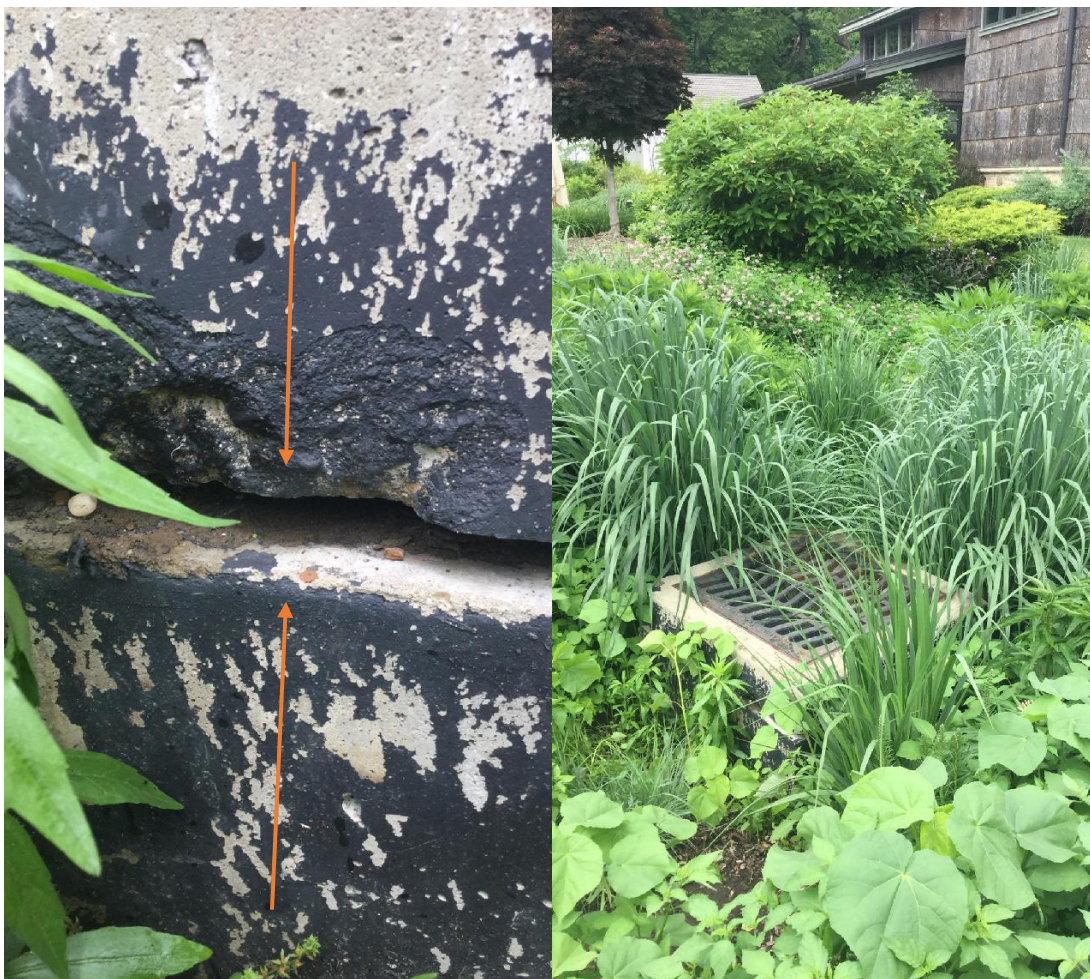
**Explanation: This cracked outlet is letting flow right into the practice without proper treatment (SE corner of building).**

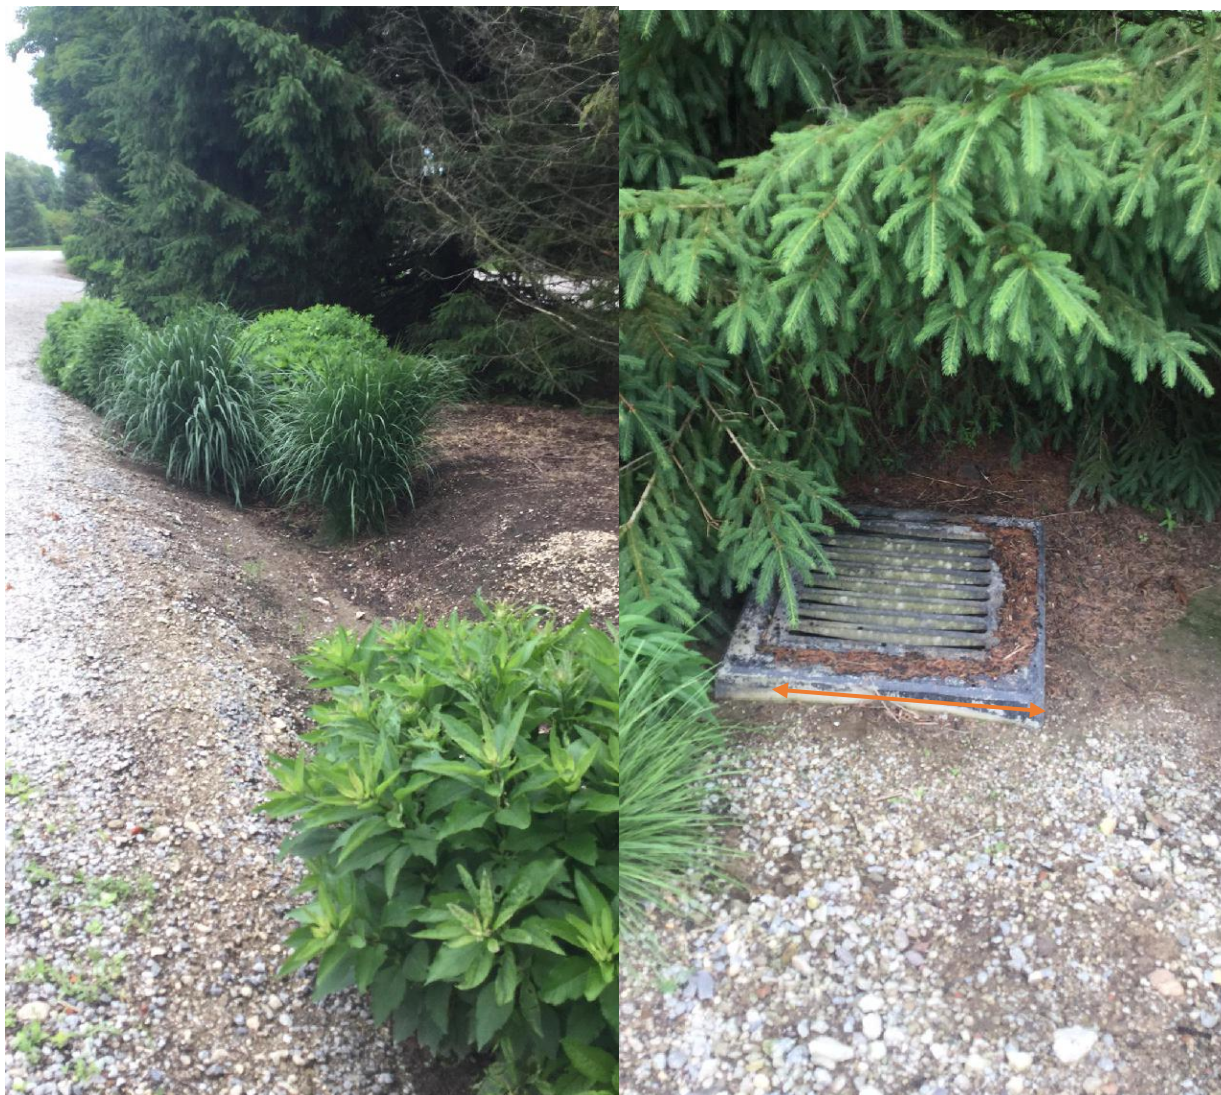
<b>BIORETENTION (Select yes or no to the following maintenance questions)</b>	
Is there debris present? <b>No</b>	Debris notes:  <b>Cell 6 has sedimentation concerns and possible leaky outlet structure.</b>
Is there a layer of sediment? <b>Yes</b>	Sediment notes:  <b>Sediment is originating from gravel parking lot.</b>
Do the inlets provide stable conveyance into facility? <b>Yes</b>	Inlet notes:  <b>N/A</b>
Presence of invasive species/weeds? <b>No</b>	Invasive notes:  <b>N/A</b>
Dead vegetation/exposed soil? <b>No</b>	Soil notes:  <b>N/A</b>

**Explanation:** The sediment from parking lot is flowing into this practice, potentially clogging the bioretention cell.
