CHIPPEWA CREEK BANK STABILIZATION AT HARRIS ROAD

Broadview Heights, OH

CUYAHOGA RIVER SOUTH · CHIPPEWA CREEK

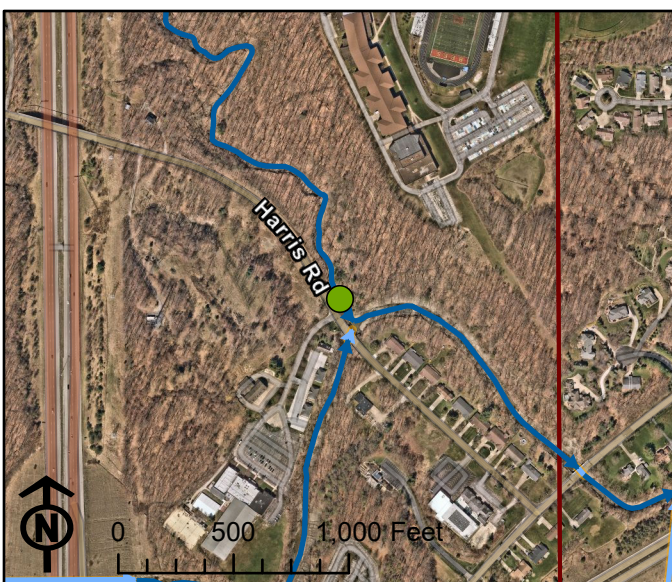
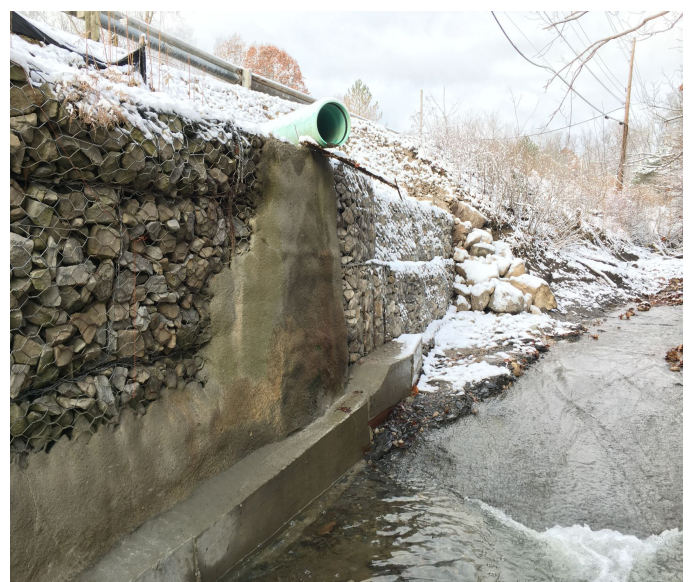
This project provided erosion protection along the right bank of Chippewa Creek near Harris Road in Broadview Heights. Roadway runoff led to the development of a rill around a PVC stormwater outfall pipe, where existing gabions had been undermined by the stream. Approximately 25 feet of new gabions were installed under the outfall pipe immediately upstream of existing gabions. Voids caused by undermining of the stream were filled with concrete grout and several concrete slabs were removed from the channel.
