SAGAMORE CREEK STRUCTURAL REPAIR AT RAULAND DR. IN WALTON HILLS

Walton Hills, OH

CUYAHOGA RIVER SOUTH · SAGAMORE CREEK

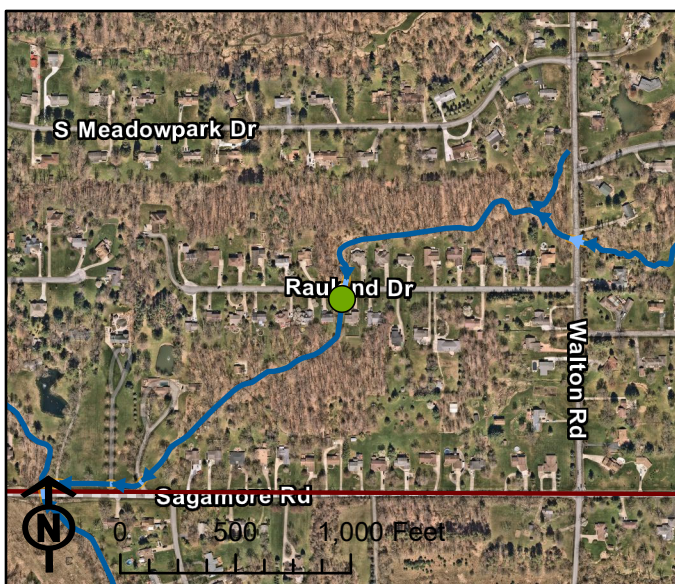
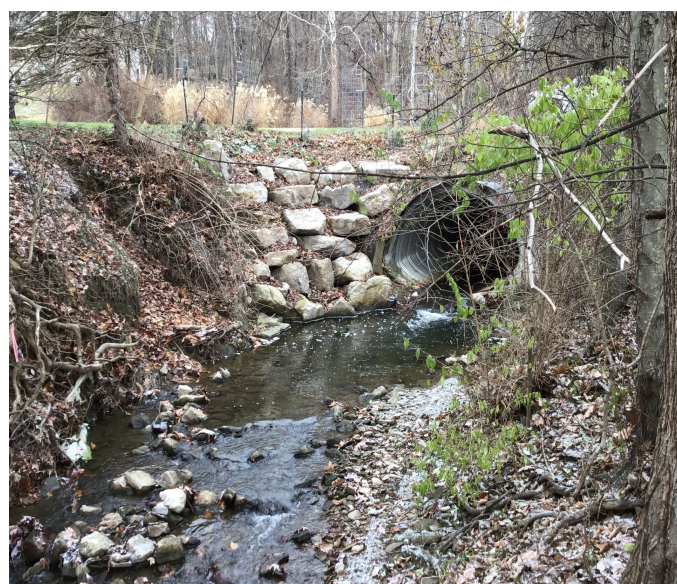
The goal of this project was to arrest erosion at the Rauland Dr. crossing outlet along the right bank. A large tree had uprooted, leaving a large scour which threatened the structure integrity of the crossing. Rock channel protection was placed along the right bank and within the scour pool to limit future erosion.
