STREAMBANK STABILIZATION AT MORNINGSIDE DR. IN VALLEY VIEW

Valley View, OH

CUYAHOGA RIVER NORTH · SMALL TRIBS TO CUYAHOGA RIVER NE WATERSHED

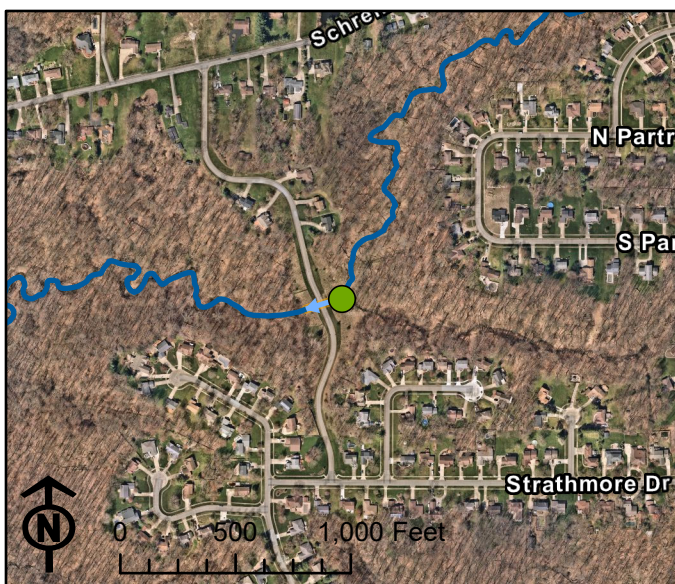
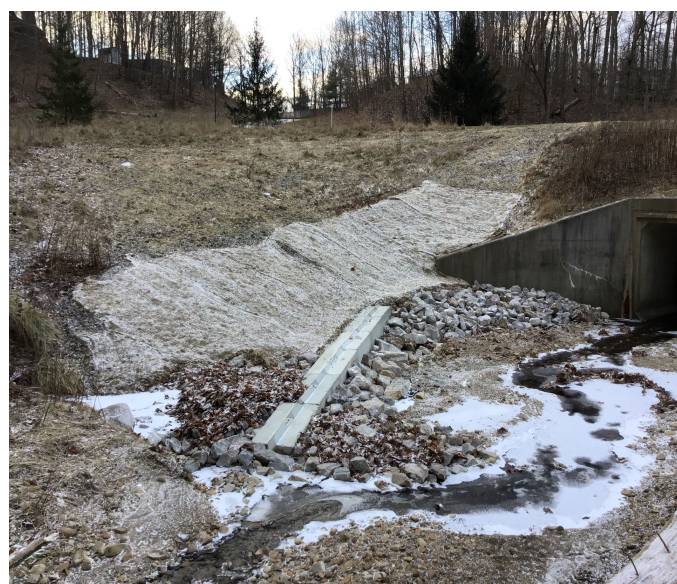
This project addressed erosion of the left streambank impacting the crossing wingwall at Morningside Dr. Rock toe protection was installed along the left bank and the bank was graded to a gentler slope. A concrete vane arm was installed in the streambed to ensure sediment transport was maintained through the crossing. The area was seeded with native vegetation and live stakes at completion.
