# Northeast Ohio Regional Sewer District

## 2022 Stream Restoration Projects Biological, Water Quality, and Habitat Study

**Water Quality and Industrial Surveillance  
Environmental Assessment Group  
April 2023**

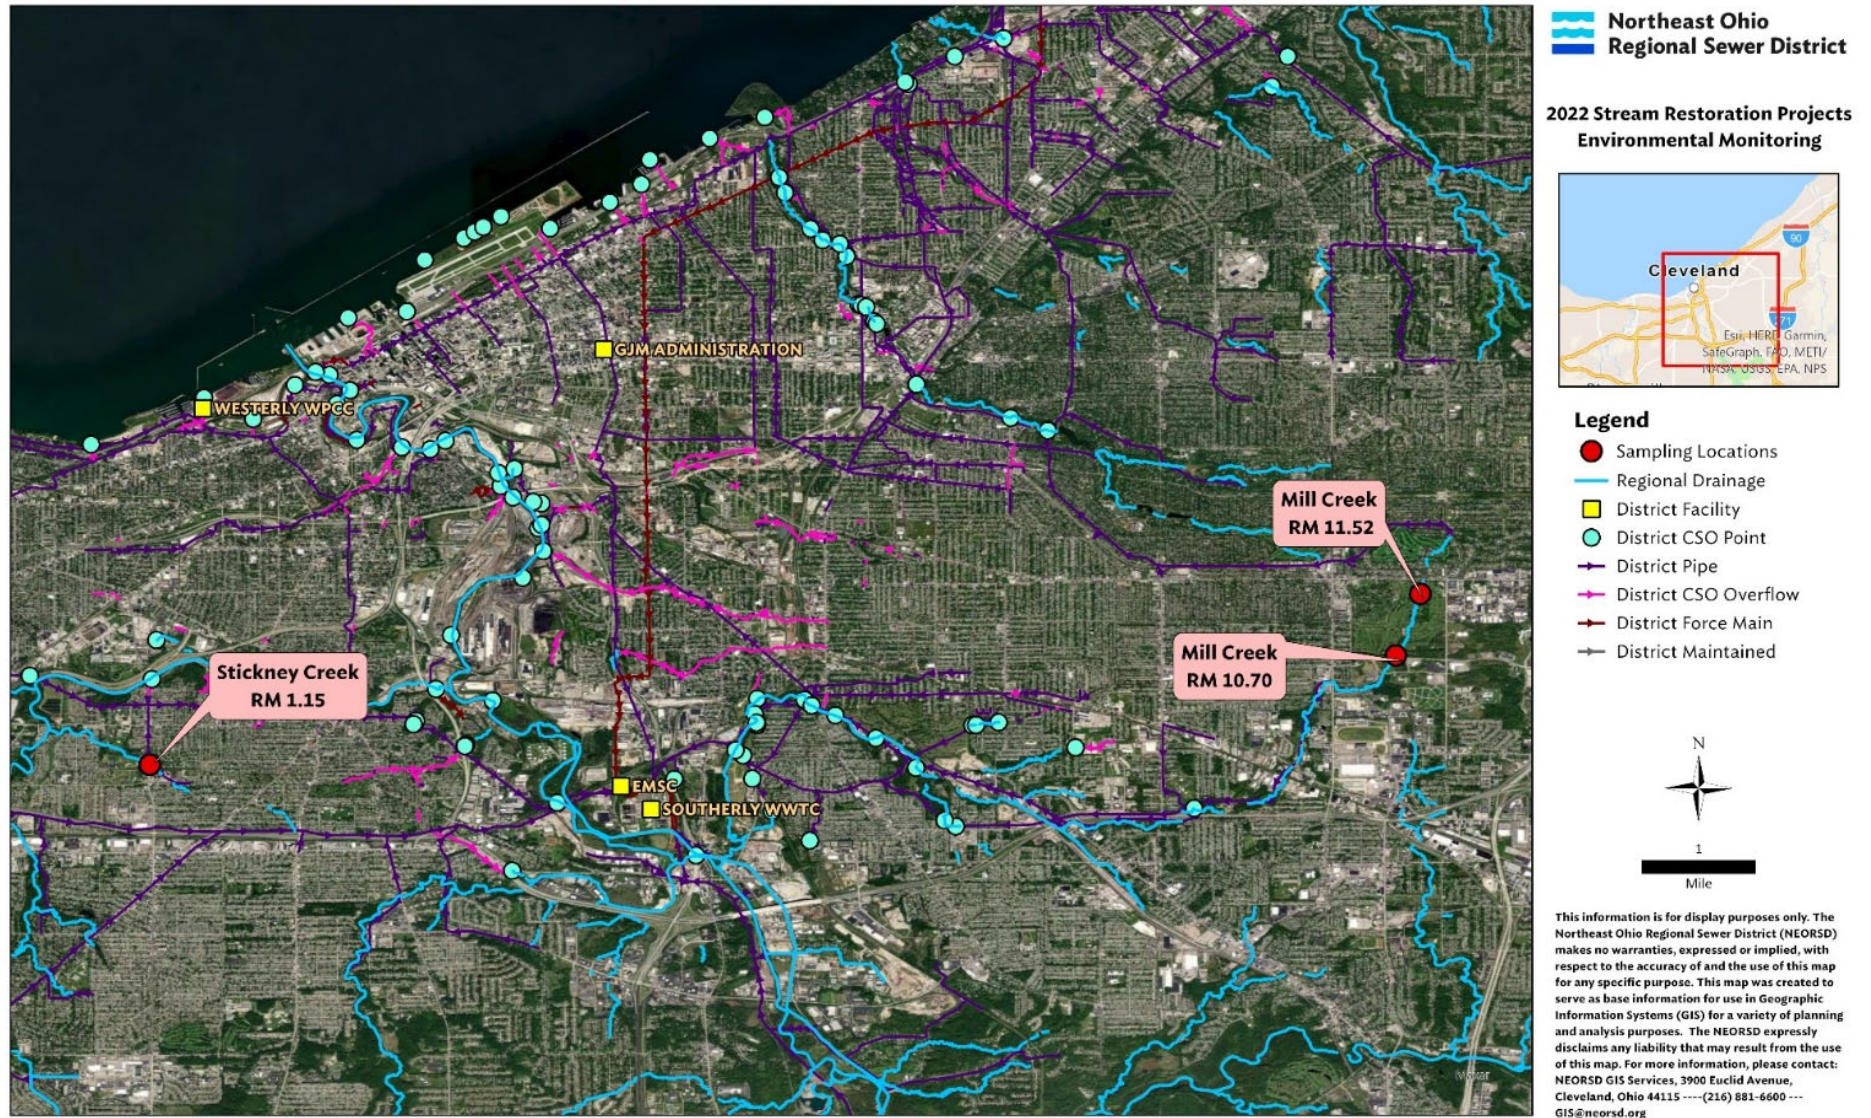
**Figure 1.** 2022 Stream Restoration Project Sampling Locations

Figure 1 shows a map of the sampling locations, and Table 1 indicates the sampling locations with respect to river mile (RM), latitude/longitude, description, and surveys conducted. A digital photo catalog of the sampling locations is available upon request by contacting the WQIS Division.

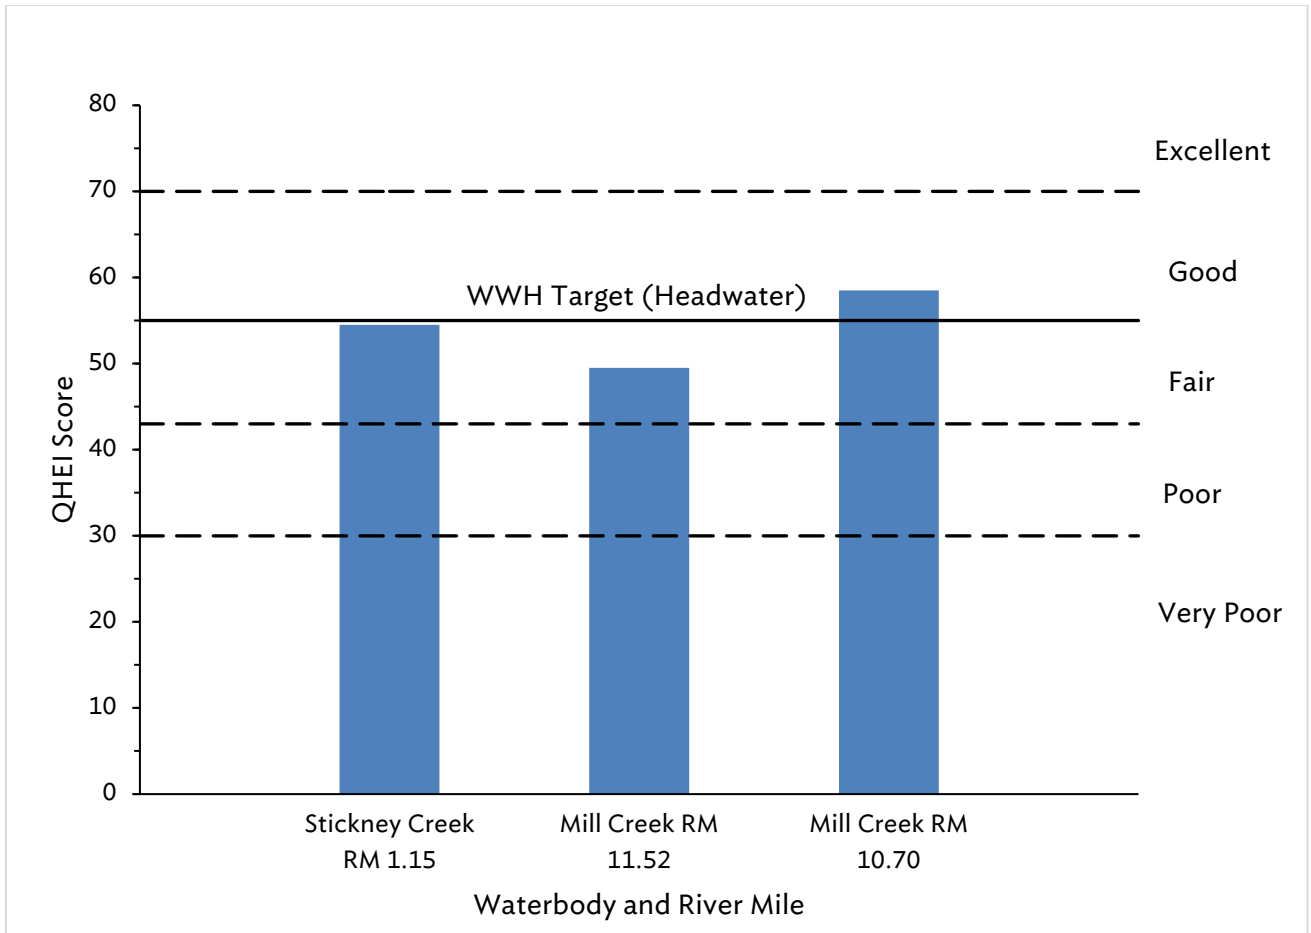
**Figure 9.** QHEI Scores for Each Site Monitored in 2022

One of the three 2022 Stream Restoration Projects sampling sites achieved the Ohio EPA Warmwater QHEI target score of 55 for headwater streams. Figure 9 shows an overview of each stream location assessed during the 2022 field season.

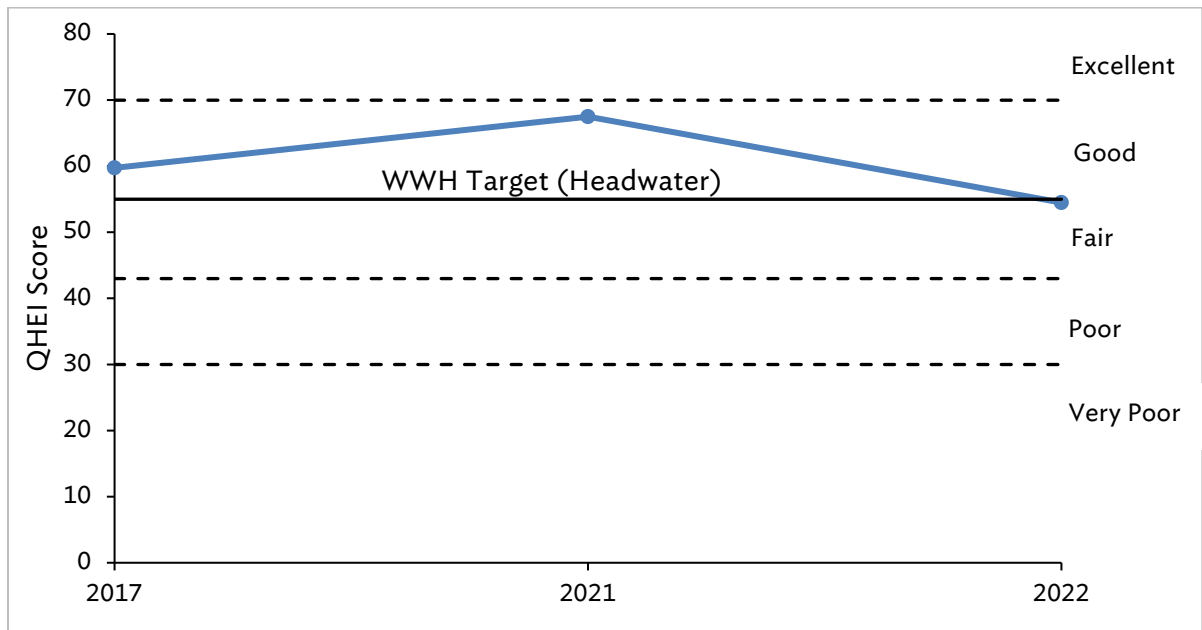
**Figure 10.** Historical Stickney Creek RM 1.15 QHEI Scores

Figure 10 below shows QHEI scores from the 2022 field season and previous NEORS D assessments. The first NEORS D assessment was completed in 2017, as part of pre-construction monitoring. The 2017 QHEI score was calculated at 59.75 (*Good*). Similarly to the 2021 assessment, instream cover metrics scored much higher than in 2022. The 2022 assessment was the first time since NEORS D has monitored Stickney Creek RM 1.15 where the stream segment did not meet the warmwater habitat target score of 55. However, as the instream cover and riparian zones continue to stabilize it is likely that QHEI scores will reach the target score of 55 in future assessments.

The habitat for the stream segment at Stickney Creek RM 1.15 was assessed on July 7, 2022. The QHEI assessment was calculated at 54.5 (*Fair*), which fell just short of the headwater target score of 55. The most prominent types of substrate present consisted of cobble and gravel with a “normal” silt narrative. The reach had mostly recovered in terms of disturbance caused by the restoration project and was characterized by additional morphology features of high sinuosity and fair to good development. Development of the riffle/pool complexes was good; however, the reach lacked depth in pools. A sparse amount of instream cover only included two distinct habitat types, overhanging vegetation and boulders, which was a key factor in reducing the QHEI score for the reach. The sample site at RM 1.15 is one of the only non-culverted sections of Stickney Creek, as the upstream sections are almost completely culverted and void of habitat. It is understood that the riparian width metrics played a significant role in the decreased QHEI score; however, it is believed that over time as trees and woody vegetation grow, the score will increase.

A post-construction QHEI assessment at Stickney Creek RM 1.15 was conducted on June 23, 2021, and was calculated at 67.5, which exceeded the headwater target score of 55. The 2021 post-construction QHEI assessment scored higher than the 2022 QHEI assessment in every metric except for gradient, which both assessments scored the same. The 2021 assessment scored much higher in the instream cover category due to having a moderate amount of instream cover, pools greater than 70 centimeters, and logs and woody debris. The decrease in the score for the instream cover metric is likely due to the stream segment beginning to stabilize post-construction.

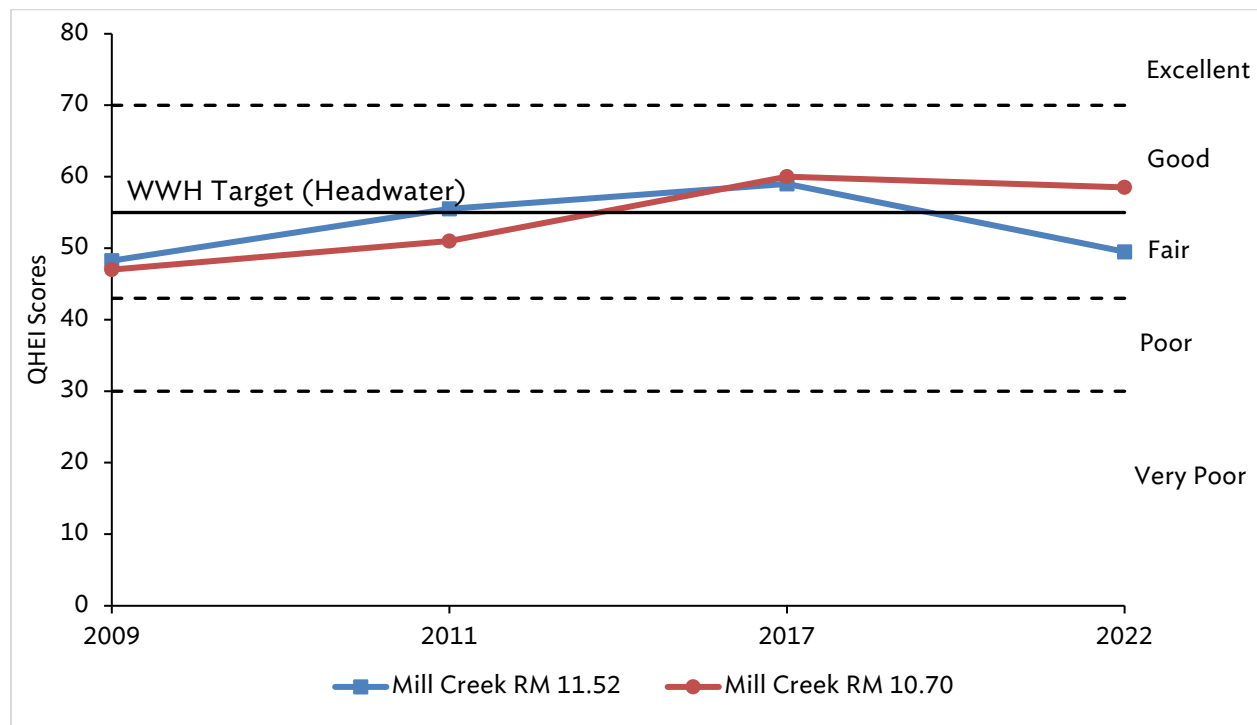
**Figure 11.** Historical Mill Creek QHEI Scores

Figure 11 below shows QHEI scores from the 2022 field season and previous NEORSRD assessments. The first NEORSRD assessment was completed in 2009 as part of pre-construction monitoring. The 2009 QHEI score was calculated at 48.25 (*Fair*), which did not meet the headwater target of 55; however, the 2011 and 2017 QHEI assessments did meet the headwater target score of 55. As mentioned previously, the lack of functional riffles is the primary contributing factor to the lower QHEI score in 2022.

Figure 11 above shows QHEI scores from the 2022 field season and previous NEORS D assessments. The first NEORS D assessment was completed in 2009 as part of pre-construction monitoring. The 2009 QHEI assessment was calculated at 47 (*Fair*), which did not meet the headwater target of 55.

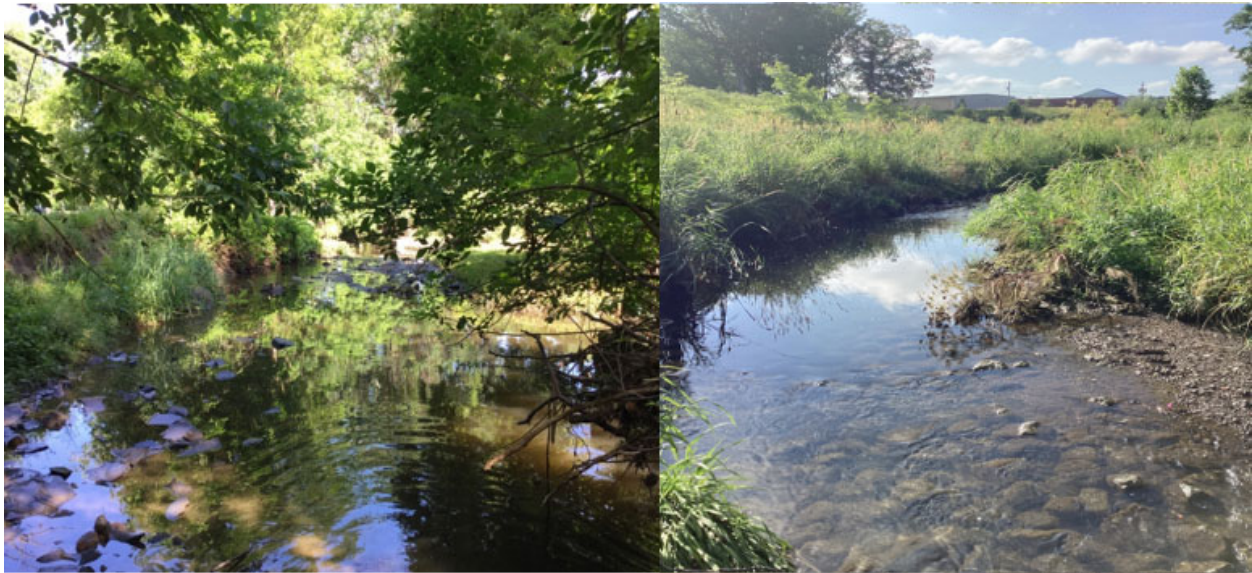
**Figure 12.** Stickney Creek RM 1.15 in 2017 (left) and 2022 (right)

Additionally, Figures 12 through 14 show each segment pre- and post-construction site photos. Figure 12 depicts Stickney Creek RM 1.15 pre- and post-construction. Prior to construction the stream banks were eroding into the sewer. Post-construction, stream bank erosion was addressed, higher quality in-stream habitat was established, and more natural hydrological function was restored. Some of the primary goals for the restoration project was to reestablish floodplain storage, slow stream velocities, and create more in-stream habitat. Figures 13 and 14 depict Mill Creek RMs 11.52 and 10.70 pre- and post-construction. Prior to construction, the stream segments provided little instream cover and were highly channelized. Post-construction photos show that the stream segments have been dechannelized, riparian zones are beginning to become established, and improved in-stream habitats have been created.

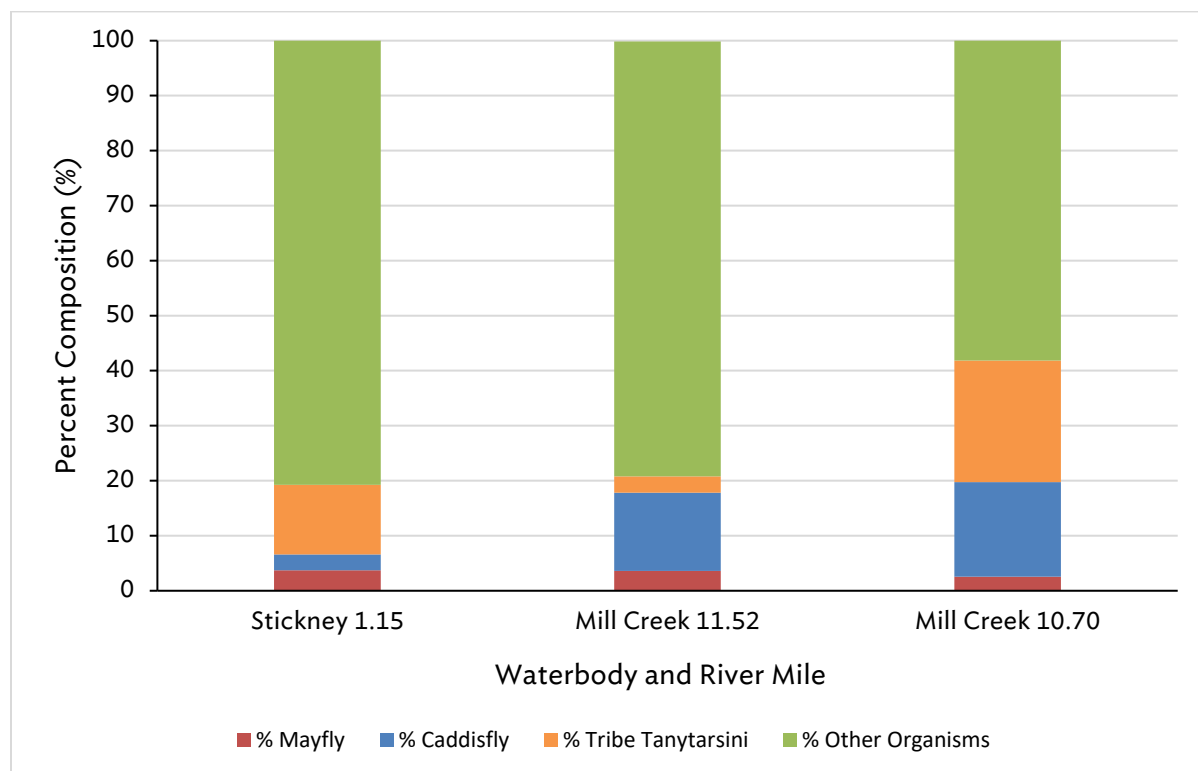
**Figure 17.** 2022 Macroinvertebrate Community Composition

Figure 17 below shows the quantitative macroinvertebrate species composition at each site. Stickney Creek RM 1.15 had a total of 2,203 organisms collected on the HD, which included 22 taxa. A high percentage of diptera and non-insects (80.75%) and a low percentage of tanytarsini (12.66%), mayflies (3.72%), and caddisflies (2.86%) were collected from the HD.

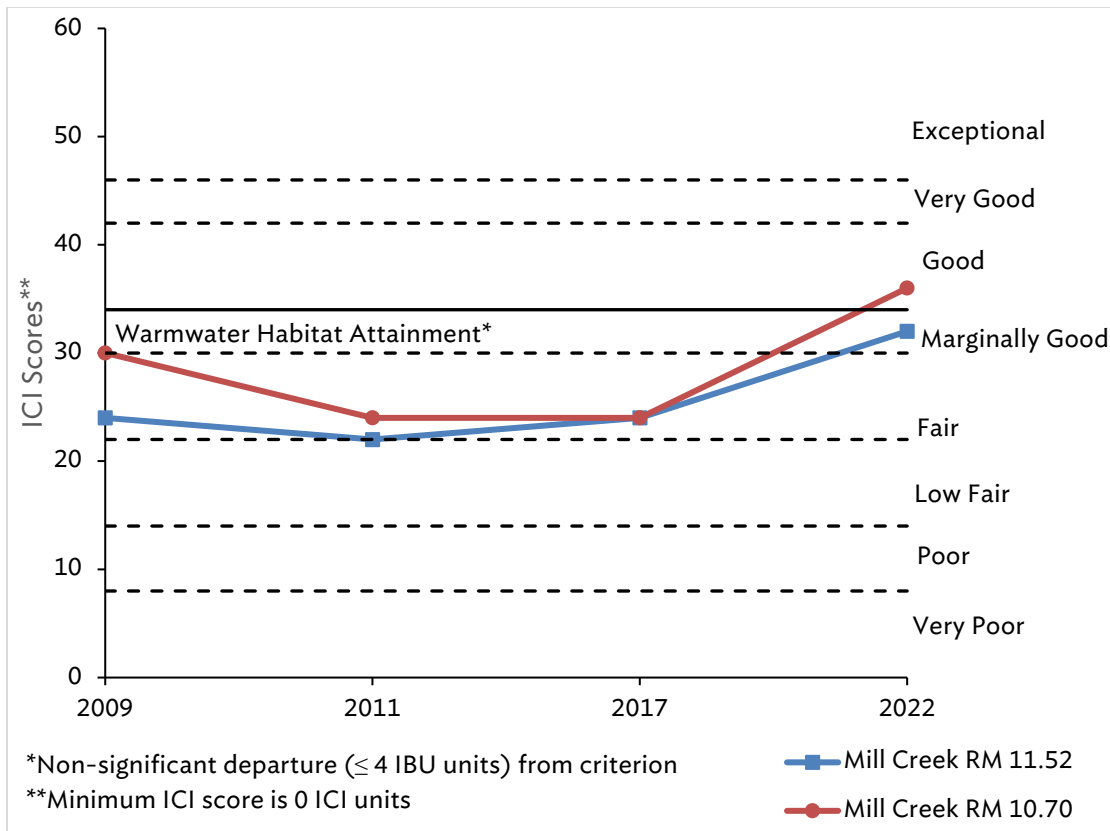
**Figure 19.** Historical Mill Creek ICI Scores

Figure 19 shows temporal trends in ICI scores from past assessments at both sites. ICI scores for each stream segment have surpassed pre-construction ICI scores. Additionally, Table 18 provides historical ICI scores with additional data summaries from Mill Creek RM 11.52 and 10.70. At Mill Creek RM 11.52 and 10.70, the macroinvertebrate communities scored similarly in 2011 and 2017 with a narrative rating of *Fair*; however, both sites showed improvements in their macroinvertebrate communities and increased their ICI score. The site at RM 11.52 received a score of 32 (*Marginally Good*), while the one at RM 10.70 increased to 36 (*Good*). Although RM 11.52 received a *Marginally Good* narrative score, some macroinvertebrates are particularly sensitive to elevated concentration of TDS and rapid variations can be stressful for certain populations (Miltner, 2021), which may be one reason why pollution-sensitive species were not found. Overall, though, these sites showed improvements in the number of qualitative EPT taxa, indicating continued improvements in biodiversity and health of the macroinvertebrate community.
