Northeast Ohio Regional Sewer District

2023 Stream Restoration Projects Biological, Water Quality, and Habitat Study

February 2024

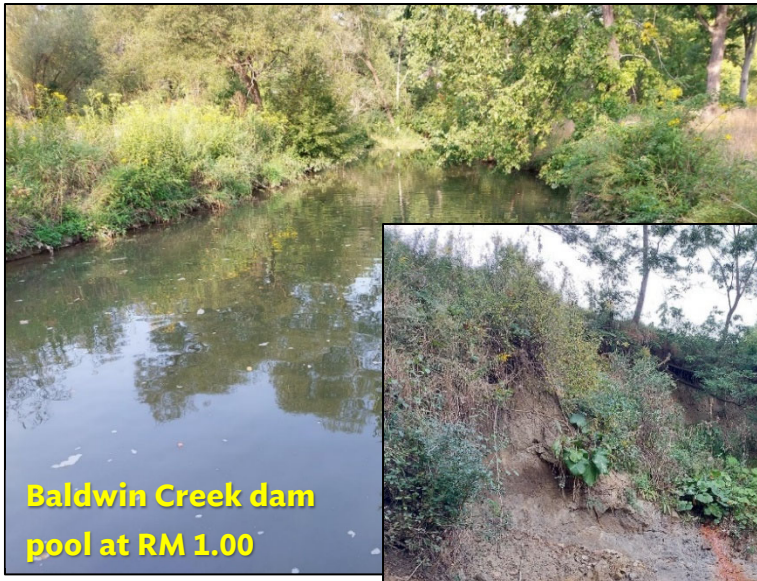
**Baldwin Creek dam
pool at RM 1.00**

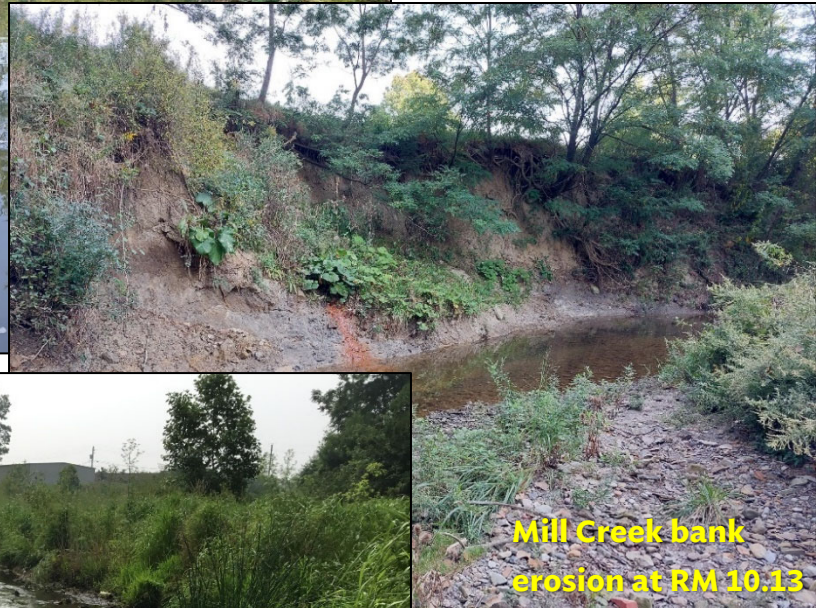
**Mill Creek bank
erosion at RM 10.13**

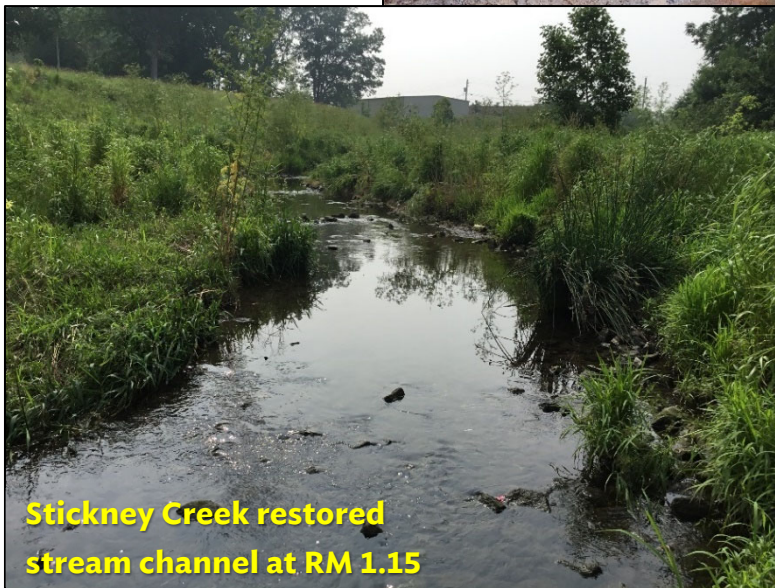
**Stickney Creek restored
stream channel at RM 1.15**

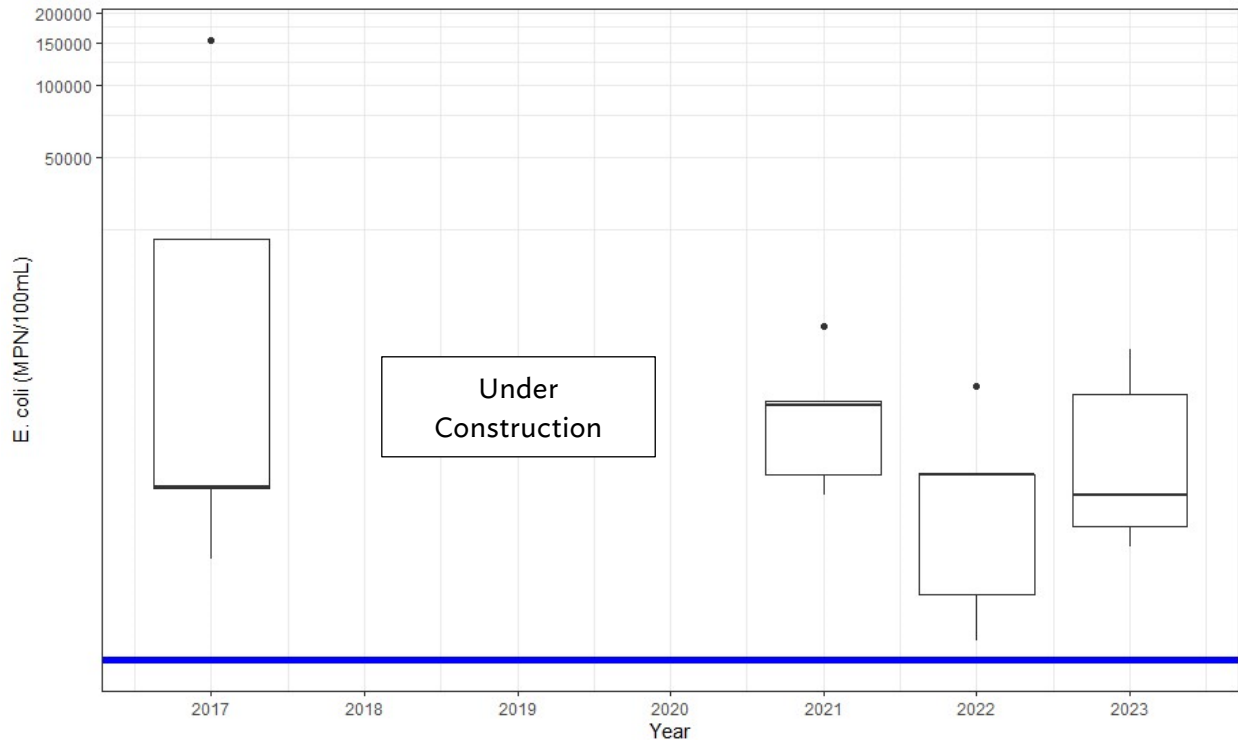
Figure 4. Box Plot for Stickney Creek *E. coli* densities from all four assessment years. The blue line represents the *E. coli* STV WQS value of 410 MPN/100mL.

Since one of the primary objectives of the Stickney Creek stream restoration project was to eliminate erosion causing sanitary contamination from a local sanitary sewer, more recent post construction (2021-2023) results were compared to pre-restoration bacteria results. Figure 4 below displays a boxplot of *E. coli* densities throughout the four assessment years. The pre-restoration boxplot contained the highest maximum and upper quartile results, although the values were not significantly different than recent years. Background *E. coli* densities in Stickney Creek from illicit discharges are likely masking a more substantial decrease in bacteria.

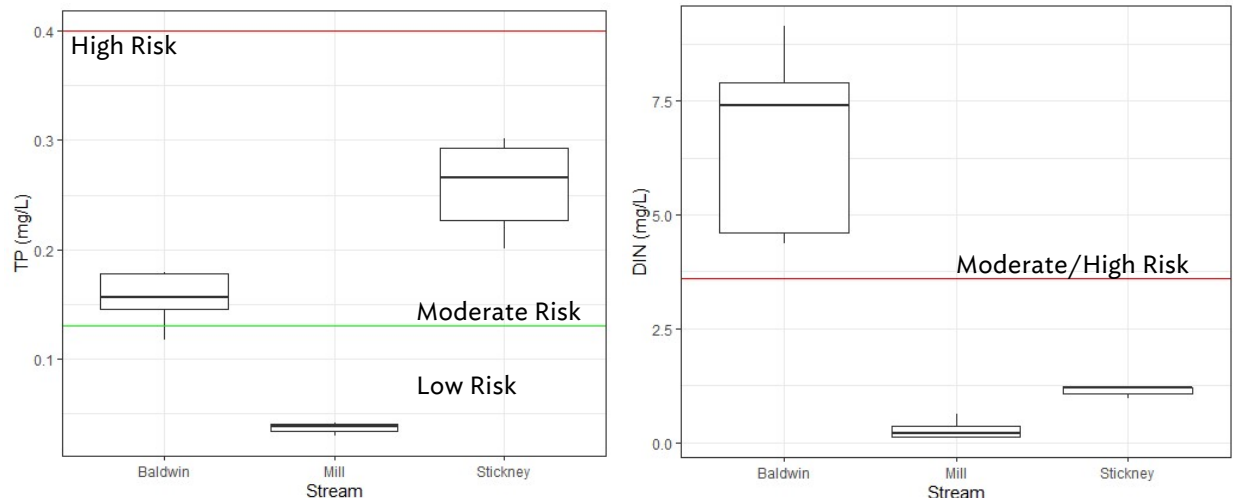
Figure 6. TP and DIN concentrations and Risk Categories for the streams assessed in 2023. Risk categories are based on Miltner (2010).

Baldwin Creek received a SNAP narrative rating of an enriched condition with generally high risk to beneficial uses and fell into the high-risk category based on Ohio EPA, 2015b. The nutrient concentrations from Baldwin Creek also resulted in a moderate-high risk using the causal association risk values (Figure 6). The DIN concentrations are the most elevated; however, TP concentrations also fell into the moderate risk narrative.

The North Royalton Wastewater Treatment Plant (WWTP) B discharges effluent to Baldwin Creek at RM 7.30 and the Strongsville C WWTP at RM 2.90. The average design flow Baldwin Creek receives from the two WWTPs is 2.8 million gallons per day (MGD), or 4.31 cubic feet per second. The more oxidized nitrogen form of nitrate-nitrite (NO₃-NO₂) discharging from these WWTPs is elevating the total DIN concentrations observed in Baldwin Creek. Neither plant has a National Pollution Discharge Elimination system (NPDES) permit limit for NO₃-NO₂ since the objective is to oxidize raw ammonia to NO₃-NO₂ via nitrification. The North Royalton WWTP B discharges NO₃-NO₂ at a much higher concentration, averaging 15.59 mg/L from the 2023 summer months of April through October, compared to the Strongsville C WWTP, which averages 0.59 mg/L (USEPA, ECHO). Elevated NO₃-NO₂ concentrations have not shown a correlation to diel DO swings compared to elevated TP (Ohio EPA, 1999) and are not as detrimental to aquatic life until concentrations exceed 3 mg/L. Median NO₃-NO₂ concentrations on Baldwin Creek were 7.26 mg/L, suggesting a potential stress to aquatic life.

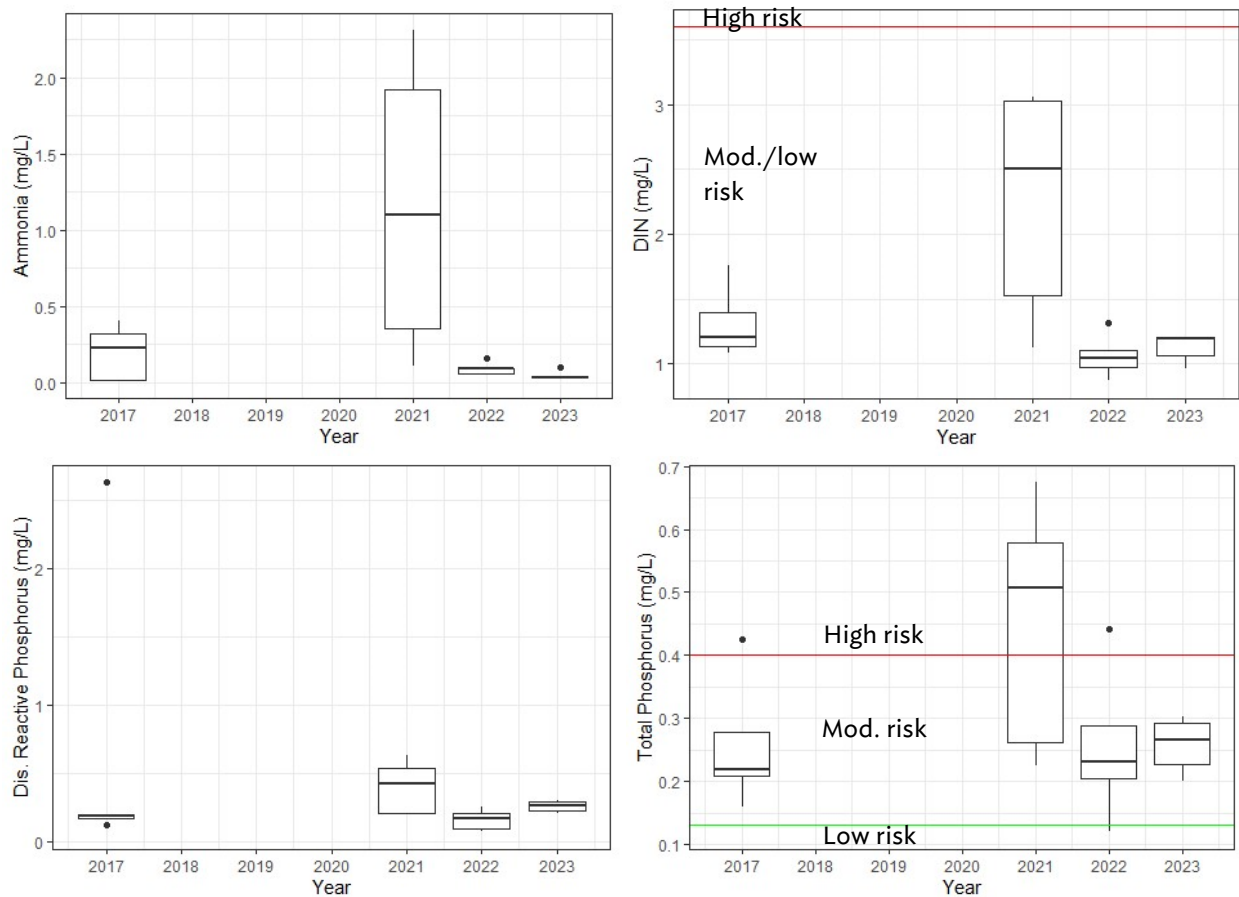
Figure 7. Stickney Creek annual nutrient concentrations boxplot. The stream restoration construction was in 2018-2019. The red lines represent the lower bound for the high-risk narrative rating and the green line represents the upper bound for the low-risk narrative rating (Miltner, 2010).

Nutrients are evident in raw wastewater as organic nitrogen and phosphorus. The restoration project on Stickney Creek removed a major source of sanitary sewage from a leaking sewer. Even though this source has been removed, major nutrient values were not significantly reduced. An analysis of variance was used to determine significant differences in means of nutrient parameters, followed by a t-test to determine which years contained different mean values. Ammonia and DIN concentrations were significantly higher ($p < 0.05$) in 2021 (Figure 7) than all other years. Overall, there are no trends in nutrient reduction since project completion.

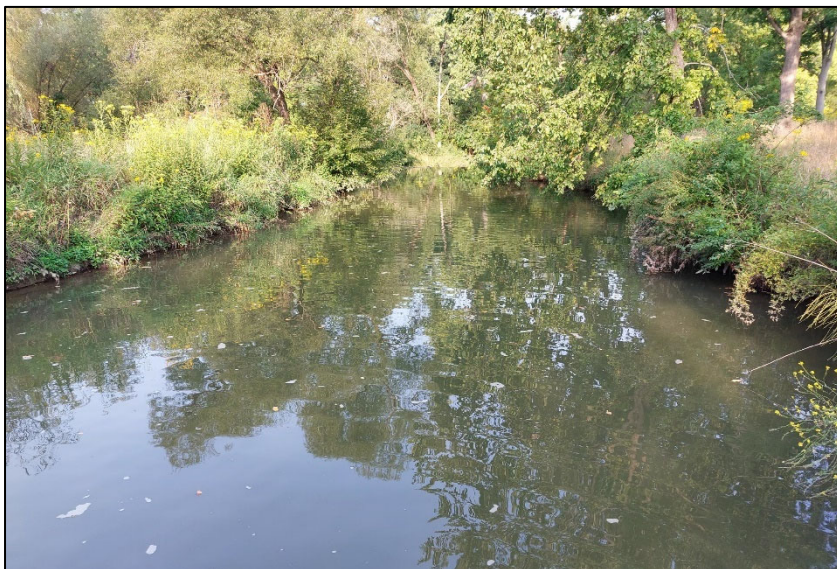
Figure 8. Baldwin Creek dam pool.

Baldwin Creek at RM 1.00 was assessed before the low-head dam is removed and other stream restoration efforts are completed. The QHEI assessment at Baldwin Creek RM 1.00 received a score of 62.50 (*Good*). The most prominent types of substrate present consisted of gravel and sand with a moderate silt narrative. This section is currently recovering from channelization, with low overall sinuosity, simply due to being impounded (Figure 8).

A moderate amount of instream cover consisted of undercut banks, deep pools, overhanging vegetation, rootwads and rootmats, woody debris, and shallows in slow water. No riffle or run habitat was documented in the sampling reach. Deep pools were present due to the dam structure, allowing solids to settle and moderately embed the underlying

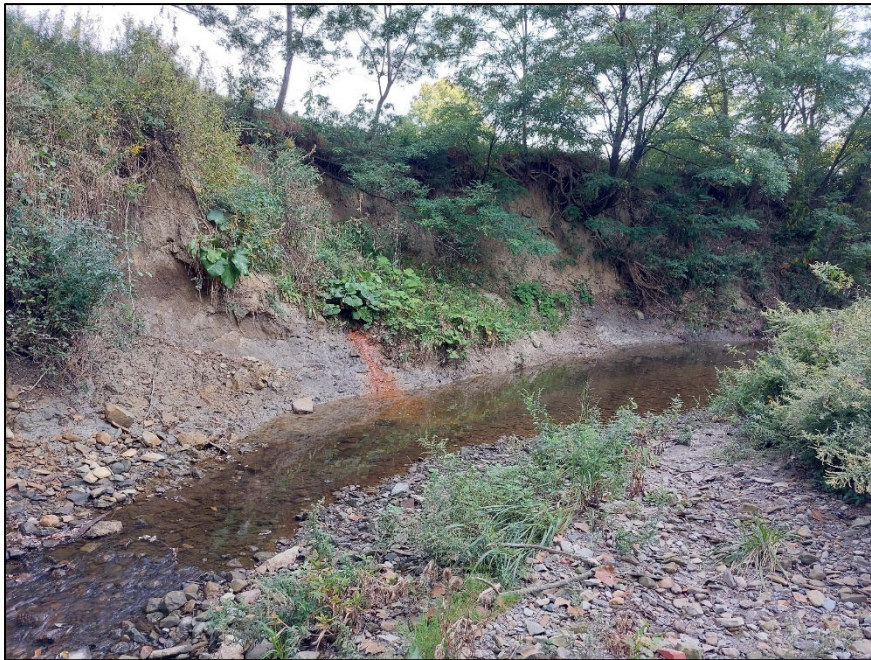
Figure 9. Erosion and lack of riparian buffer on Mill Creek.

Mill Creek at RM 10.13 was assessed prior to a major stream restoration project. The QHEI assessment at Mill Creek RM 10.13 scored a 72.75 (*Excellent*). The most prominent types of substrate present consisted of cobble and gravel with a normal silt narrative. Moderate sinuosity, with shallow riffles and deeper pools resulted in fair to good development. A moderate amount of instream included undercut banks, rootmats and rootwads, deeper pools, and woody debris.

Erosion in this area is exasperated by the lack of riparian wooded vegetation on river right. A mowed grassy area is nearly exposed with the last row of immature trees hanging over the stream channel (Figure 9). These eroding banks are proposed to be protected with a rock toe. The stream channel downstream of the sharp, eroding bends are planned to be widened with a floodplain bench in the immediate downstream sections.

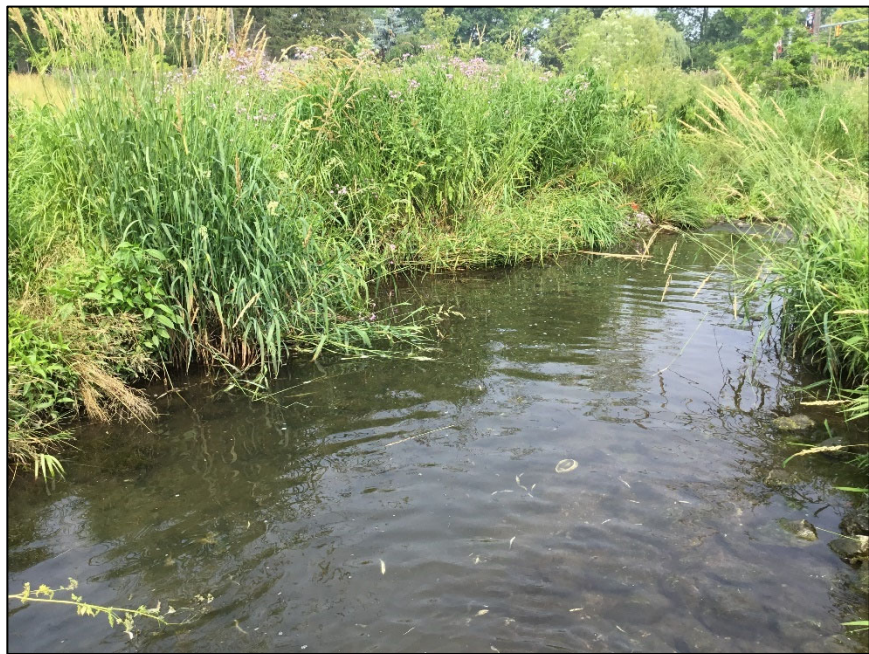
Figure 10. In-stream overhanging vegetation in Stickney Creek.

due to the lack of pool depth. A sparse to moderate amount of instream cover included an increased abundance of overhanging vegetation (Figure 10), newly forming aquatic macrophytes, and shallows in slow water compared to previous habitat assessments. The lack of wooded riparian vegetation lowered the score and is typical of newly restored stream sections. As the riparian zone matures, woody vegetation should grow and offer shade and riparian protection.

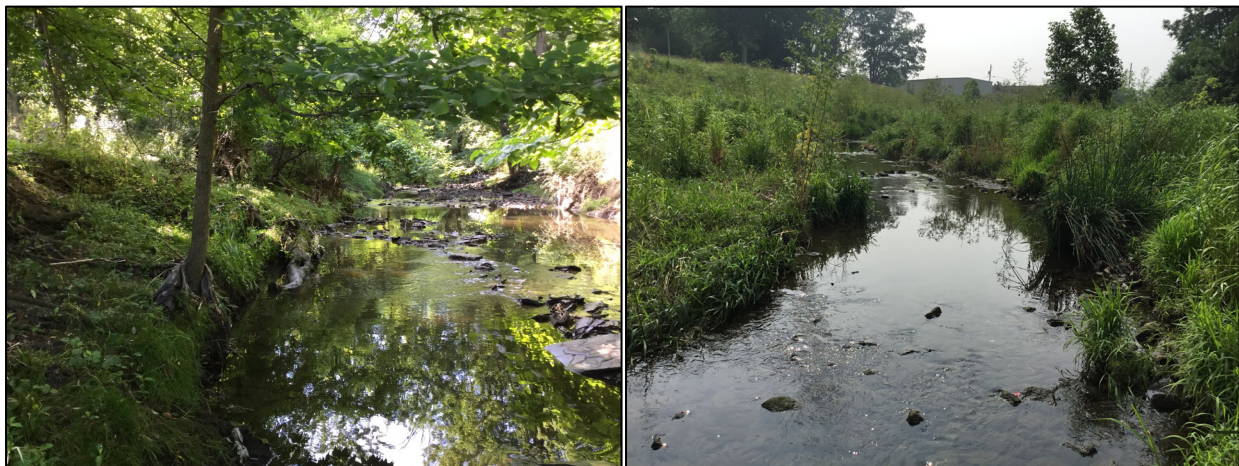
Figure 11. Stickney Creek RM 1.15 in 2017 (left) and in 2023 (right).

Figure 11 below shows Stickney Creek before (left) and after (right) restoration. In 2023, the riparian area is beginning to establish wooded growth, tall grasses, and shrubs. A few small trees were planted in 2017 during the restoration and are growing, but still provide no shade for the stream. Although the riparian grass and shrub offer limited shade relief, they do provide important bank stabilization features for the stream. The 2023

picture also shows the floodplain access the river has on both sides of the stream. During high-flow conditions, the river will rise into the floodplain while the vegetation may allow for solids and nutrients to settle. Over time, the trees planted in the riparian area will offer some woody protection for Stickney Creek.

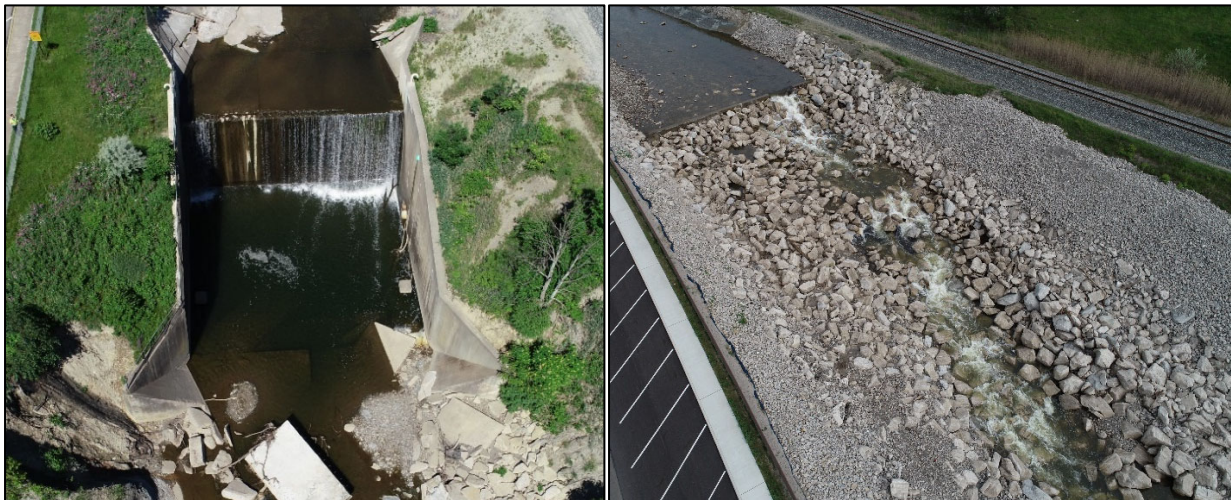
Figure 14. Big Creek 30-foot drop structure (left, 2018) and rock cascade (right, 2020) fish passage barriers.

There are no obvious fish passage barriers along Stickney Creek downstream of the sampling location. Stickney Creek flows into Big Creek, which has its own array of urban water quality issues. A fish passage barrier in the form of a high gradient rock cascade replaced a 30-foot drop structure on Big Creek at RM 2.90 (Figure 14), separating the headwaters of Big Creek and the entirety of Stickney Creek from fish colonization from the Cuyahoga River. The fish community in Stickney Creek is similar to Big Creek, both highly simplified and comprised of predominately highly tolerant fish capable of surviving the urban environment. Even with the ability of fish to recolonize Big and Stickney Creeks from the Cuyahoga River, the urban land use may limit the biological potential of both streams.

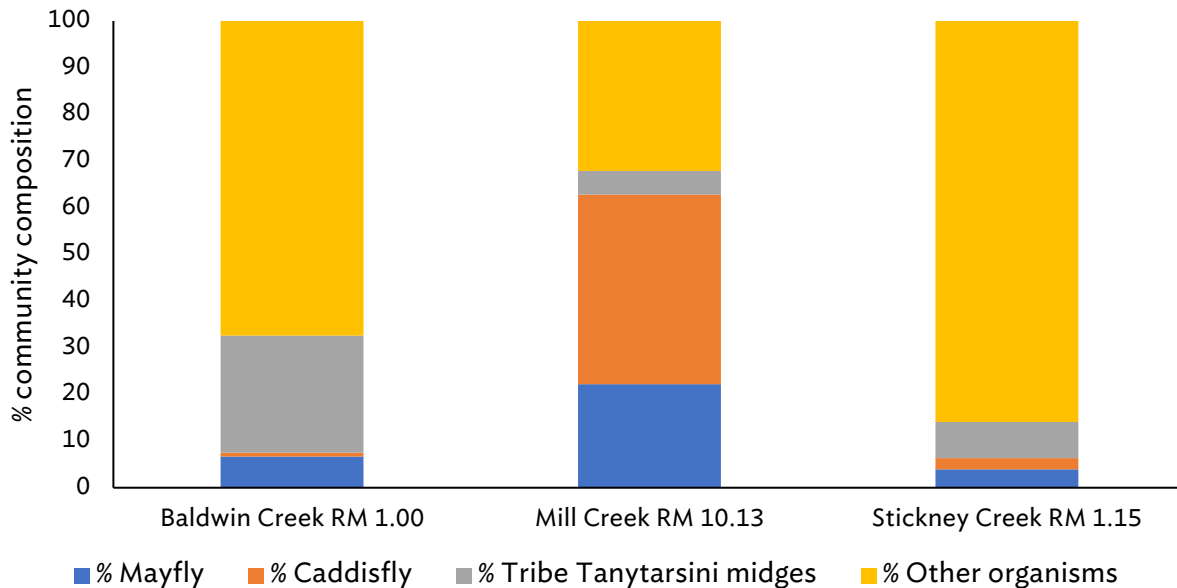
Figure 15. 2023 Macroinvertebrate Community Composition

The macroinvertebrate community composition based on percent identified from the artificial substrate is displayed in Figure 15. Nearly 86% of the community at Stickney Creek was composed of “other diptera and non-insects”. Breaking down this 86% further, 60% were listed as non-tribe tanytarsini midges and 39% were a combination of flatworms and aquatic earthworms. The high proportion of these facultative or tolerant macroinvertebrates in Stickney Creek reflects the stress from urban land use.

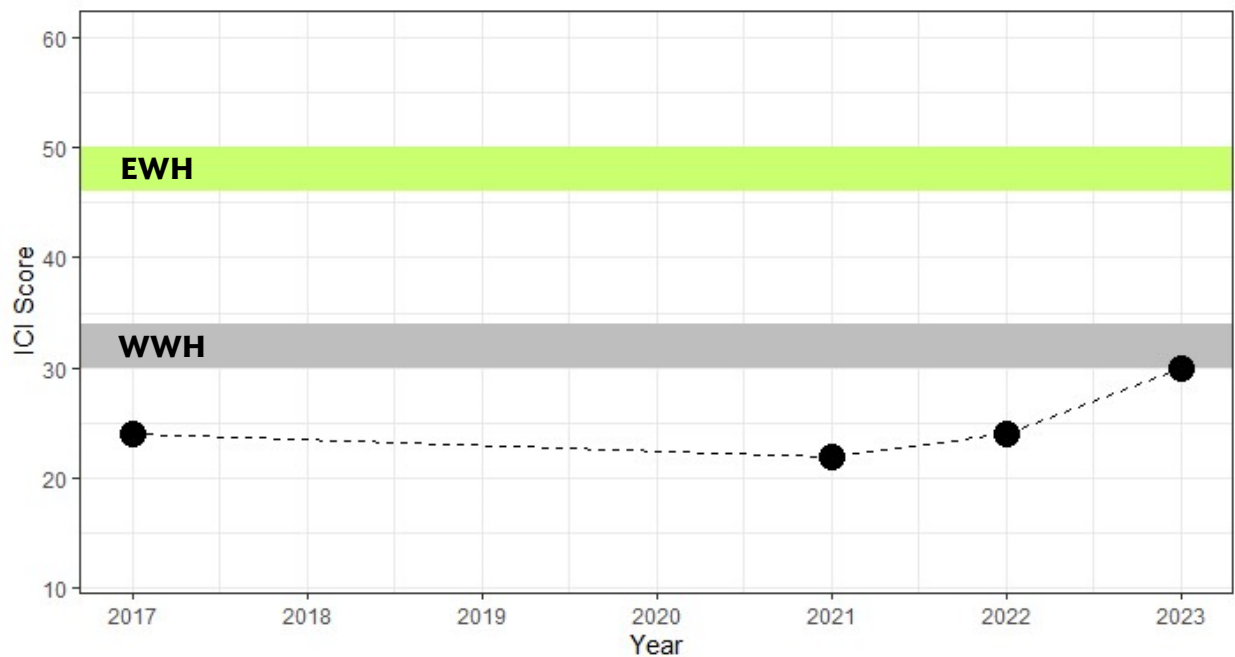
Figure 16. Stickney Creek ICI scores from 2017-2023. The gray box represents range of WWH attainment and NSD; the green box represents range of EWH attainment and NSD.
