DATE: December 2, 2008

FROM: Kathryn Crestani
Tiffany Moore
Seth Hothem
WQIS Investigators

RE: *2006 Benthic
Macroinvertebrate Sampling
Upstream of NEORSD CSO
Areas*

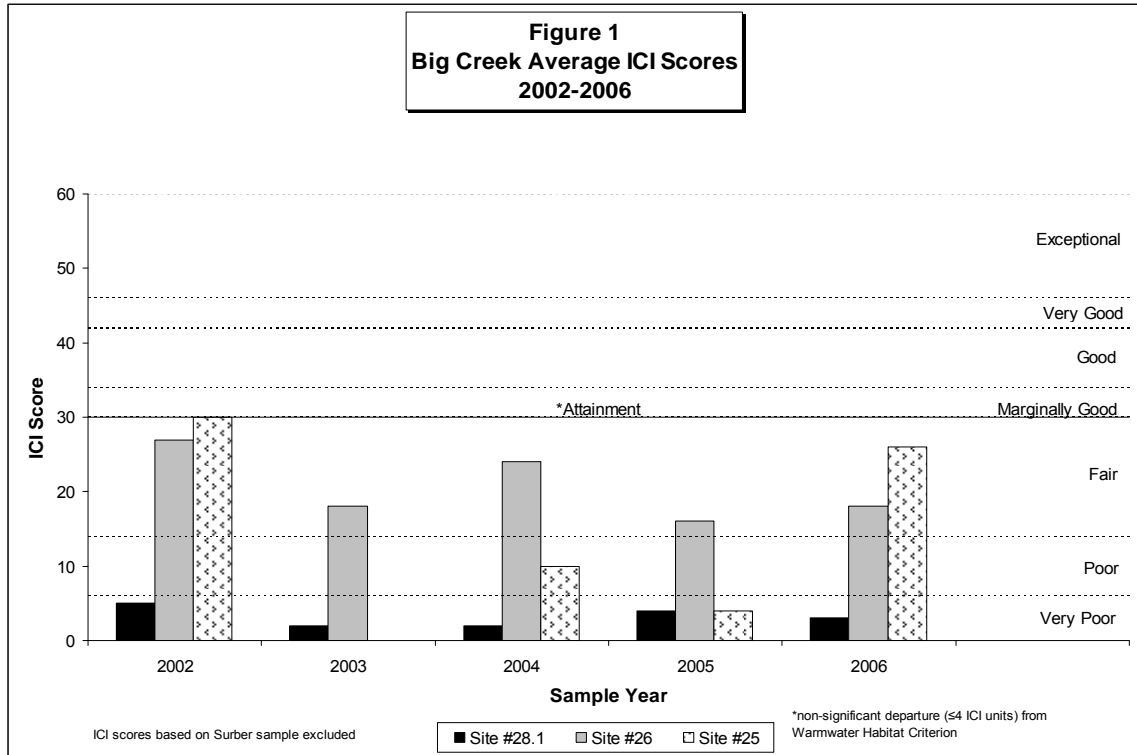
Average ICI score results from 2002 through 2006 are graphically displayed in Figure 1. Chemical water quality parameters exceeding the applicable statewide water quality criteria for the Protection of Aquatic Life are listed in Table 3.

Average ICI scores at Site #28.1, the most upstream site, remained in the *Very Poor* range from 2002 through 2006 (Figure 1). This site is designated a LRW by Ohio EPA as the site is subject to small drainageway maintenance. Exceedances of the Outside Mixing Zone Maximum (OMZM) water quality criteria for aquatic life protection occurred at this site on June 22, 2006 for zinc and on July 27, 2006 for zinc, copper and cadmium. Exceedances on both dates can be attributed to the effects of wet weather conditions. The small drainage area and lack of quality habitat likely contribute to the low ICI scores at Site #28.1.

Average ICI scores (Figure 1) at Site #26 have been in the *Fair* range from 2002 to 2006. Three exceedances of the OMZM water quality criteria for aquatic life protection occurred at this site in 2006 for copper, cadmium and zinc. These exceedances occurred during wet weather events and may be attributed to runoff or other nonpoint sources of pollution. ICI scores at Site #26 demonstrate the potential for high temporal variability of macroinvertebrate communities, as the first colonization period had an ICI score of 32 while the second period had an ICI score of 4. These scores represent the highest and lowest ICI scores produced at this site from 2002 through 2006.

At Site #25, the downstream site, average ICI scores were in the *Very Poor* to *Marginally Good* range (Figure 1). Seven exceedances of the OMZM water quality criteria (copper, cadmium, zinc, and dissolved oxygen) and one exceedance of the OMZA water quality criteria (copper) for aquatic life protection

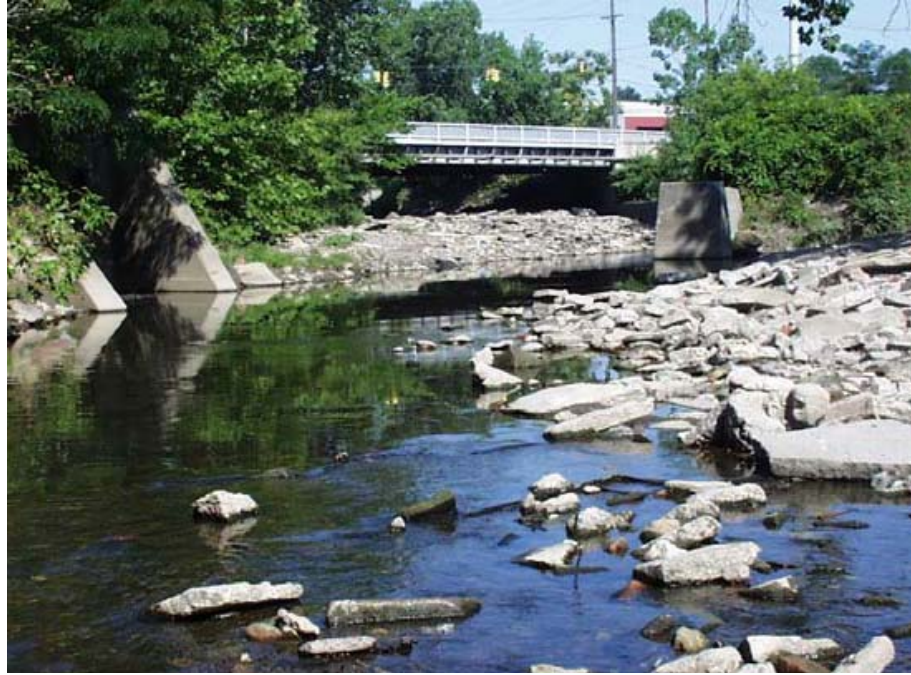
Figure 2. Jennings Road bridge prior to construction.

During the summer and fall of 2006, the Jennings Road bridge, located over Big Creek just upstream of Site #25, was rebuilt. This project caused a considerable amount of silt to enter the creek during both colonization periods. At times, investigators observed a plume of silt entering the Cuyahoga River at the confluence with Big Creek. The creek banks were straightened, and the substrate was reconfigured. Figure 2 shows the condition of Big Creek prior to the bridge construction. Figure 3 depicts the condition of the Big Creek during the bridge construction. In spite of the construction impact on the creek habitat, Site #25 produced the highest average score as well as the highest individual colonization score of all Big Creek sites in 2006. This site also showed considerable improvement over its 2004 and 2005 average scores. It is uncertain why this occurred, but suggests that there may be numerous factors affecting the ability of macroinvertebrates to colonize a given location.

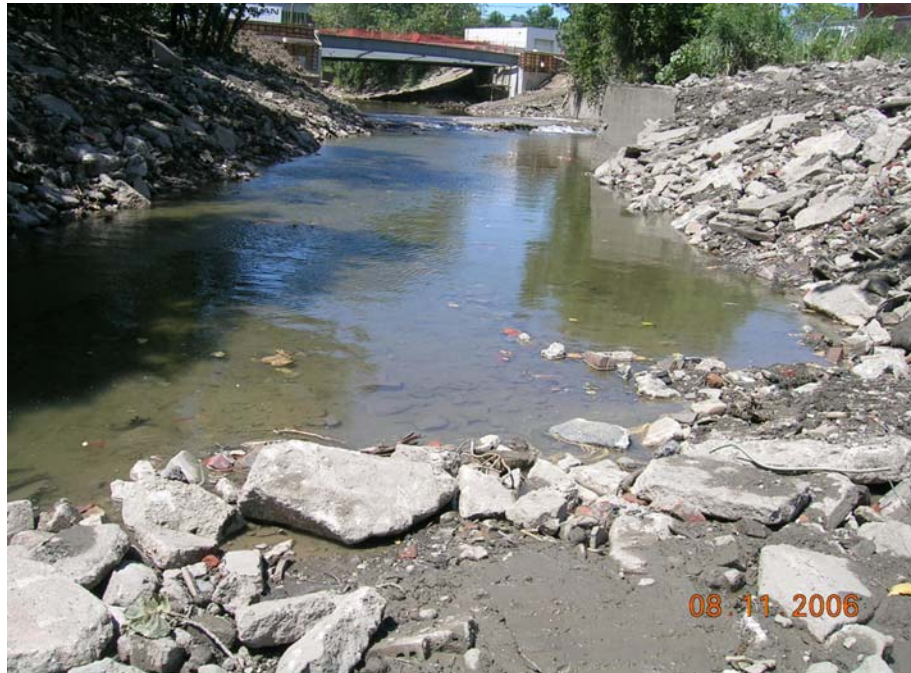
Figure 3. Jennings Road bridge during construction.

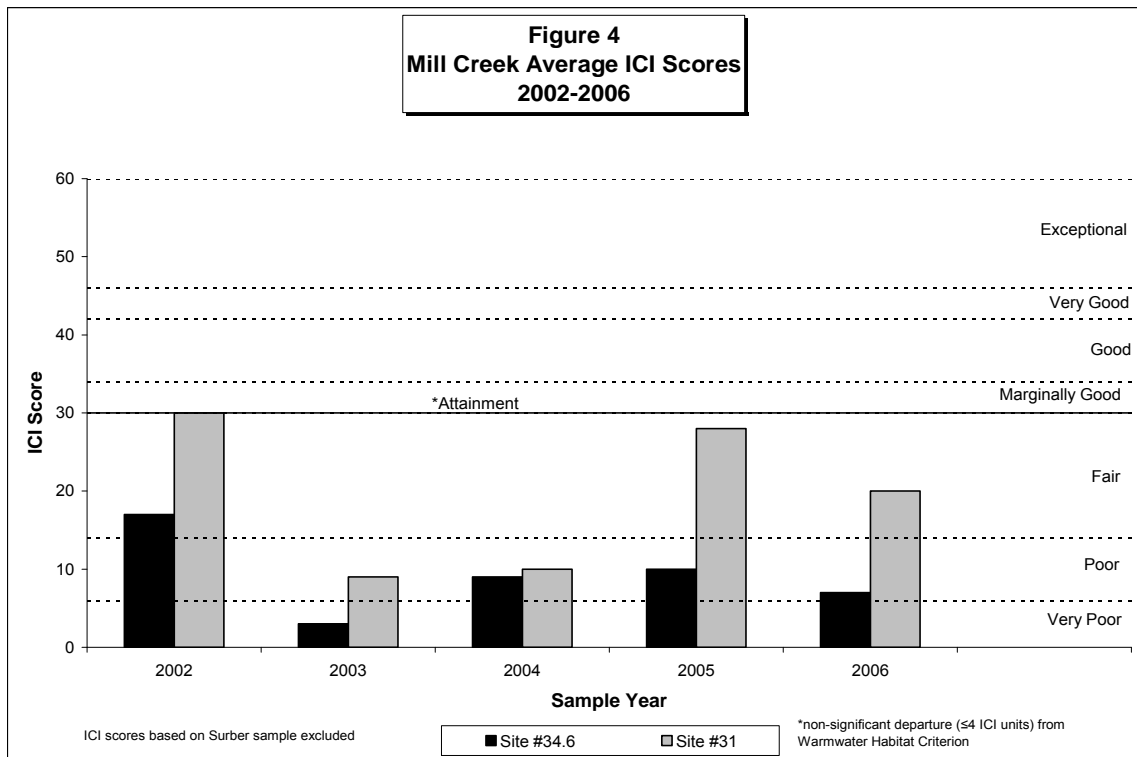
Average ICI score results from 2002 through 2006 are graphically displayed in Figure 4. Chemical water quality parameters exceeding the

In 2006, ICI scores at Site #34.6, the furthest upstream site, ranged from 14 (Fair) to 0 (Very Poor). This site had one exceedance of Outside Mixing Zone Average water quality criteria for protection of wildlife (Table 4), which occurred during wet weather. These relatively low scores may be a reflection of the habitat quality at this site, including a very small drainage area of 3.9 square miles. This site is located in an industrial area with a minimal riparian zone.

Site #31, the downstream site, had ICI scores from 12 to 28 in 2006. This site also had two exceedances of OMZM water quality criteria for aquatic life protection (Table 4). The copper exceedance occurred during a wet weather event.

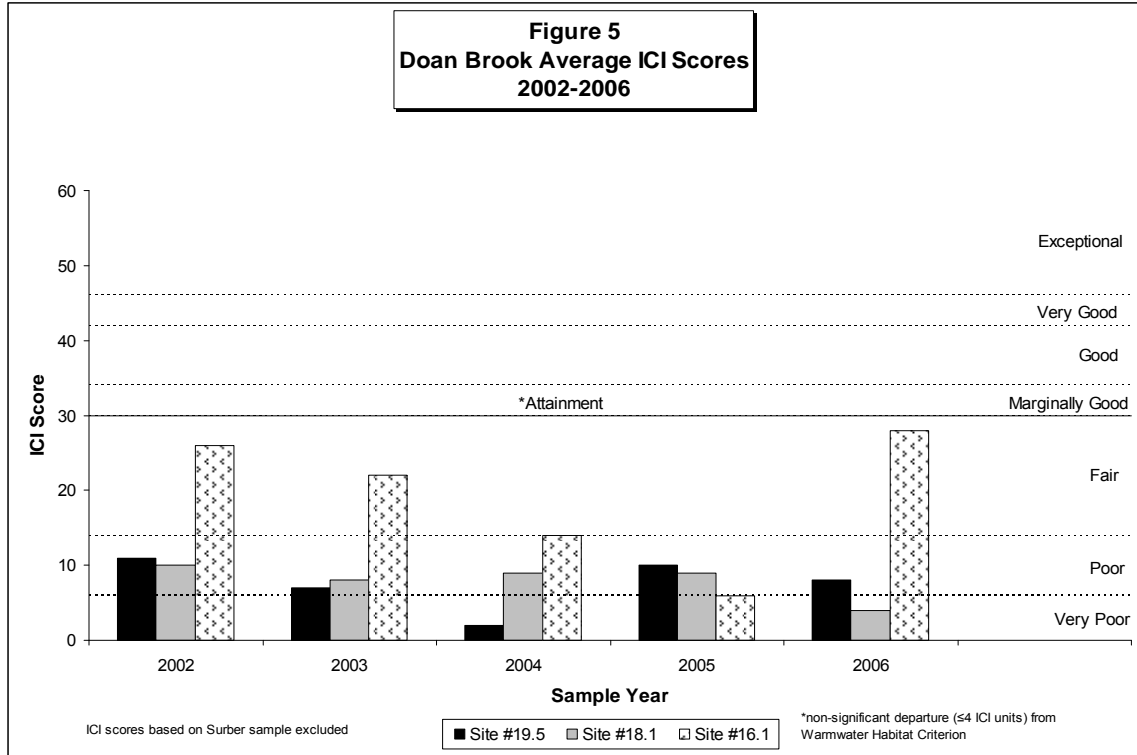
Average ICI score results from 2002 through 2006 are graphically displayed in Figure 5. Chemical water quality parameters exceeding the applicable statewide water quality criterion for the Protection of Aquatic Life are listed in Table 5.

In 2006, the downstream site, Site #16.1, had its highest average ICI score since the two colonization sampling periods began in 2002 (Figure 5). OMZM water quality criteria for aquatic life protection were exceeded twice at this site in 2006 (Table 5). Although Site #16.1 is located in an urban park within a channelized stream section having little or no riparian zone, and is downstream of NEORSD-owned CSOs, it has consistently had better average ICI scores than the other two Doan Brook sites. The score for the second colonization period in 2006, 30, is within non-significant departure (≤ 4 ICI units) from the WWH criterion. It is possible that a better flow regime has enough impact at this site to overcome habitat or water chemistry stressors and thus produce higher ICI scores as compared to the other Doan Brook sites.

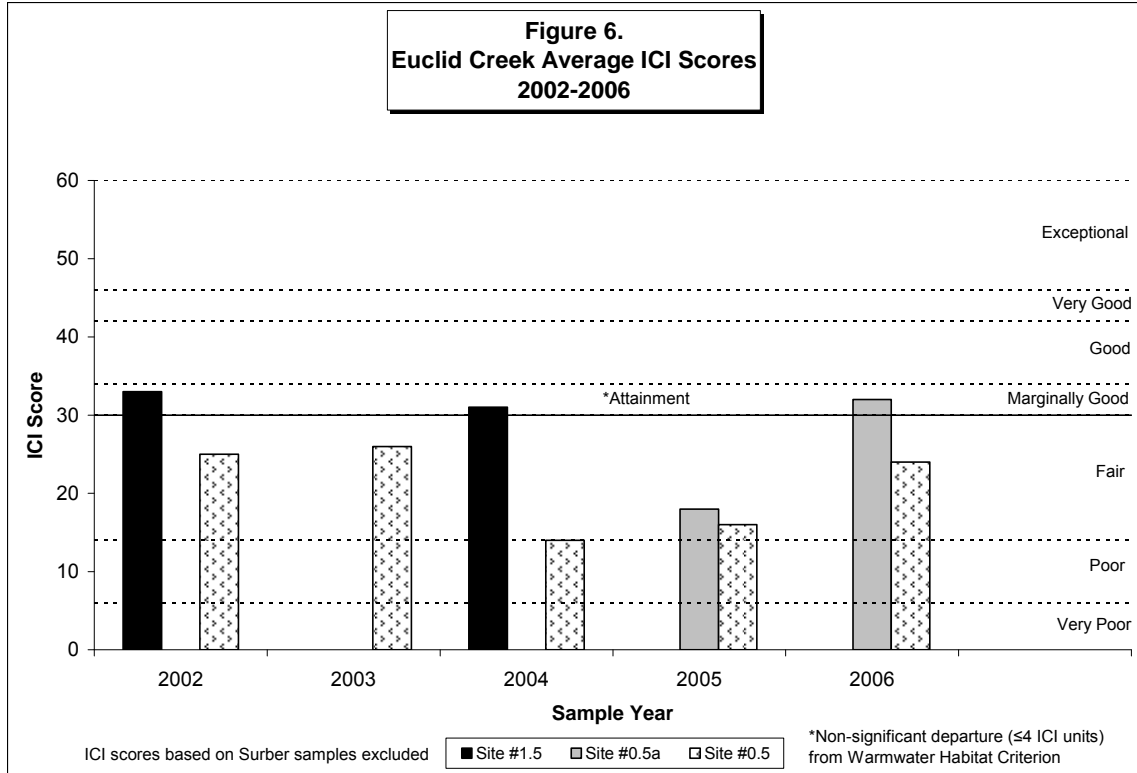
Average ICI score results from 2002 through 2006 are graphically displayed in Figure 6. There were no chemical water quality parameter exceedances of the applicable statewide water quality criterion for the Protection of Aquatic Life at either Site #1.5 or Site #0.5 in 2006. Due to its proximity to Site #0.5, chemical water quality sampling was not conducted at Site #0.5a.

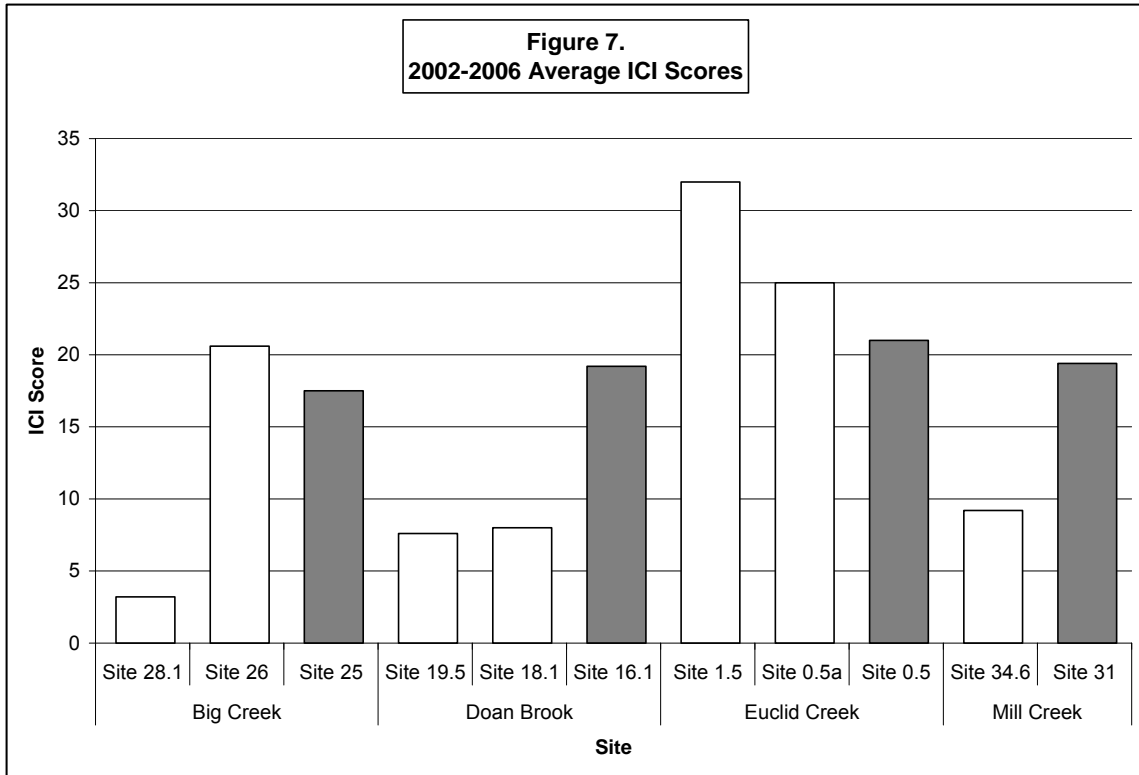
Figure 7 depicts the average ICI scores for all sites. It should be noted that the downstream site average ICI scores, depicted by the gray columns, generally fall in the middle of the graph. It would appear from this figure that, while CSOs may be having some impact on benthic macroinvertebrate communities (because the downstream sites do not always have the highest scores overall), other factors, such as point/non-point sources, the lack of suitable macroinvertebrate colonization habitat and stream order, are causing even lower ICI scores upstream of the CSOs. Point sources with potential impact include SSOs, storm sewer outfalls, upstream tributaries and home sewage treatment systems. Non-point sources with potential impact include urban runoff, landfill leachate and spills.

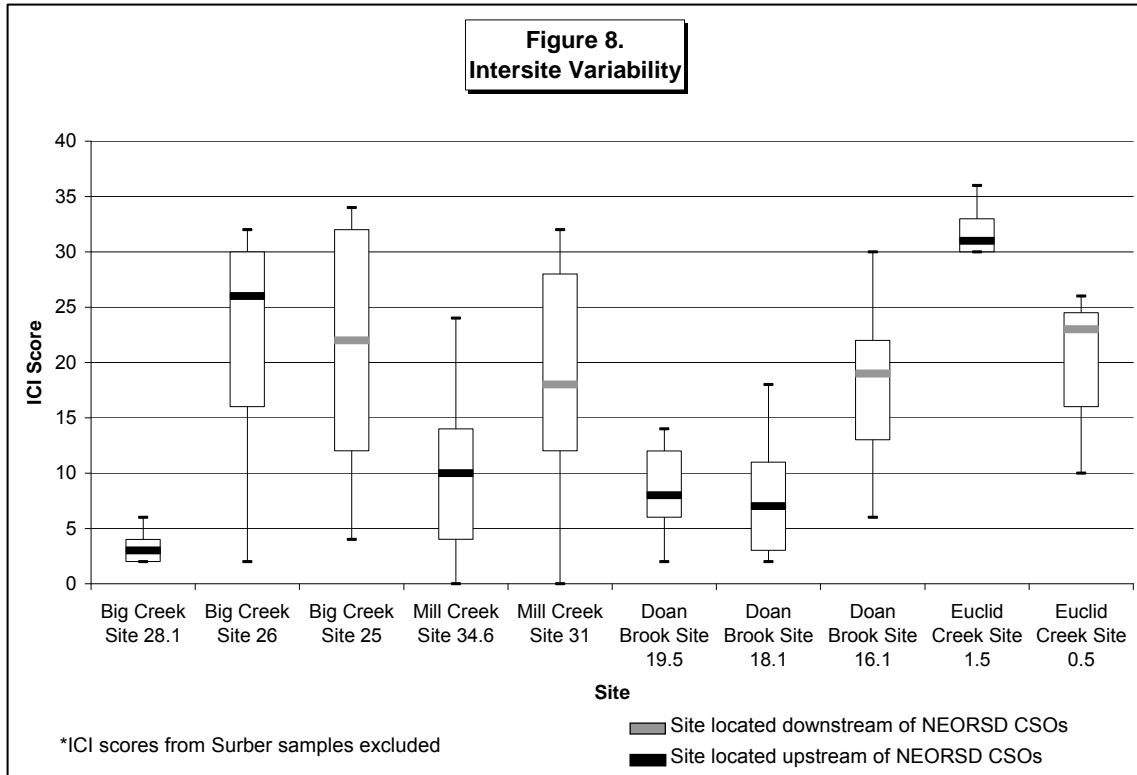
Figure 8 shows the variability of ICI scores for each site, using an averaged ICI score each year from 2002 through 2006. If CSOs were having a very strong impact on downstream sites, it would be expected that the downstream sites would generally have the lowest median scores. The site with the lowest median score (Big Creek Site #28.1) is an upstream site. Doan Brook and Mill Creek had higher median scores at the downstream locations than at the upstream locations.
