NORTHEAST OHIO REGIONAL SEWER DISTRICT

2017 Mill Creek Highland Golf Course Restoration Environmental Monitoring: Biological, Water Quality, and Habitat Survey Results

**Prepared by
The Water Quality and Industrial Surveillance Division**

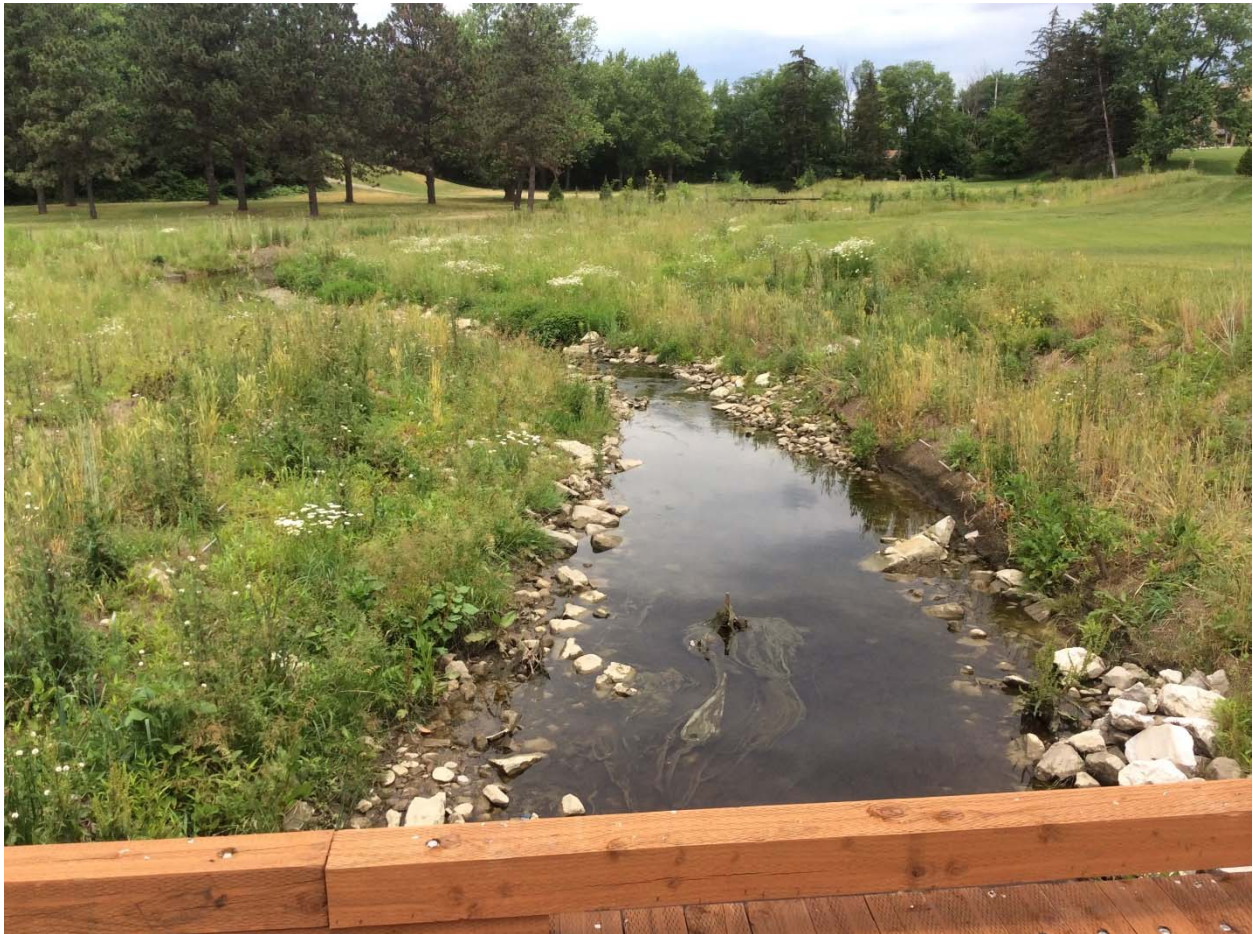
Photo: Mill Creek golf course on June 15, 2017, River Mile 11.52

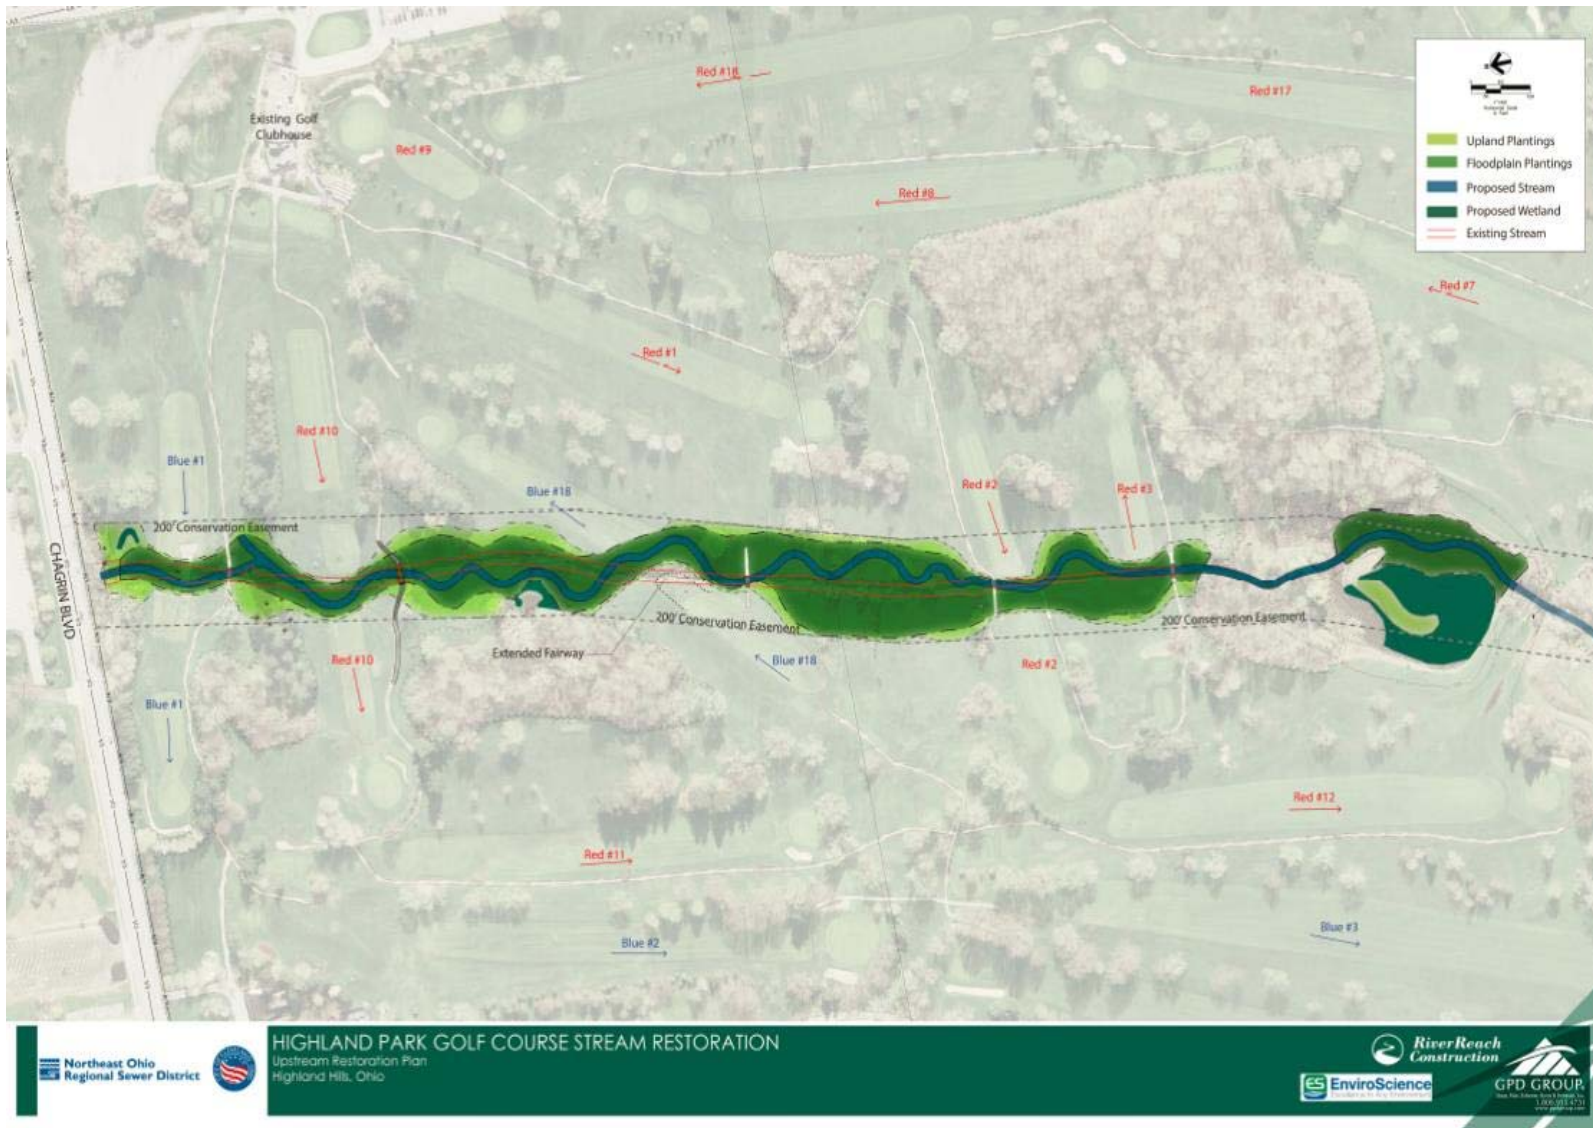
Figure 1. Mill Creek Restoration Area

The Mill Creek Restoration Project included the restoration of approximately 4,336 linear feet (LF) of Mill Creek, 181 LF of an un-named tributary to Mill Creek, and construction of 1.2 acre floodplain wetland depressions in place of an existing pond (Figures 1-3). The project also resulted in the permanent placement of stream fill in approximately 3,546 LF in Mill Creek and an un-named Mill Creek tributary. Post-restoration monitoring of the habitat was required under the permit; fish and macroinvertebrate surveys were also completed to compare to data collected prior to the restoration project.

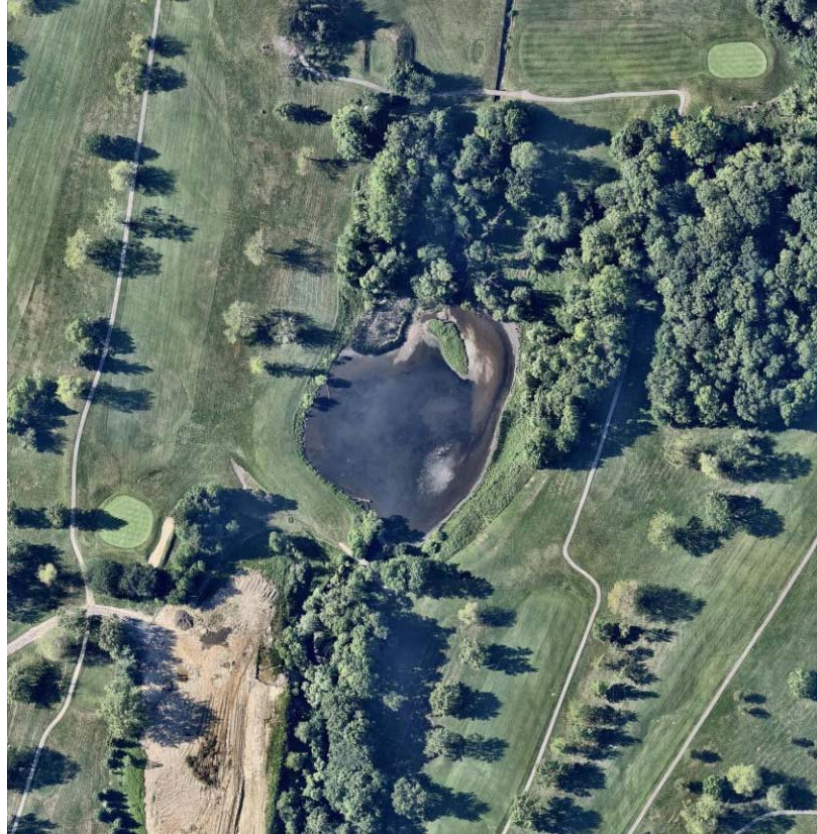
Figure 2. Pond at approximately RM 11.10 (2015)

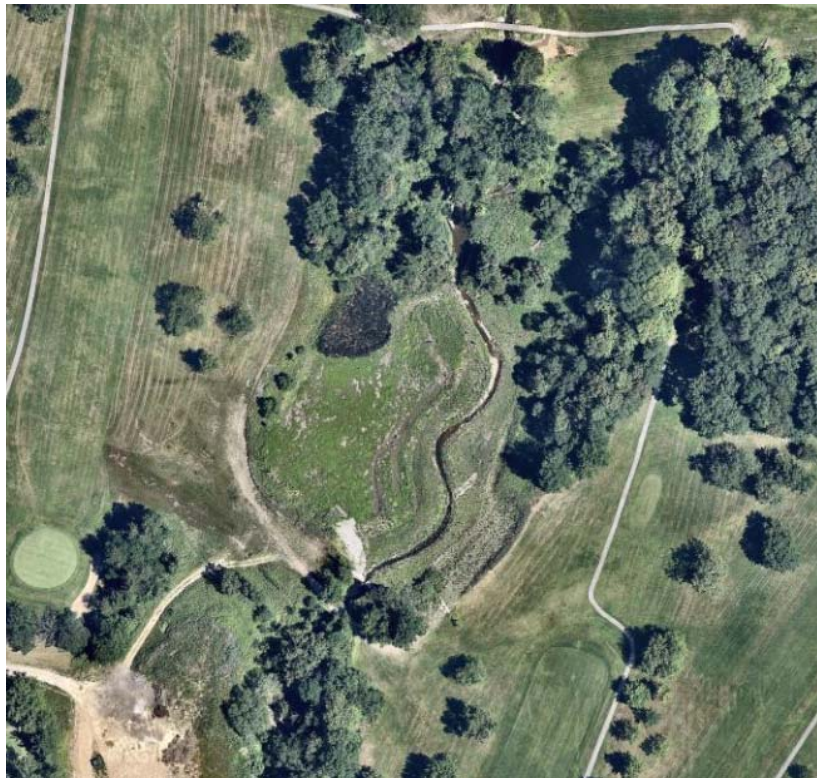
Figure 3. Constructed wetland depression in place of drained pond (2017)

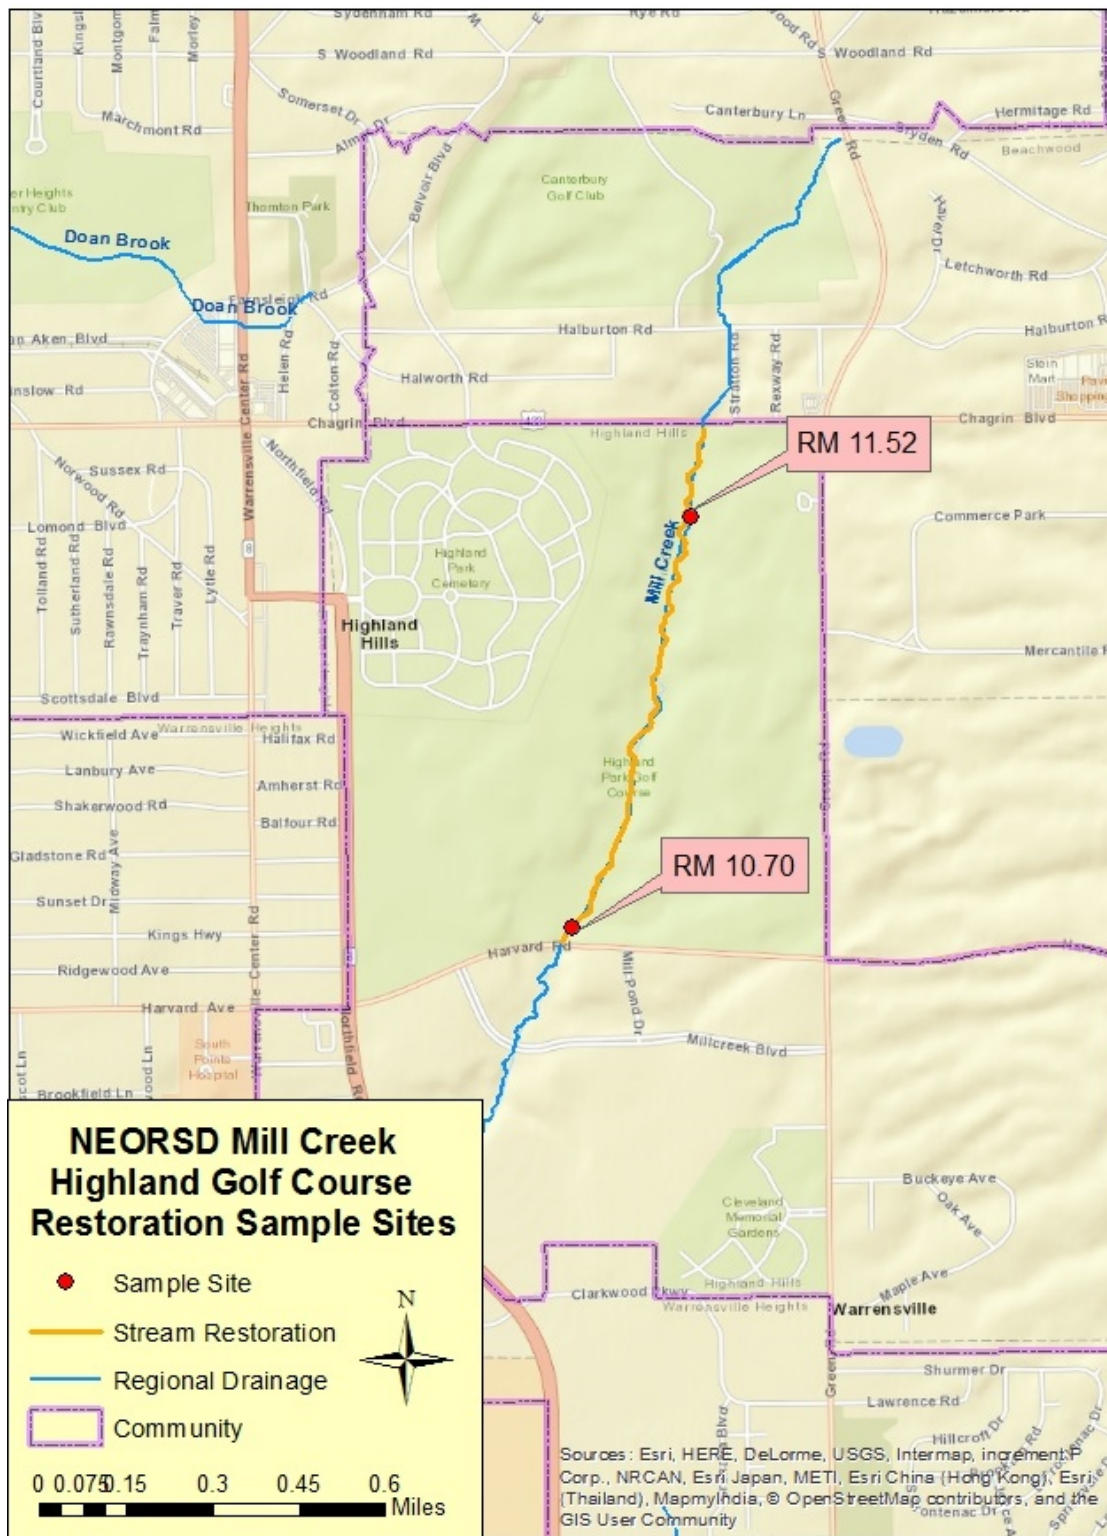
Figure 4. Sampling Locations

Figure 4 is a map of the sampling locations on Mill Creek Highland Restoration Golf Course, and Table 1 lists the sampling locations and their respective river mile, latitude/longitude, site description, and surveys conducted. A digital photo catalog of the sampling locations is available upon request by contacting the NEORS Water Quality and Industrial Surveillance (WQIS) Division.
