# **Northeast Ohio Regional Sewer District**

## **2024 Mill Creek**

### **Biological, Water Quality, and Habitat Study**

**May 2025**

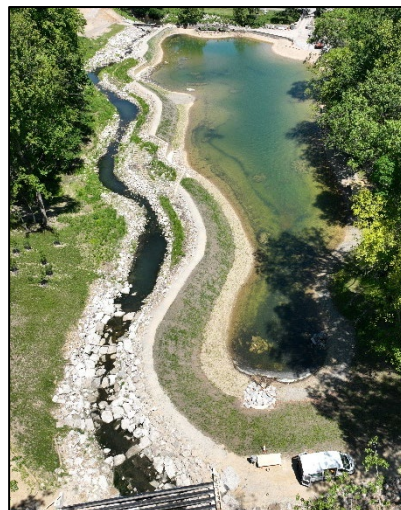
Wolf Creek is a tributary to Mill Creek at RM 4.36. NEORS D partnered with Cleveland Metroparks, with funding from Ohio EPA's Section 319(h) program, to restore and stabilize approximately 1,600 linear feet of stream and riparian buffer along Wolf Creek, in the Garfield Park Reservation. In 2023, the creek and a

Wolf Creek RM 0.05  
Looking Downstream

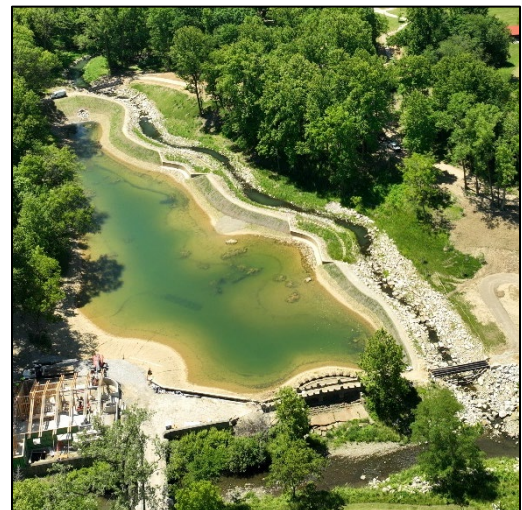
Wolf Creek RM 0.05  
Looking Upstream from Mill Creek

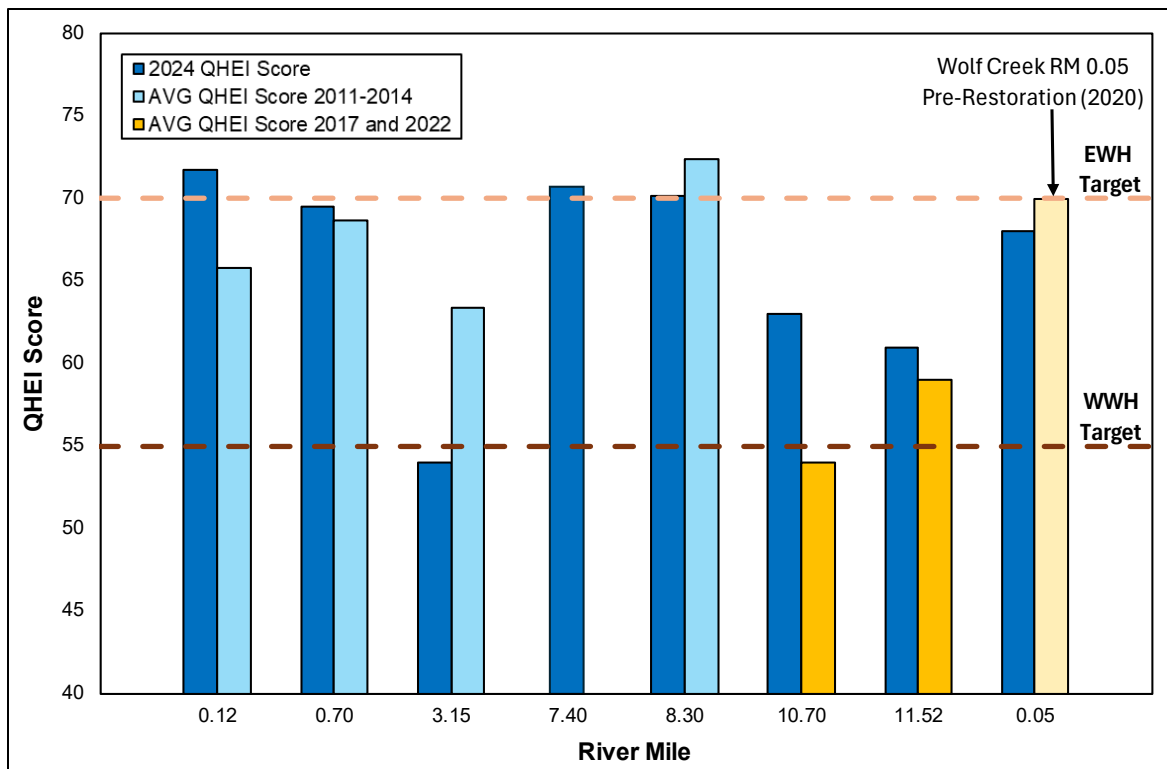
**Figure 7.** Mill Creek QHEI Scores.

There were some variations in scores when compared to historical QHEI data, with scores either remaining similar or increasing slightly in 2024, with the exception of RM 3.15, where the narrative rating declined from *Good* to *Fair*. (Figure 7). The QHEI at RM 3.15 decreased significantly in 2024, likely due to changes with in-stream cover and increases in silt loadings covering the bottom substrates, generally causing moderate to extensive embeddedness. The lack in habitat at RM 3.15 could be related to flows being well below median causing available functional habitat to be out of the water during the site monitoring. The QHEIs conducted at the Mill Creek stream restoration sites (RM 10.70 and 11.52) showed an increase in scores due to increased in-stream habitat cover, decreased substrate embeddedness, and improved riffle substrates.

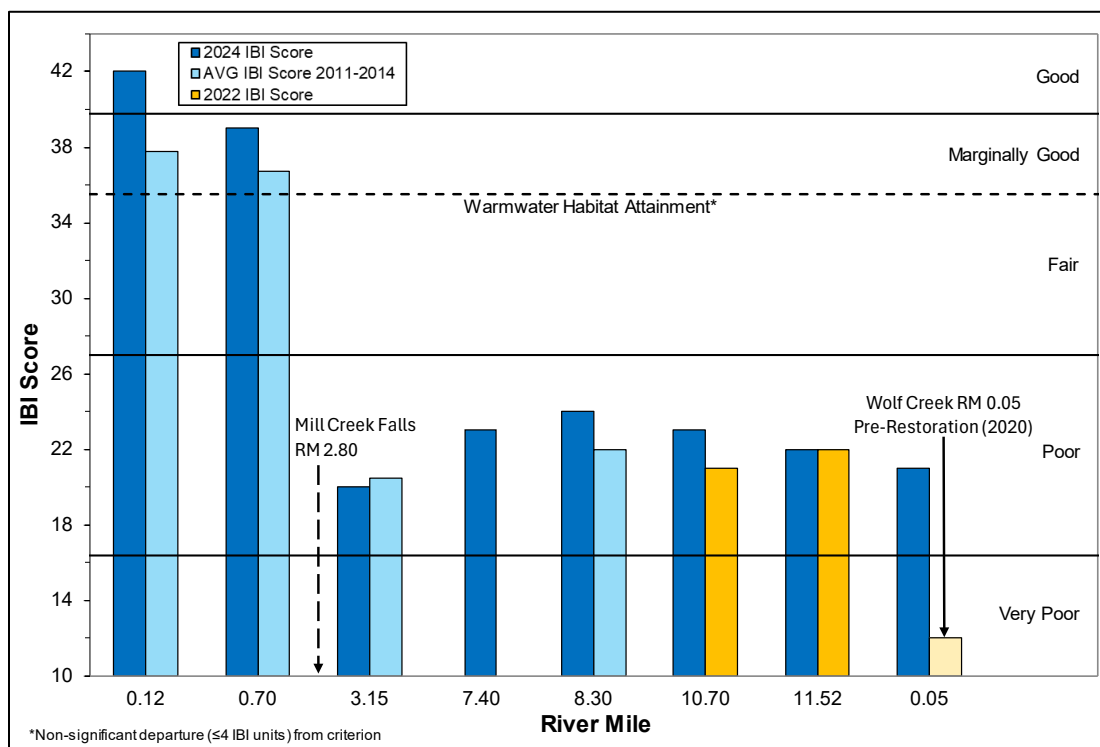
Figure 8. Mill Creek IBI Scores.

Fish assemblages throughout the upper reaches of the Mill Creek Watershed failed to meet the WWH IBI designated use scoring criterion in 2024. Most of the surveyed site locations were dominated by highly pollution-tolerant species of Creek Chubs and Blacknose Dace along with Central Stoneroller Minnows; these are species typically found in an urbanized watershed. The predominate species per site are listed in Table 12. The lower section of Mill Creek consisted of the highest fish IBI scores, as well as the highest species richness. Fish community biology scores in 2024 were consistent with scores from previous studies (Figure 8). A direct historical comparison is not available for RM 7.40 due to this site being surveyed for the first time in 2024. Pre-restoration baseline data from Wolf Creek RM 0.05 was collected by Ohio EPA's Ecological Assessment Unit (EAU) in 2020 (Ohio EPA, 2025).

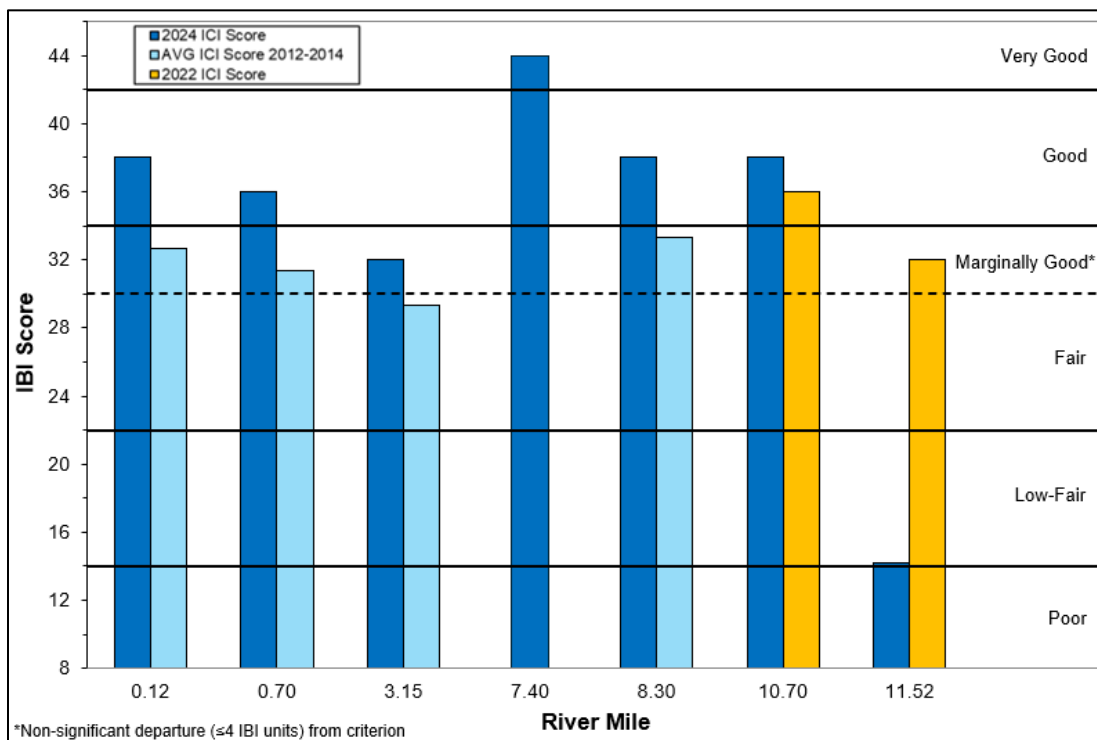
**Figure 9.** Mill Creek ICI Scores.

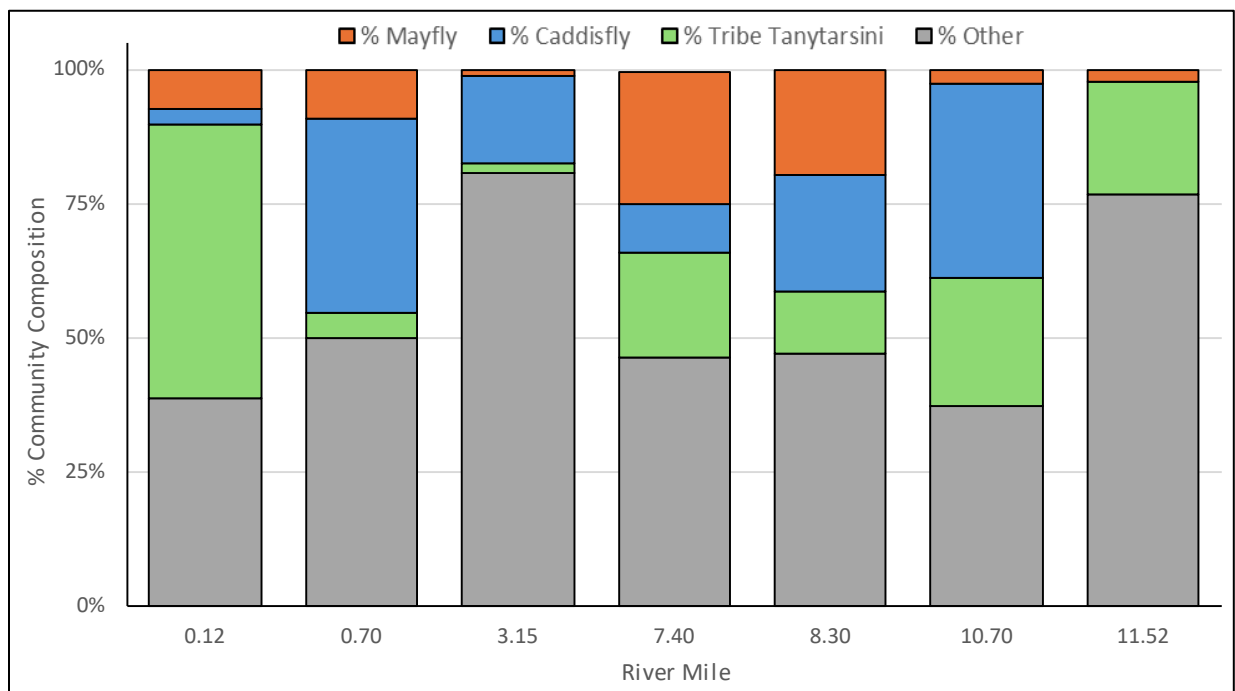
**Figure 10.** Mill Creek Main-Stem Macroinvertebrate Community Composition by Site.

The macroinvertebrates can be combined into taxonomic groups to determine overall composition. Figure 10 below shows the breakdown in macroinvertebrate community composition of mayflies, caddisflies, tribe tanytarsini midges, and other organisms (including non-tanytarsini midges, other diptera, and non-insects) that colonized the HD sampler at each site. Higher quality macroinvertebrate communities are typically represented by a greater proportion of mayflies and caddisflies, which are in the EPT families.

The greater abundance of mayfly and caddisfly taxa, with the exception of RM 3.15 and 11.52, demonstrates the well-balanced benthic community and is reflected in the *Good* and *Very Good* ICI scores. The abundance of EPT taxa limits proportions of the more tolerant “other dipterans and non-insect” taxa throughout these stream reaches. RM 3.15 and 11.52 contained a lower proportion of EPT family taxa and a higher proportion of “other dipterans and non-insects”. RM 11.52 also contained a higher percentage of pollution-tolerant taxa (Table 15). A decrease in the percent of caddisflies or mayflies, and an increase in percent “other organisms” at these study locations may be due to increases in substrate embeddedness, changes in urban land use, or changes in flow conditions due to a dryer than normal field season.
