Re: Annual Inspection with Concerns
Project Title: First Unitarian Solar Rain Garden

Rain Barrel/Cistern Inspection and Maintenance Checklist

| Green Infrastructure Site Location and Address: First Unitarian Solar Rain Garden | | |

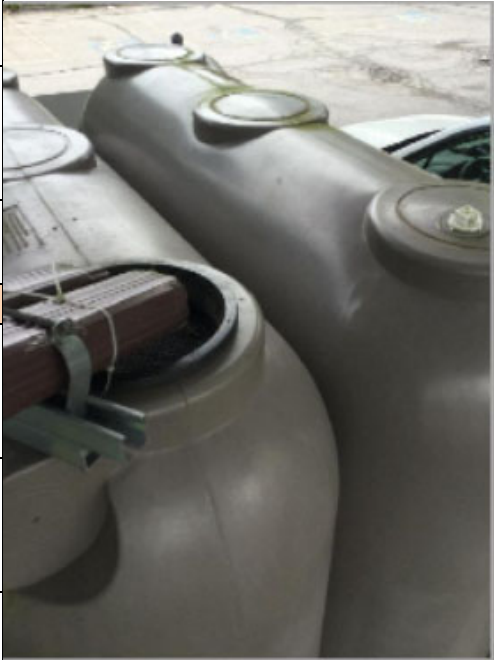
| Inspection Item | Images |
|---|--|
| Gutters and downspouts joints are disconnected and/or leaks are present: <input type="checkbox"/> Yes <input checked="" type="checkbox"/> No <input type="checkbox"/> NA | Photo 1. --- --- |

| Inspection Item | Images |
|---|--|
| Comments: Accumulation of debris in the filter for the square cisterns. Remove the debris that is present and dispose of properly. Please refer to photo 1. | |

| SUMMARY Please address the following items: <ol style="list-style-type: none"> Provide verification how the stored water is being utilized and an estimate of how much is utilized. Clear the debris that has deposited in the pretreatment filters (square cisterns) (Refer to photo 1 for location). | |
