# BEAR CREEK BANK STABILIZATION NORTH OF MILES ROAD

North Randall, OH

CUYAHOGA RIVER SOUTH · BEAR CREEK

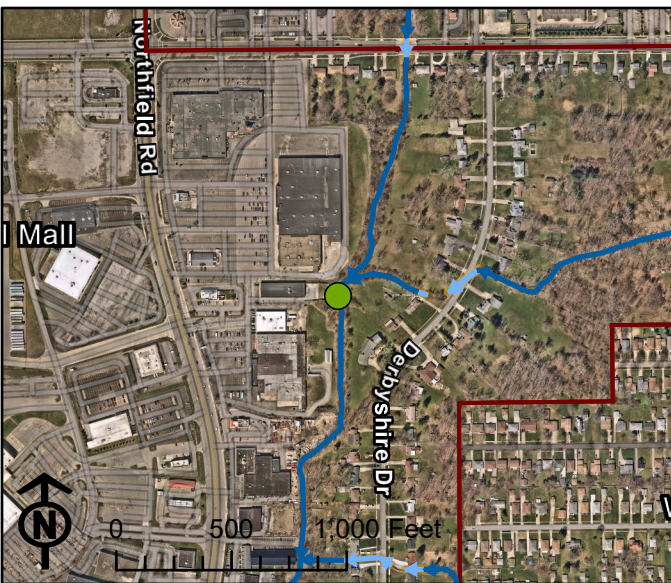
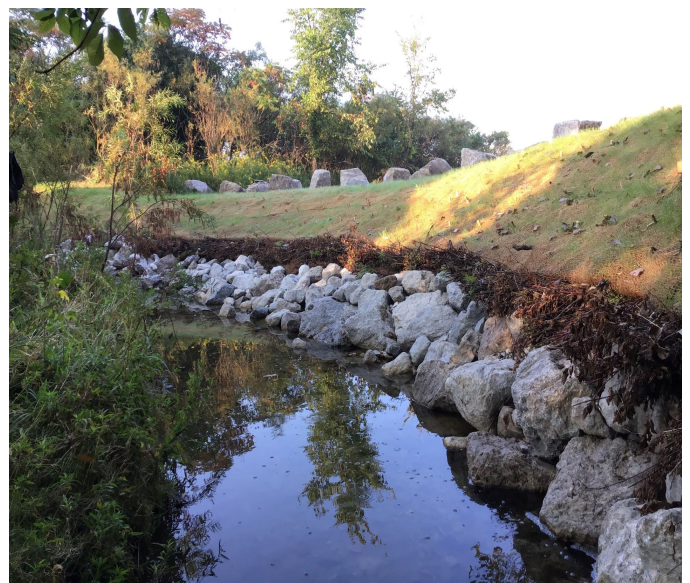
This project stabilized over 90ft of eroding streambank along Bear Creek that had exposed a local stormwater outfall and concrete headwall. The eroding right bank was no longer able to support the headwall or protect the encased stormwater pipe. The bank was re-graded to a stable slope and reinforced with riprap toe protection. Live stakes and native vegetation were planted to further stabilize the new bank configuration.
