Re: Annual Inspection
Project Title: Colfax Green Links

Awarded Green Infrastructure Grants Program (GIG)

Maintenance Inspection Checklist

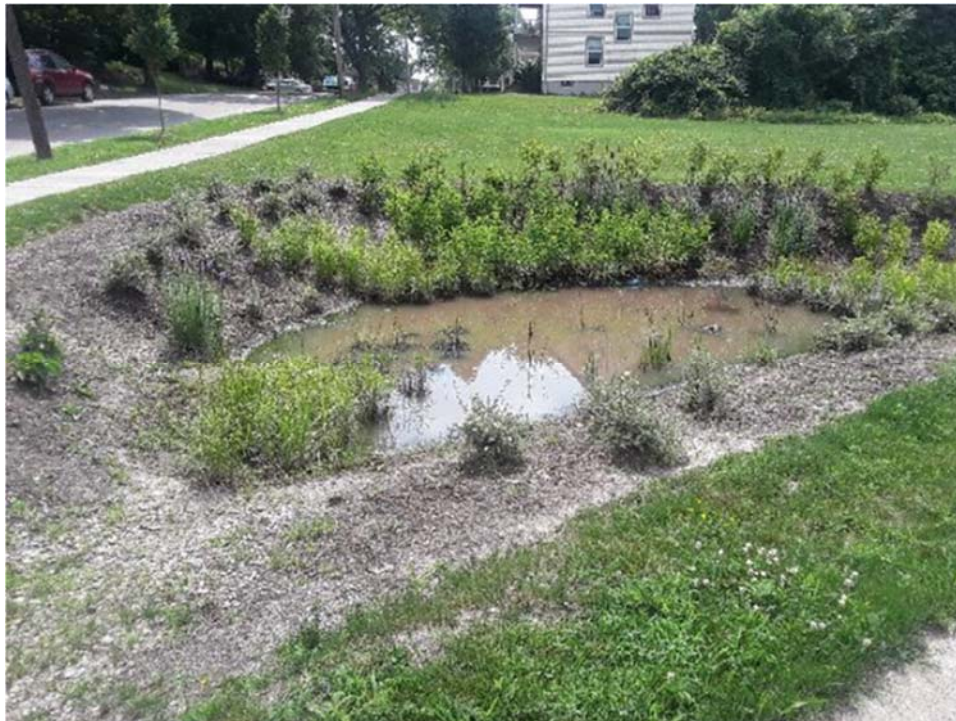
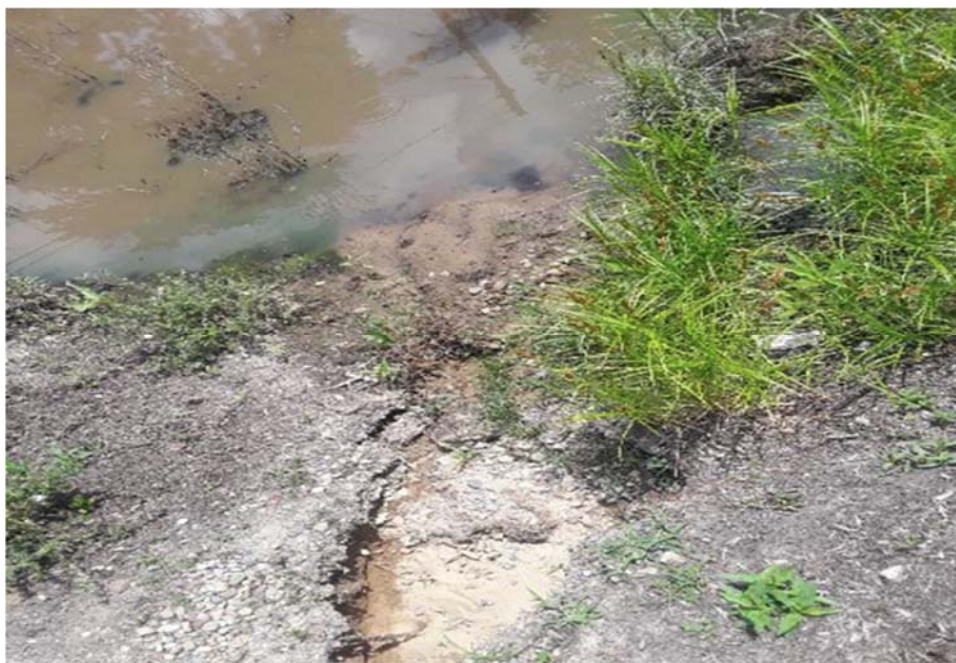
PHOTO(S) INFORMATION

Site Name: Colfax Green Links	
Address:	
Inspector's Name: Christopher Hartman, CPESC, CPSWQ, CESSWI	Date and Time: 7/3/2018, 11:00am
Overall Notes: Southeast corner of the GI project has issues, but we have met with the applicant to discuss concerns and options since this inspection was completed.	
The southeastern cell has been compromised...erosion of inlet areas has resulted in clogging of the cell.

CISTERN (Select yes or no to the following maintenance questions)	
Is there debris present? Yes	Debris notes: Minor debris present.
Is there a layer of sediment? Yes	Sediment notes: Sediment has clogged the cell.
Do the inlets provide stable conveyance into facility? No	Inlet notes: Stone inlet protection has been washed away.
Presence of invasive species/weeds? No	Invasive notes: N/A
Dead vegetation/exposed soil? Yes	Soil notes: Dead vegetation caused by the ponding water.
Evidence of clogging? Yes	Clogging notes: N/A
Evidence of erosion? Yes	Erosion notes: N/A

CISTERN (Select yes or no to the following maintenance questions)	
Evidence of standing water? Yes	Standing water notes: Standing water present. N/A
Filter media too low? No	Filter media low notes: N/A
Evidence of blockage in or around outlet? No	Blockage notes: N/A
Replant? Yes	Replant notes: N/A
Complaints from local residents? No	Complaints notes: N/A
