Stream & Location: Baldwin Creek (1st of Quarry Lane) RM: 0.2 Date: 6/27/19

Scorers Full Name & Affiliation: Si Hothem, J. Telep Northeast Ohio Regional Sewer District

River Code: 13-101-000 STORET #: 101G01 Lat./ Long.: 41.363281, 8542 Office verified location

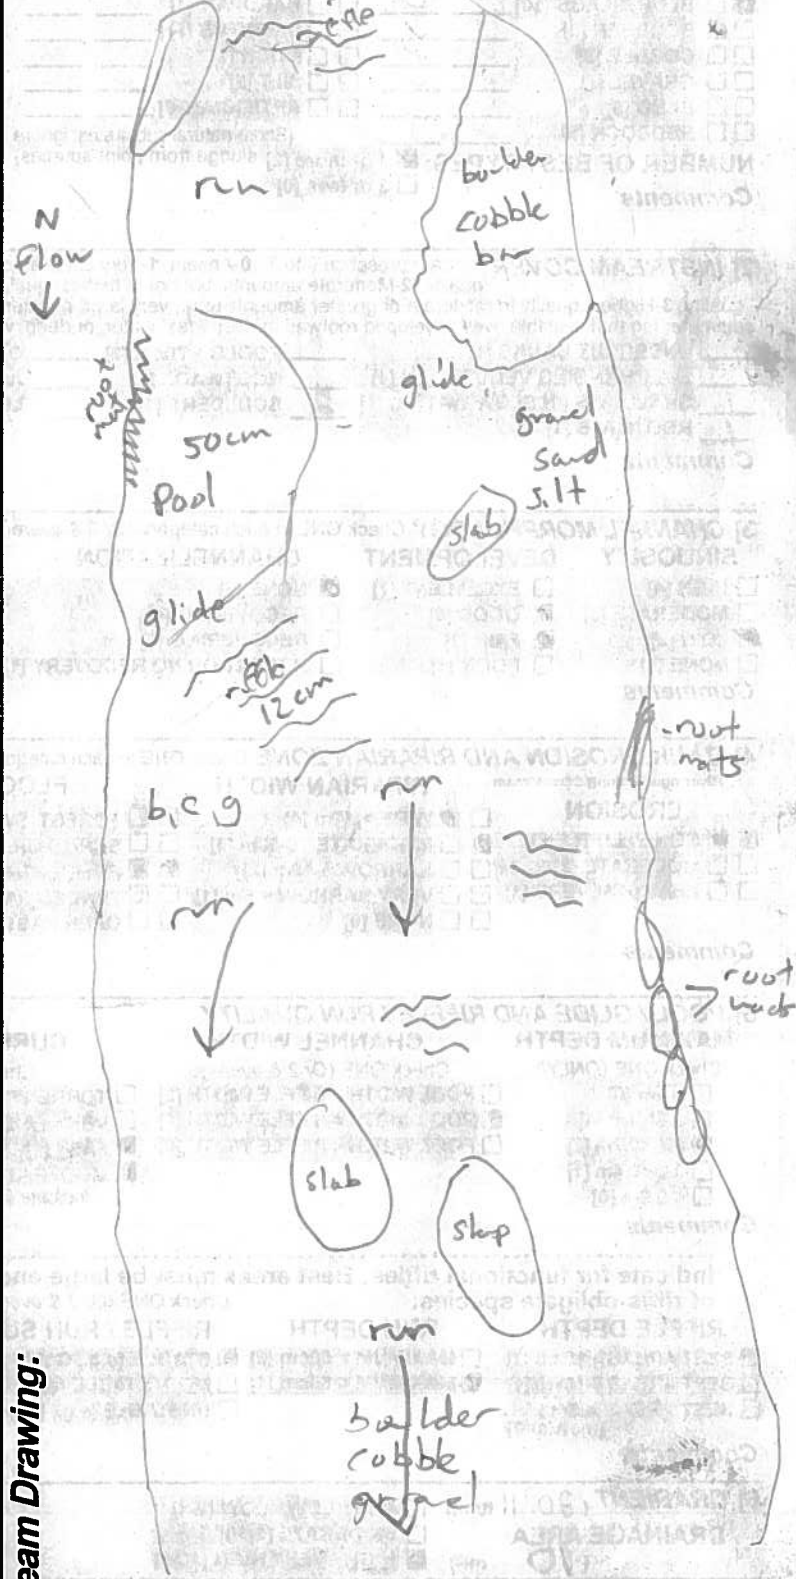
**Stream Drawing:**

Site located between two sections of Quarry rock walls. Small pool with mostly cipple habitat throughout.
