NORTHEAST OHIO REGIONAL SEWER DISTRICT

2017 Lake Erie Beach Monitoring

Prepared by
Water Quality and Industrial Surveillance Division

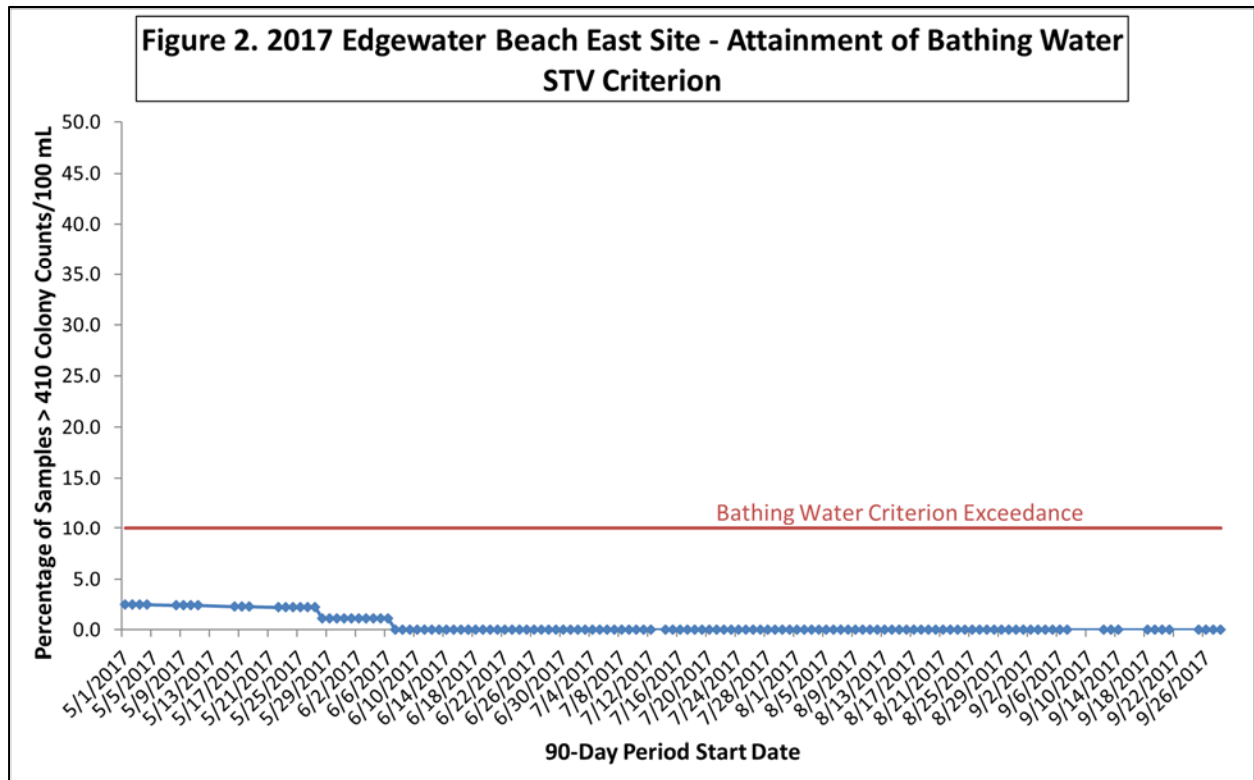
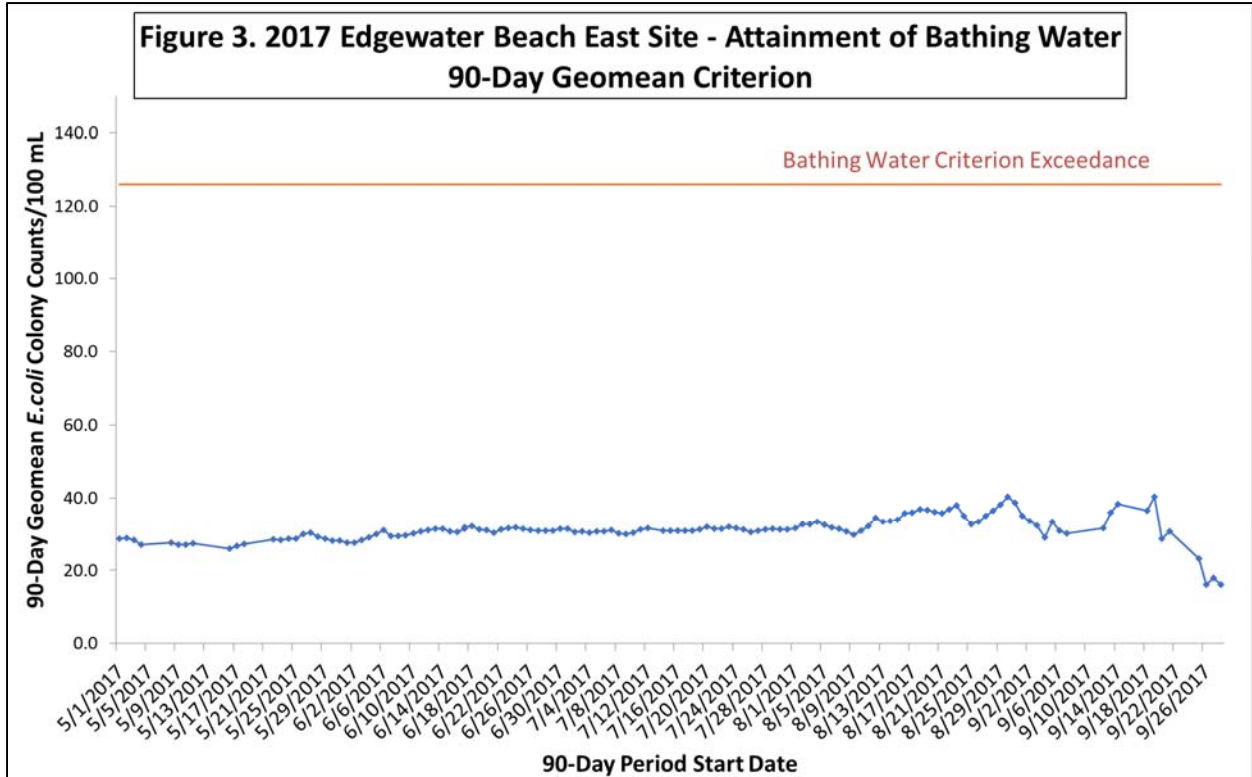
The water quality at Edgewater Beach was found to be in full attainment of the Bathing Water recreational use STV and geometric mean criteria (Figures 2 and 3) for all 90-day periods in the 2017 recreational season. Single samples exceeded the beach action value of 235 colony counts/100mL for only 9 of the 130 sampling events, a frequency of 6.9%. Four of the 9 exceedances of the beach action value (44.4%) occurred within 48 hours of a rain event with a total rainfall greater than 0.10 inches.

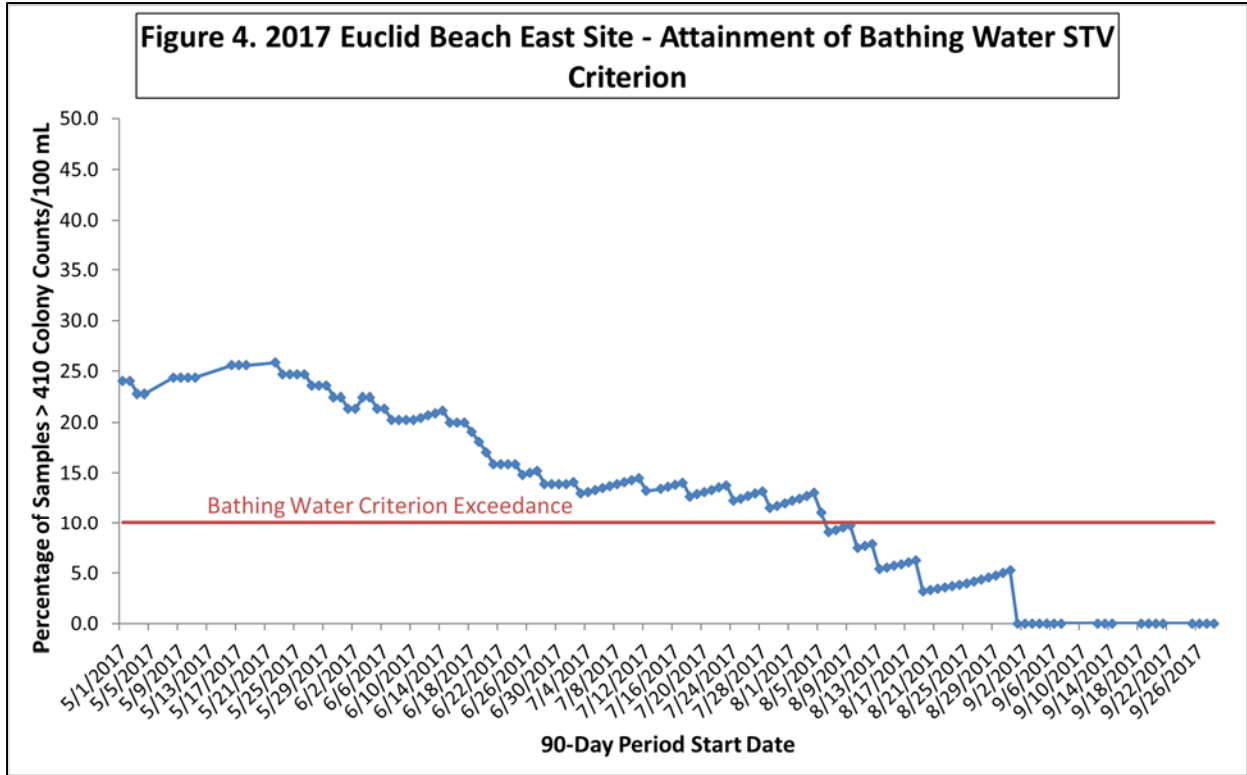
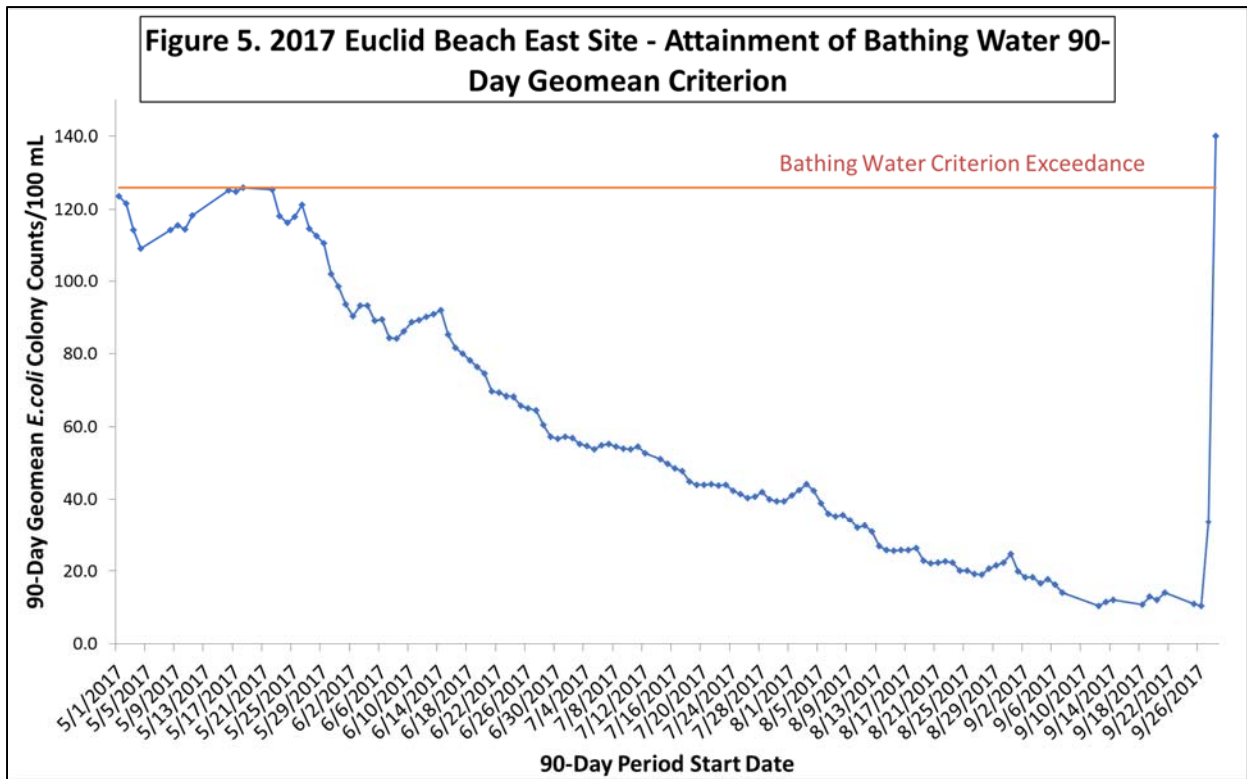
Euclid Beach was in non-attainment of the Bathing Water recreational use criteria in 2017. Euclid Beach was in non-attainment of the STV criterion for 66.1% of the 90-day periods (Figure 4). Euclid Beach was also in non-attainment of the geometric mean criterion for two of the 90-day periods (1.5%) (Figure 5). It should be noted that one of the two 90-day periods began on September 28, 2017, which was the last day of sample collection. Therefore this 90-day period had only a single data point. Single samples exceeded the beach action value of 235 colony counts/100mL for 33 of the 130 sampling events, a frequency of 25.4%. Twenty-three of these 33 exceedances (69.7%) occurred within 48 hours of a rain event with a total rainfall greater than 0.10 inches.

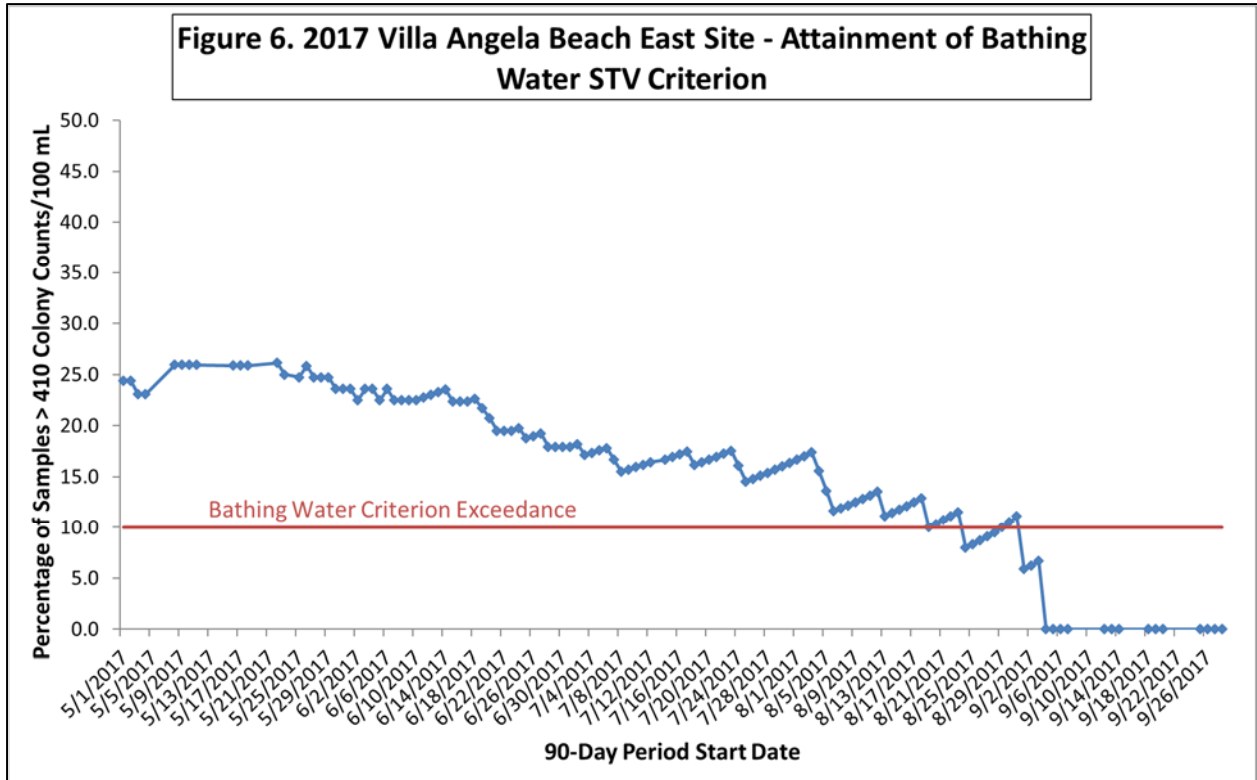
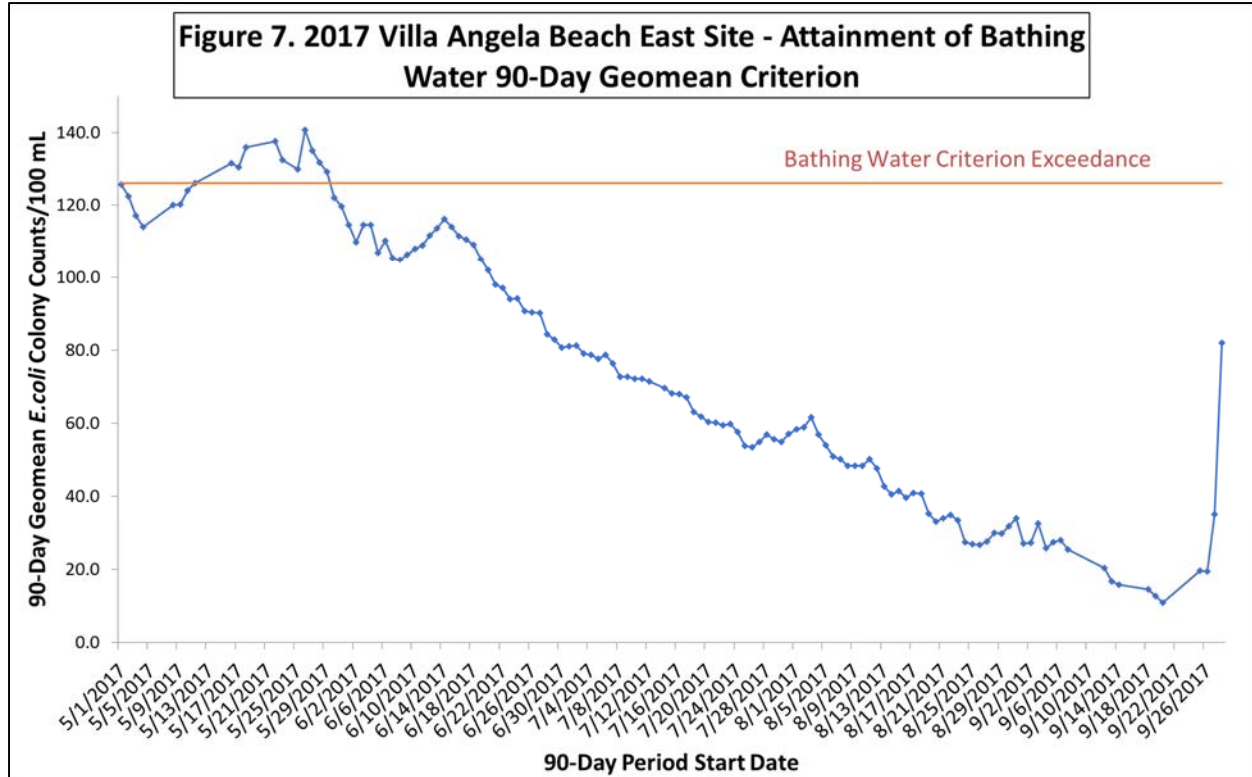
Villa Angela Beach was in non-attainment of both Bathing Water recreational use criteria in 2017. Villa Angela exceeded the STV criterion for 81.3% of the 90-day periods (Figure 6), and the geometric mean criterion for 8.6% of the 90-day periods (Figure 7). Single samples exceeded the beach action value of 235 colony counts/100mL for 38 of the 130 sampling events, a frequency of 29.2%. Twenty-six of these 33 exceedances (68.4%) occurred within 48 hours of a rain event with a total rainfall greater than 0.10 inches.

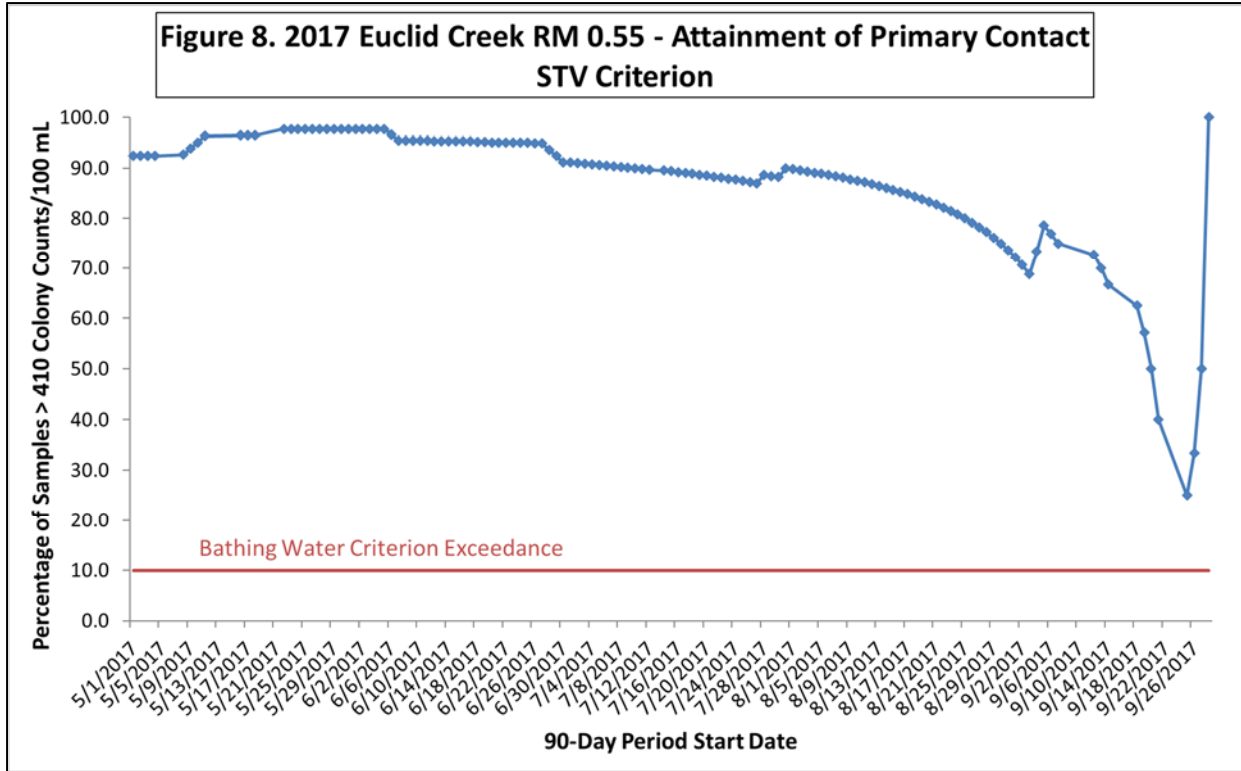
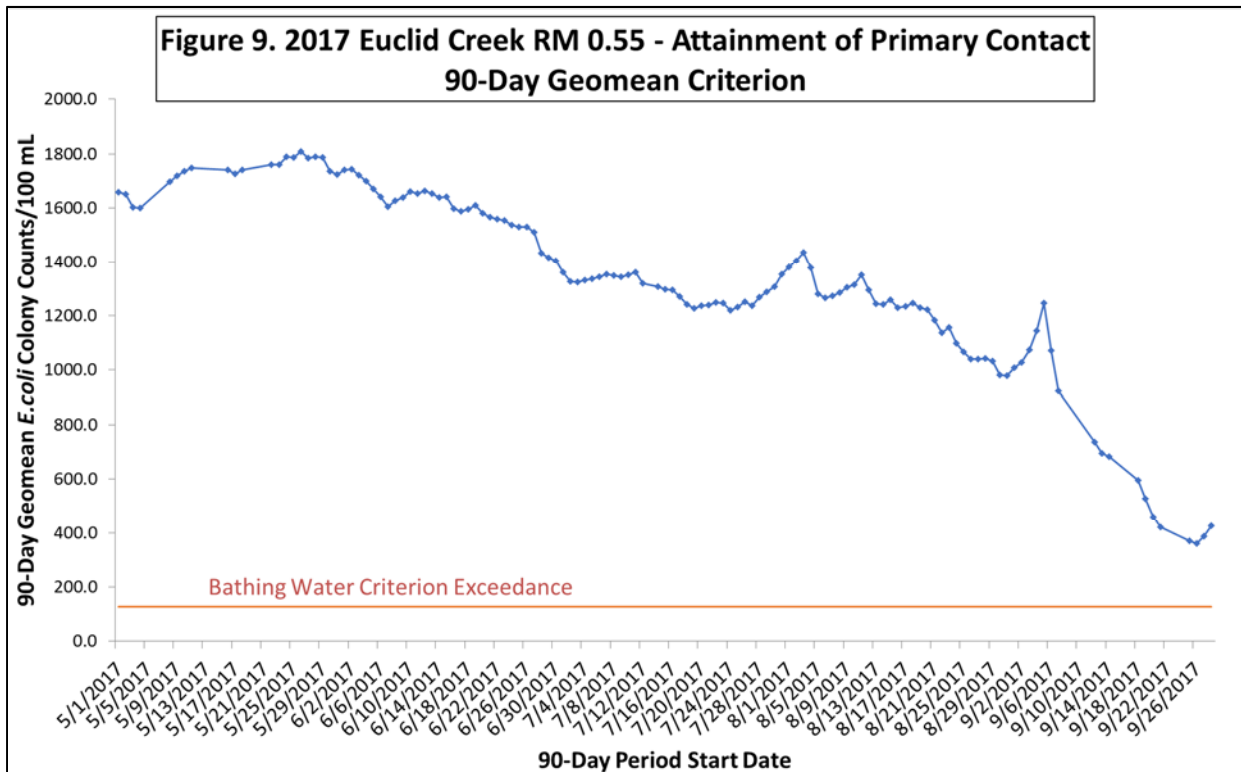
Euclid Creek was in non-attainment of both Primary Contact recreational criteria in 2017 (Figures 8 & 9). Euclid Creek exceeded both the STV and geometric mean criteria for 100% of the 90-day periods. As further discussed below, Euclid Creek RM 0.55 has displayed this degree of exceedance for as long as monitoring has been performed by the NEORS.

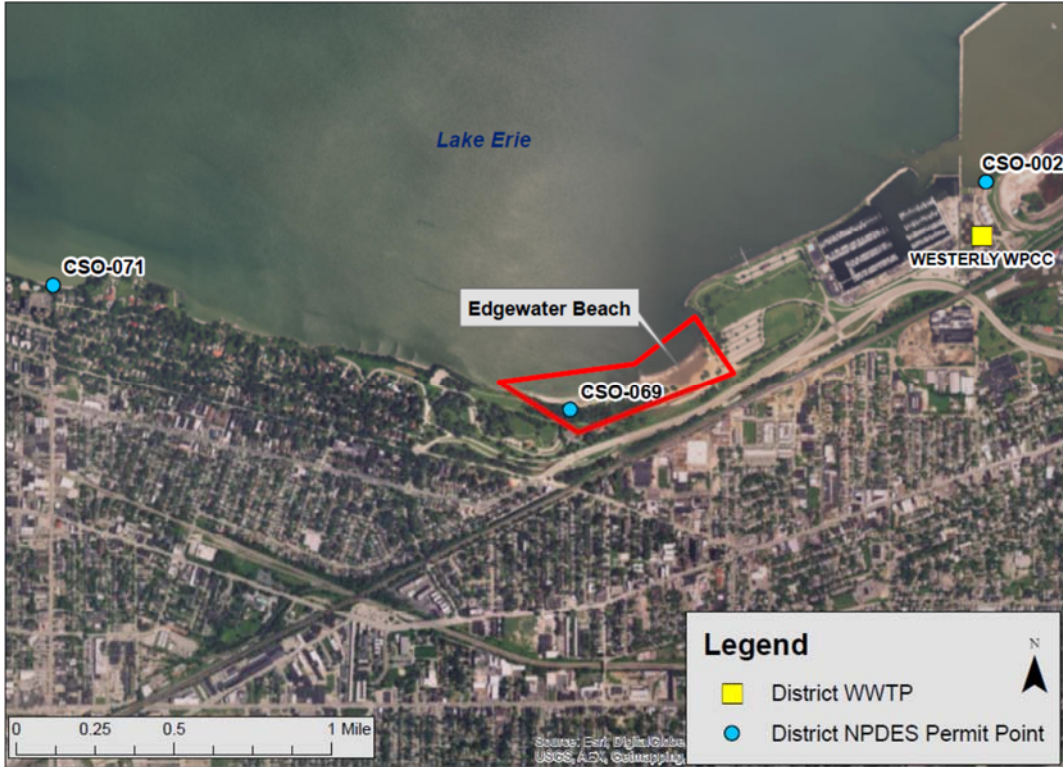
Figure 10. Proximity of CSO Outfalls to Edgewater Beach

Combined sewer overflow discharge may have contributed to the elevated *E. coli* densities observed at Villa Angela and Euclid beaches. Proximity of nearby CSO outfalls to Edgewater, Euclid, and Villa Angela Beaches are shown in Figures 10 and 11. The number of overflow events and total volume of discharge from each of the listed CSOs from May 1 to October 31, is presented in Table 5. In the proximity of Edgewater Beach, only 8 overflow events occurred during the 2017 recreational season, all from CSO-002, the Westerly Wastewater Treatment Center Overflow. This was decreased from 16 overflow events from 2015, a relatively rainy year, further emphasizing the impact that the dry season in 2017 had on factors influencing beach water quality.
