Northeast Ohio Regional Sewer District

2020 Lake Erie Beach Monitoring

**Water Quality and Industrial Surveillance
Environmental Assessment Group
April 2021**

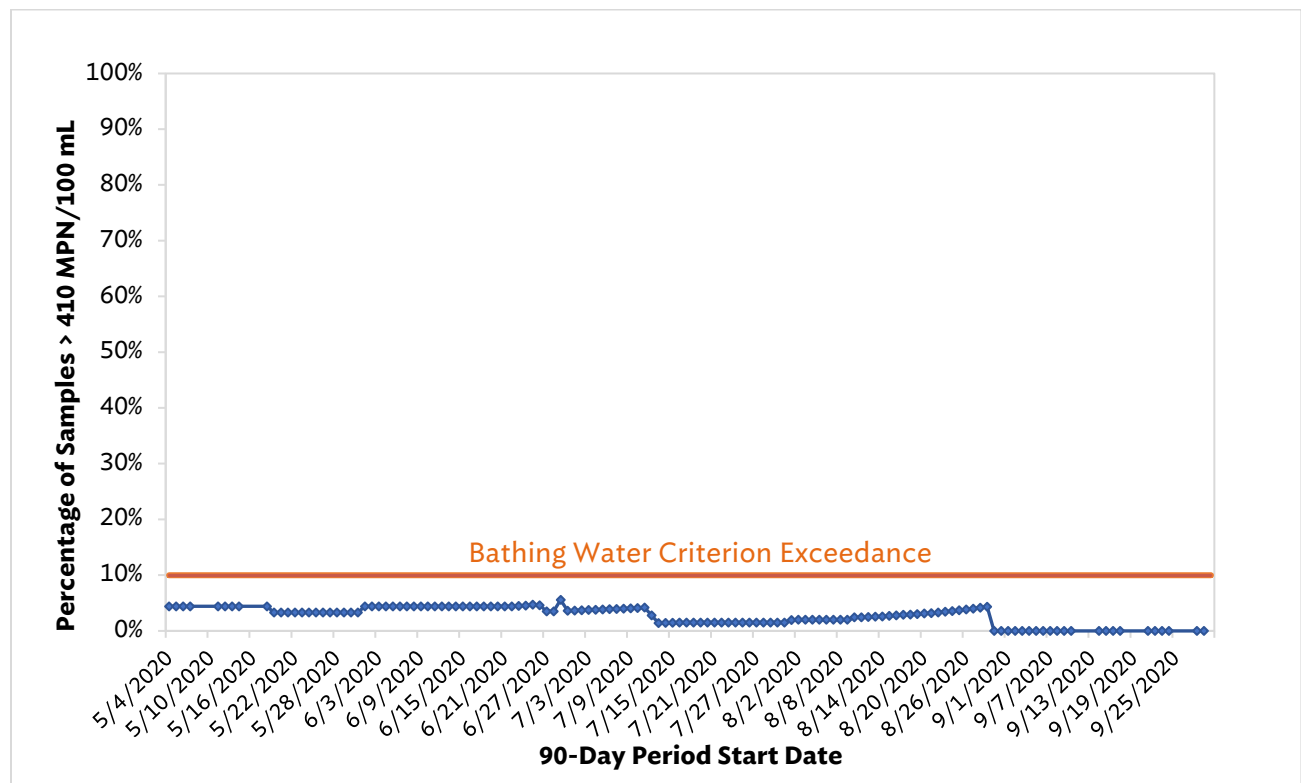
Figure 2. 2020 Edgewater Beach East Site - Attainment of Bathing Water STV Criterion

Water Quality Standards attainment status of Edgewater Beach for Bathing Water recreational use criteria are shown in (Figures 2 and 3). Edgewater Beach was in attainment of the recreational use criteria for all of 2020, as there were no exceedances of the STV or geomean criterion for the 90-day periods. Single samples exceeded the Beach Action Value of 235 colony counts/100mL for 17 of the 135 sampling events, a frequency of 12.6%. Fifteen of the 17 exceedances of the Beach Action Value (88.2%) occurred within 48 hours of a rain event with a total rainfall greater than 0.10 inches.

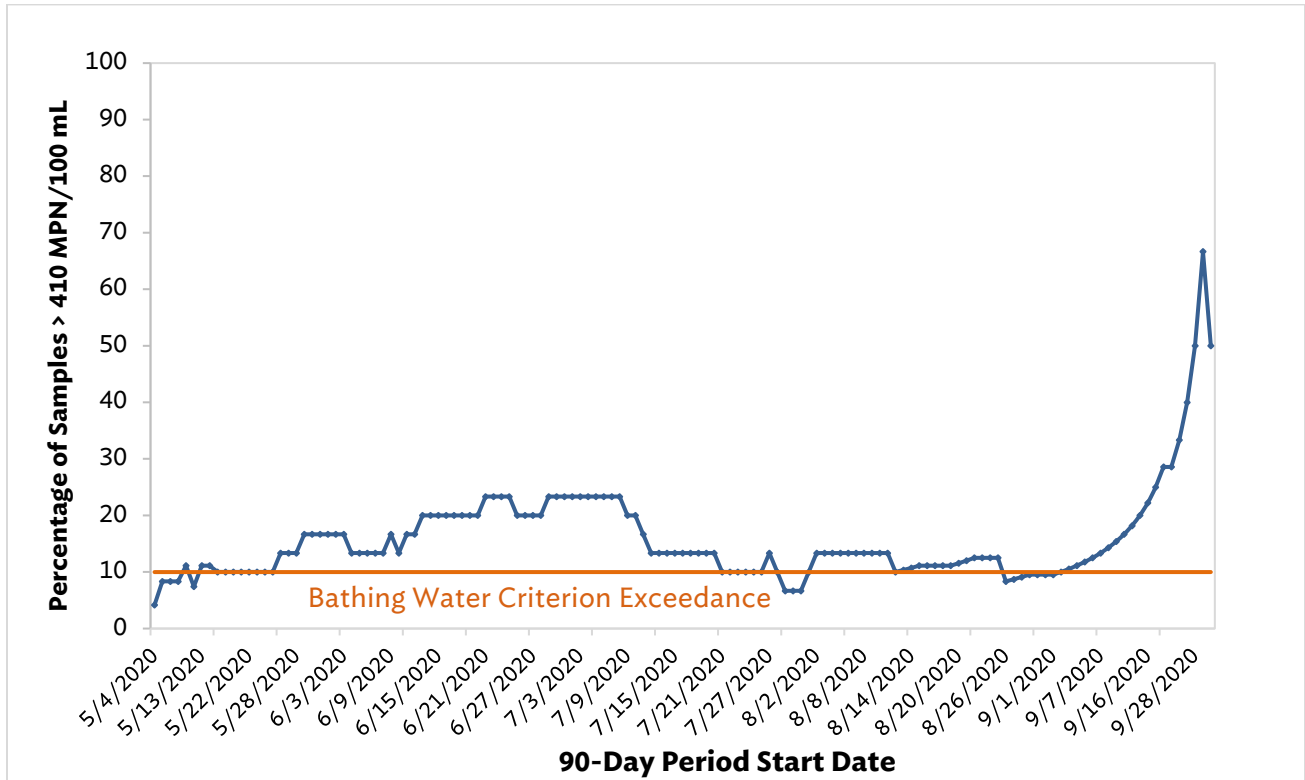
Figure 6. 2020 Villa Angela Beach East Site - Attainment of Bathing Water STV Criterion

Villa Angela Beach was also in non-attainment of the Bathing Water recreational use criterion for most of 2020 (Figures 6 and 7). Villa Angela exceeded the STV criterion for 74.8% of the 90-day periods and exceeded the geomean criterion for 3.7% of the 90-day periods in 2020. Single samples exceeded the beach action value of 235 colony counts/100mL for 27 of the 135 sampling events, a frequency of 20.0%. Sixteen of these 27 exceedances (63.2%) occurred within 48 hours of a rain event with a total rainfall greater than 0.10 inches.

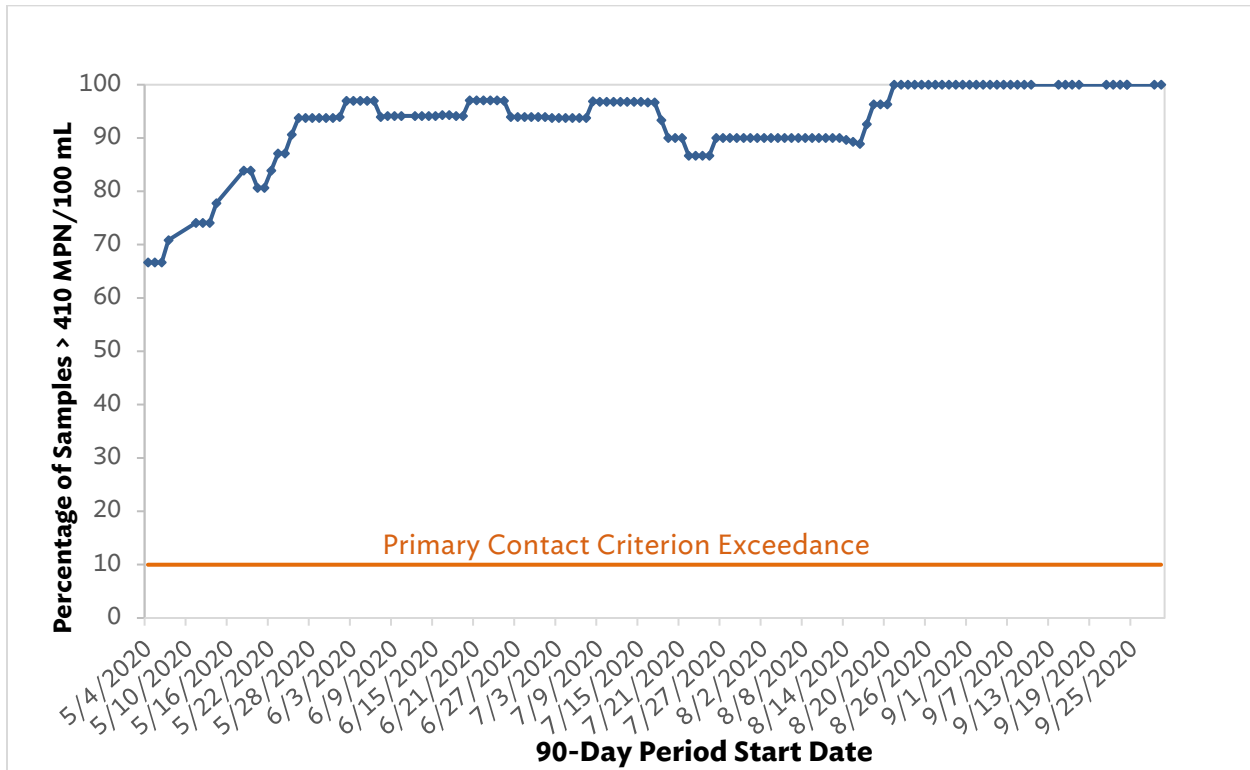
Figure 8. 2020 Euclid Creek RM 0.55 - Attainment of Bathing Water STV Criterion

Euclid Creek was in non-attainment of both Primary Contact recreational criteria in 2020 (Figures 8 and 9). Euclid Creek exceeded both the STV and geomean criterion for 100% of the 90-day periods. As further discussed below, Euclid Creek RM 0.55 has displayed this degree of exceedance for as long as monitoring has been performed by the NEORS.

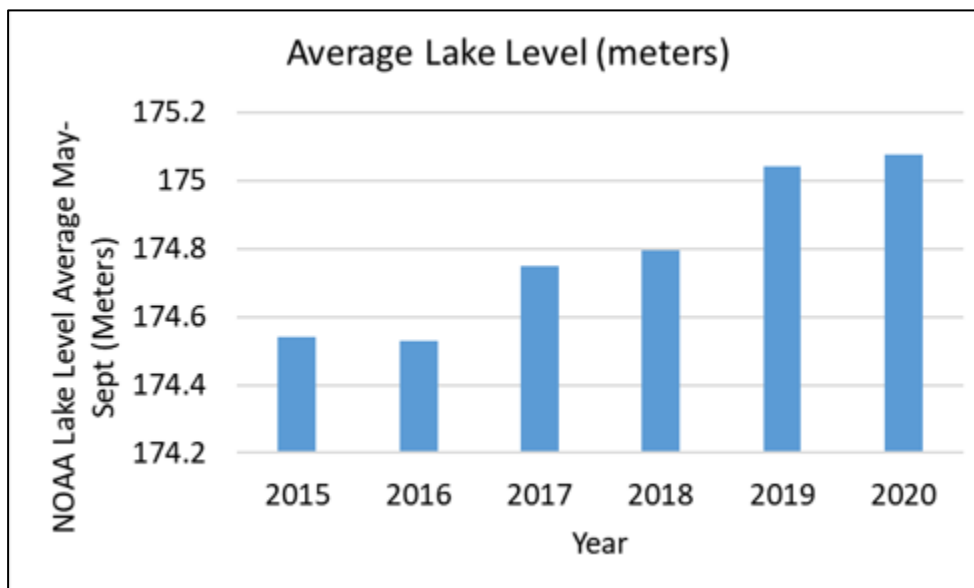
Figure 10. NOAA Lake Erie water average water level May-September

Euclid Creek did not see a reduction in *E. coli* densities during the 2020 recreational season, as discussed later in the report. It is unclear what caused the reduction in *E. coli* densities at the beaches during 2020, though it is possible that elevated Lake Erie water levels may have contributed to the improved water quality. Lake Erie water levels have increased by approximately one foot since 2018 (Figure 10). The USGS Euclid Creek Flow Gauge located at Lakeshore Boulevard (RM 0.60) measured daily discharge during the 2020 recreational season. The Euclid Creek daily discharge geometric mean decreased from 27.0 cubic feet per second (CFS) during the 2019 recreational season, to 13.1 CFS in 2020. Additionally, backflow conditions at Euclid Creek were regularly observed from May-October. Villa Angela and Euclid Beaches have likely been less impacted from Euclid Creek, especially during dry-weather and low flows, because the elevated lake water levels have caused a decrease in Euclid Creek discharge. It is also possible that the lower

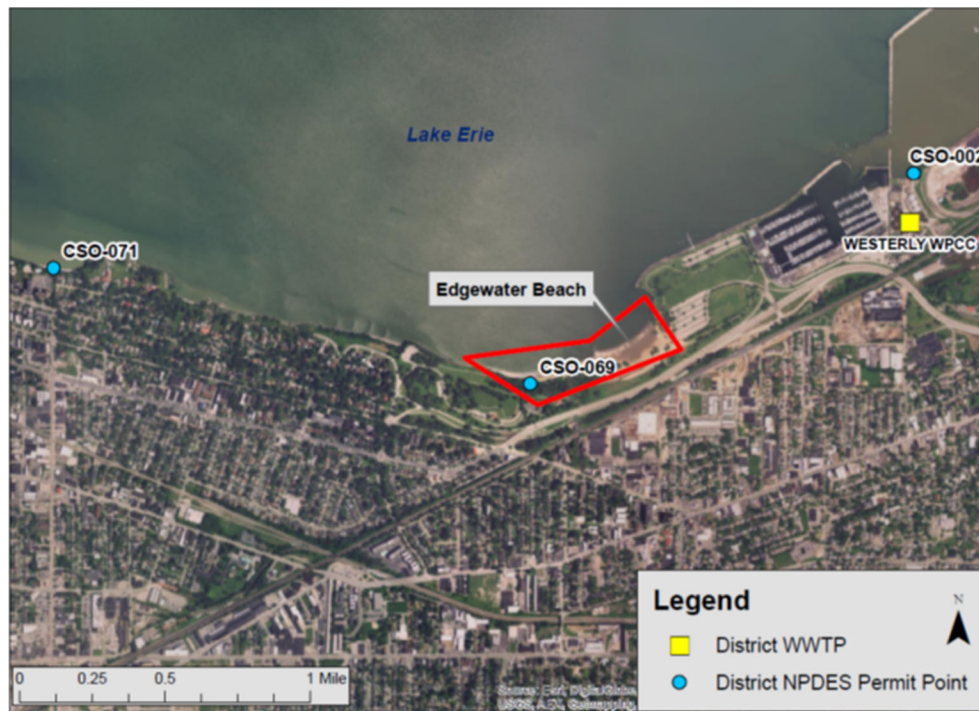
Figure 11. Proximity of CSO Outfalls to Edgewater Beach

Combined sewer overflow discharges may have contributed to the criteria exceedances at Villa Angela and Euclid Beaches in 2020. Proximity of nearby CSO outfalls to Edgewater, Euclid, and Villa Angela Beaches are shown in Figures 11 and 12. The number of overflow events and total volume of discharge from each of the listed CSOs from May 1 to October 31, is presented in Table 5.

In the proximity of Edgewater Beach, 20 overflow events occurred during the 2020 recreational season. Fourteen of these events occurred from CSO-002, the Westerly Wastewater Treatment Center Overflow, three from CSO-069, and three from CSO-071.

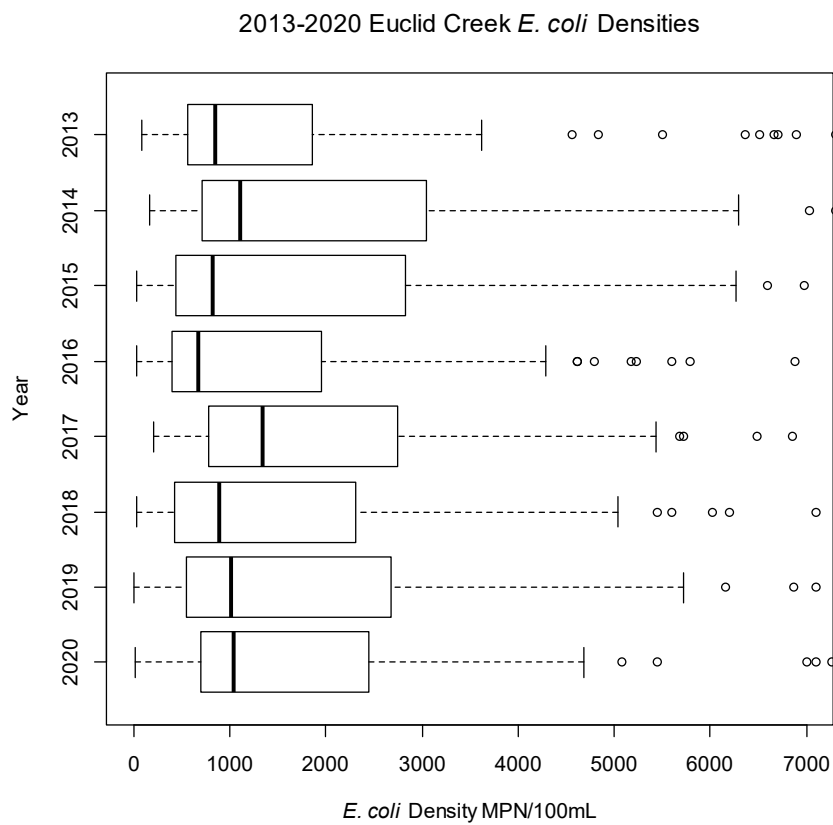
Elevated *E. coli* densities at Euclid and Villa Angela Beaches are additionally influenced by the proximity of these beaches to Euclid Creek. Euclid Creek was in 100% exceedance of the recreational water quality criteria for 11 of the past 12 years. A one-way ANOVA was conducted to compare the annual differences of *E. coli* densities at Euclid Creek, from 2013 through 2020. The analysis determined there was not a significant difference in annual *E. coli* densities from 2013 through 2020 ($F(7,1039) = 2.018, p = 0.809$). *E. coli* densities did not vary significantly in 2020 from the previous years, even with the completion of the Euclid Creek Storage Tunnel (Figure 13).

Figure 13. Comparison of Euclid Creek *E. coli* densities from 2013–2020
